**PRELIMINARY SITE
INVESTIGATION
PROPOSED PLAN CHANGE
TO THE WAIPA DISTRICT
PLAN**

**PREPARED FOR:
BARDOWIE INVESTMENTS
LTD**

Contaminated Site Investigation
34 Brookfield Street
Hamilton

**PSI REPORT: PROPOSED PLAN CHANGE TO THE
WAIPA DISTRICT PLAN**

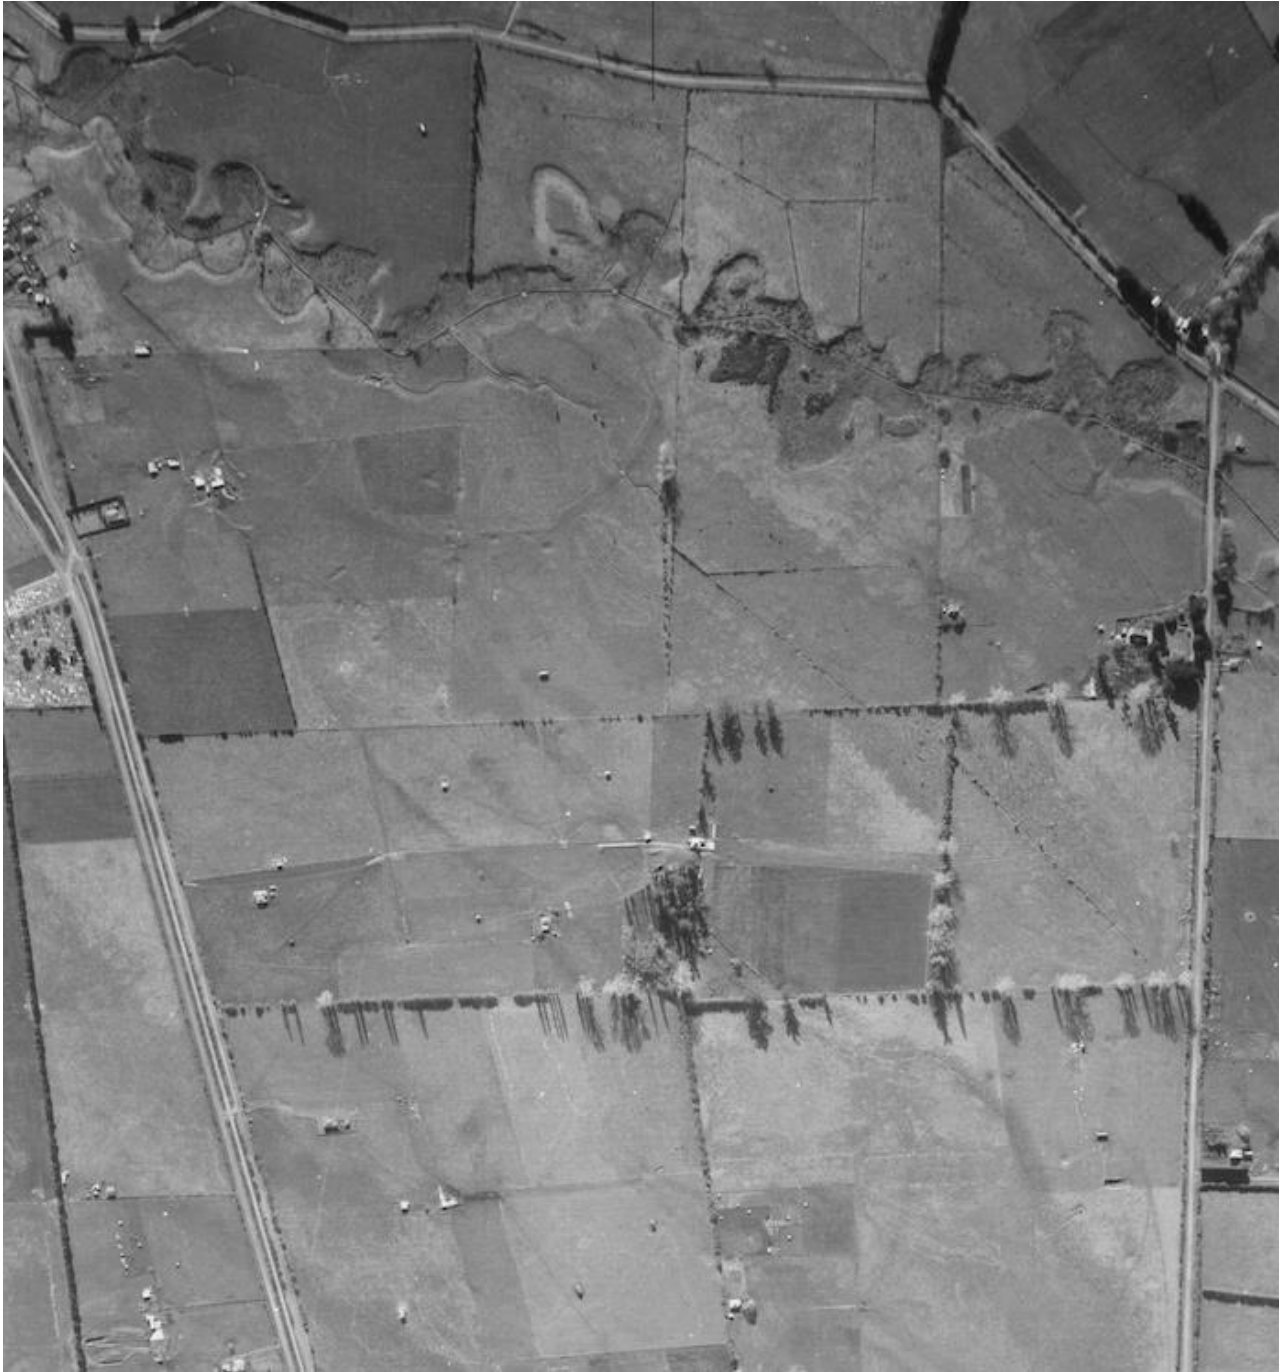
CSI Contaminated Site Investigations 34 Brookfield Street Hamilton	140 – 224 LAURENT ROAD, CAMBRIDGE
	SK01
	1943

- 3.1.1 Reproductions of aerial photos are included in this report as SK01 (1943) to SK8 (2008) and are located in Appendix B.
- 3.1.2 The **1943** reproduction (SK01) shows the piece of land as predominantly pastoral land with structures present across the piece of land. A number of structures are present in the northwest including what appears to be a residential dwelling adjacent to the road. A residential dwelling is located in the southwestern corner. Residential dwellings appear to be located in the central south. A number of small structures are present in the central south. The surrounding land is predominantly pastoral. The Mangaone Stream with an associated gully, wetlands and hollows is present immediately to the north. A grove of trees is present immediately to the southeast as is a residential dwelling. Beyond the road in the west is a cemetery.

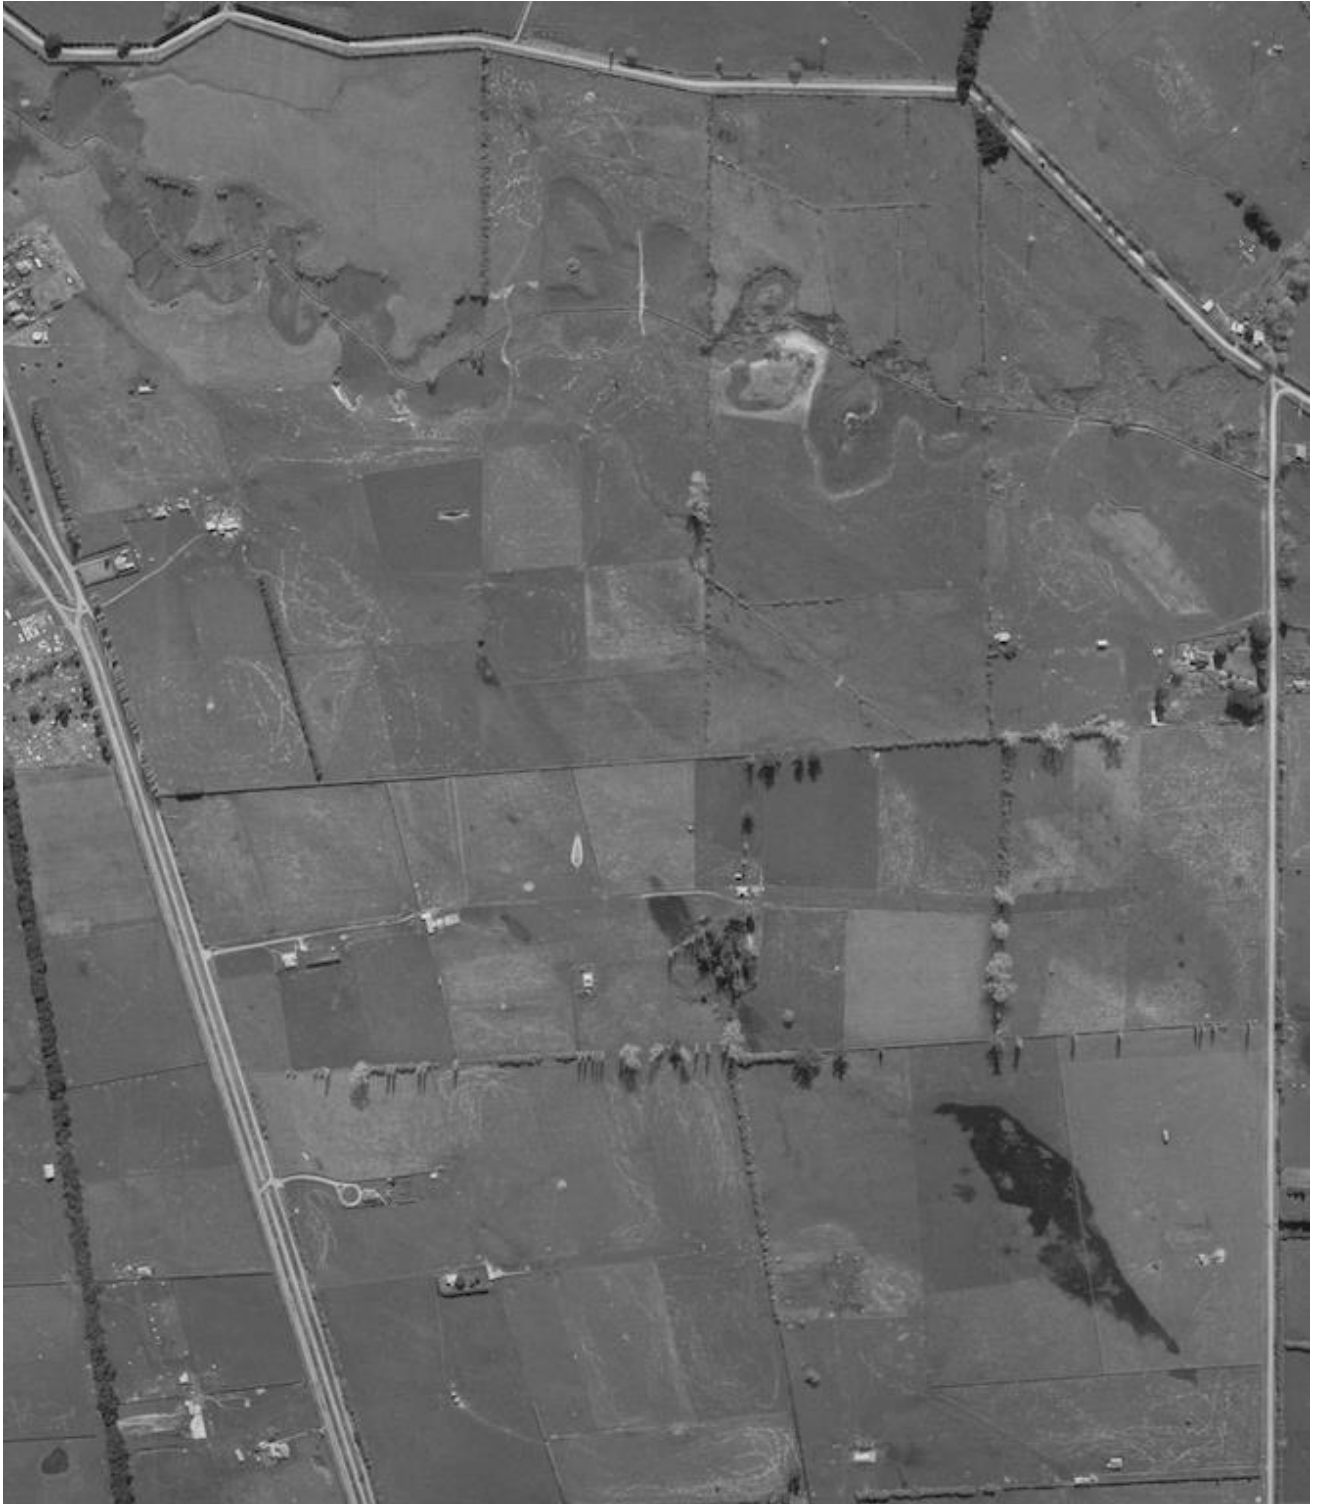
CSI Contaminated Site Investigations 34 Brookfield Street Hamilton	140 – 224 LAURENT ROAD, CAMBRIDGE
	SK02
	1953

- 3.1.3 The **1953** reproduction (SK02) shows similar conditions to the 1943 reproduction with the main difference being the introduction of structures in the southwestern including what appears to be a milking shed and structures in the east and a large pit in the central northeast. The surrounding land also shows similar conditions. However, the grove of trees to the southeast appears to be in a pond/wetland.

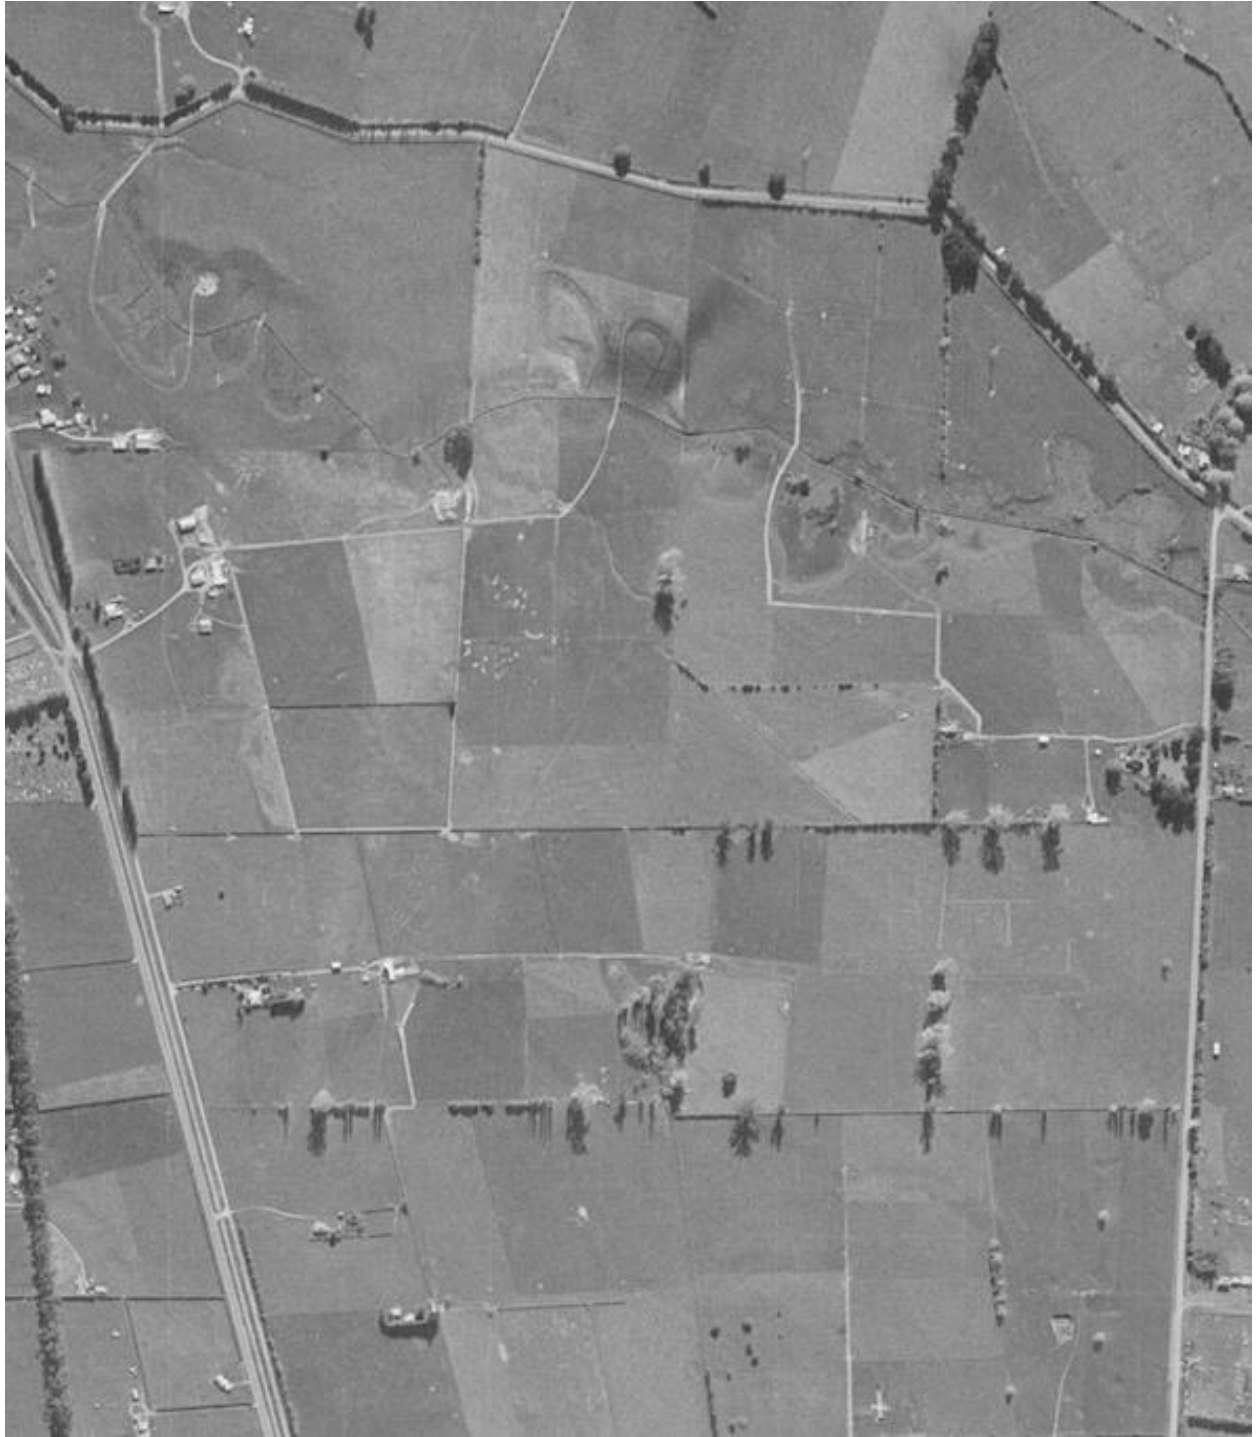
CSI Contaminated Site Investigations 34 Brookfield Street Hamilton	140 – 224 LAURENT ROAD, CAMBRIDGE
	SK03
	1967

- 3.1.4 The **1967** reproduction (SK03) appears to show similar conditions on the piece of land to the 1953 reproduction. The main changes being: the number and size of the buildings in the northwest has increased; a structure is present in the northeast; and the pit has gone. The immediate surrounding land remains similar to the previous reproductions.

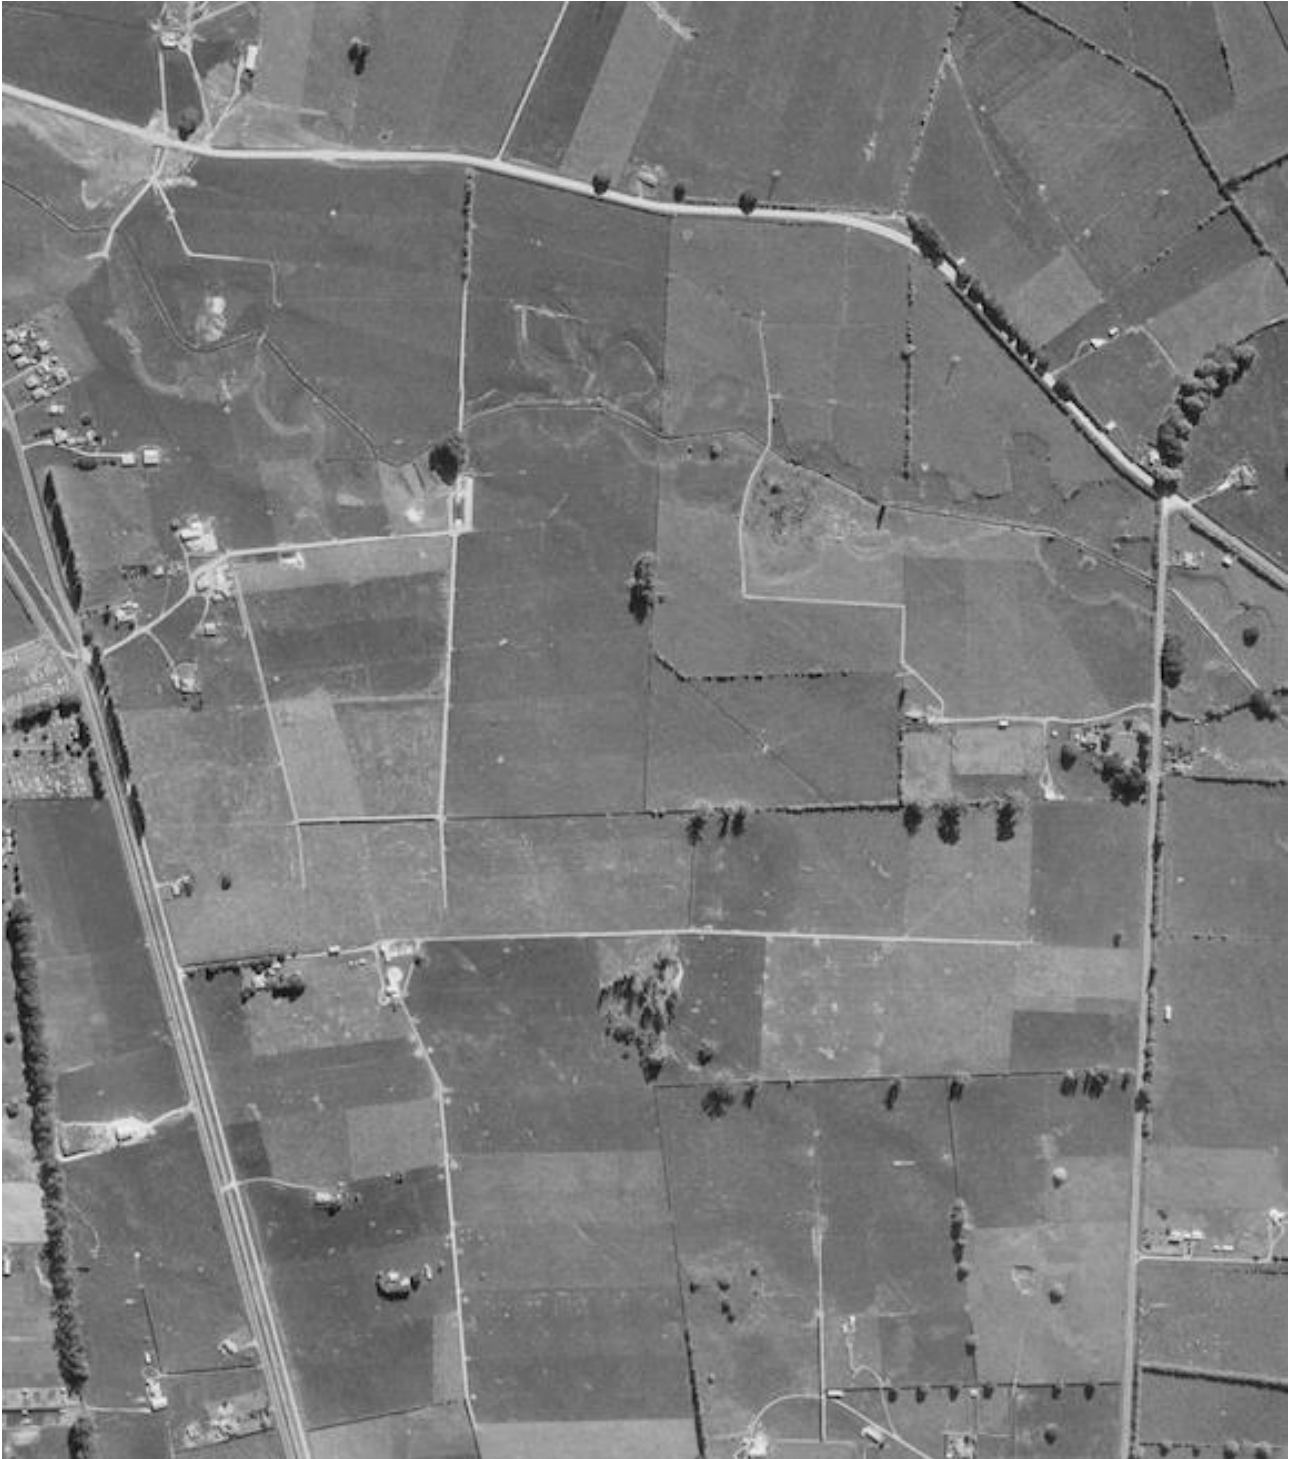
CSI Contaminated Site Investigations 34 Brookfield Street Hamilton	140 – 224 LAURENT ROAD, CAMBRIDGE
	SK04
	1974

- 3.1.5 The **1974** reproduction (SK04) appears to shows similar conditions to the 1967 reproduction. The main changes being: the appearance of two residential dwelling in the west, one immediately south of the cluster of buildings and the second further south; and the removal of the structure in the northeast. The surrounding land remains as predominantly pastoral however, the structures in the southeast have gone.

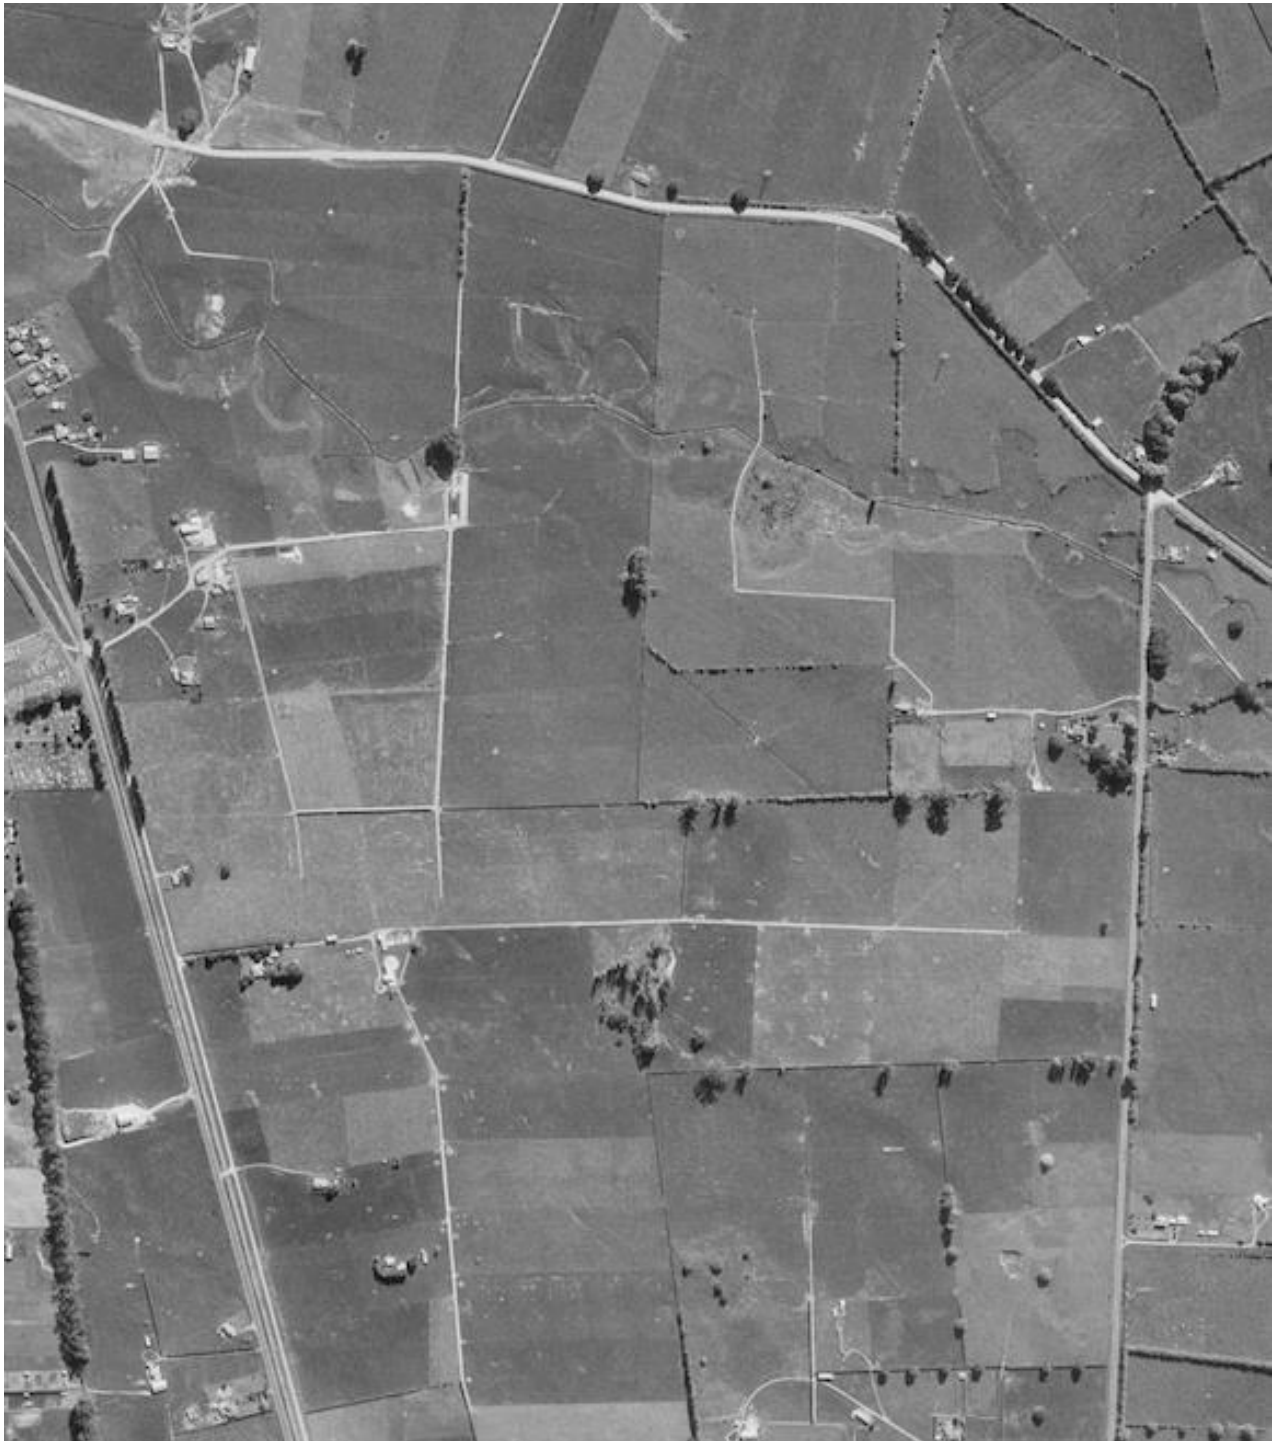
CSI Contaminated Site Investigations 34 Brookfield Street Hamilton	140 – 224 LAURENT ROAD, CAMBRIDGE
	SK05
	1979

- 3.1.6 The **1979** reproduction (SK05) shows very similar piece of land conditions to the 1974 reproduction. The main difference being a series of elongated structures in the north and a pond in the southeast. The immediate surrounding land also remains relatively unchanged to the 1967 and 1974 reproductions however, the majority of trees within the pond/wetland have been removed.

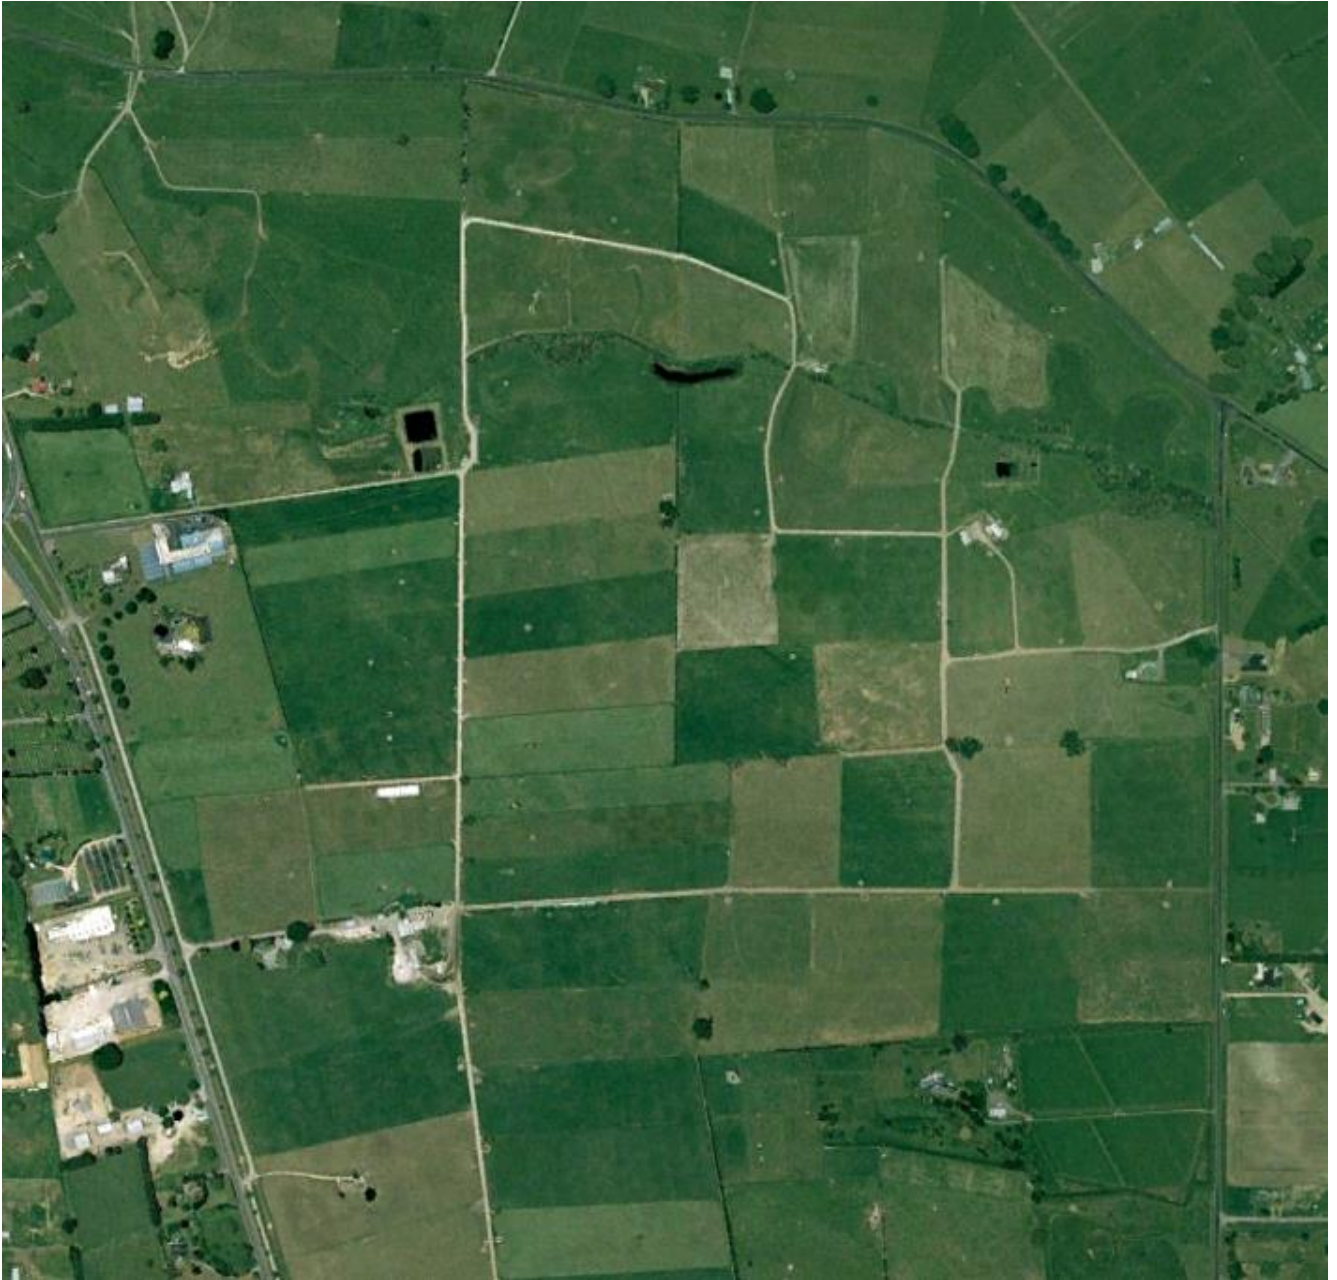
CSI Contaminated Site Investigations 34 Brookfield Street Hamilton	140 – 224 LAURENT ROAD, CAMBRIDGE
	SK06
	2008

- 3.1.7 The **2008** reproduction (SK06) shows the piece of land as pastoral land in the south, east and north with a number of structures including a residential dwelling, a milking shed and silos in the southwestern corner. Also present in the northeast is an effluent pond. A lifestyle block containing a dwelling is present in the west. Immediately to the north is a series of joined buildings with a driveway to Laurent Road. Also present adjacent to Laurent Road is a dwelling and associated garage. The land immediately to the north, northeast, east and south is pastoral with the exception of a residential dwelling in the northwestern corner. The Mangaone Stream including an oxbow lake and wetlands is still present to the north. The land beyond Laurent Road is industrial with exception of the cemetery and vacant land.

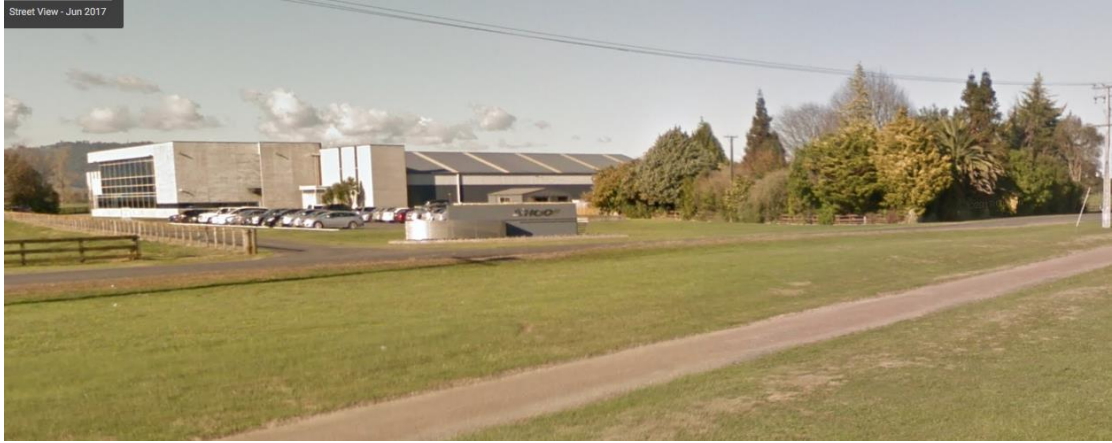
CSI Contaminated Site Investigations 34 Brookfield Street Hamilton	140 – 224 LAURENT ROAD , CAMBRIDGE
	SK09
	2013

- 3.2.1 Reproductions of Google Drive-by images are included in this report as SK09 to SK11 and are located in Appendix C.
- 3.2.2 A **2017** reproduction (SK09) from the southwestern corner on Victoria Road shows a residential house surrounded by pastoral land. In the distance are a number of large structures including grain silos.
- 3.2.3 A **2017** reproduction (SK10) from central Victoria Road shows a residential dwelling surrounded by pastoral land fenced with wooden western style fences.
- 3.2.4 A **2017** reproduction (SK11) from northern Victoria Road shows vegetation and vacant land in the foreground with large structures present in the background. Also present in the foreground is a sign showing 'Shoof'.
