Victoria St Bridge(RP969) - Main Arch Bridge Structural Assessment Report

Prepared for Waipa District Council
Prepared by Beca Limited

10 November 2021

Victoria Bridge-Cambridge Steel Components Inspection Report

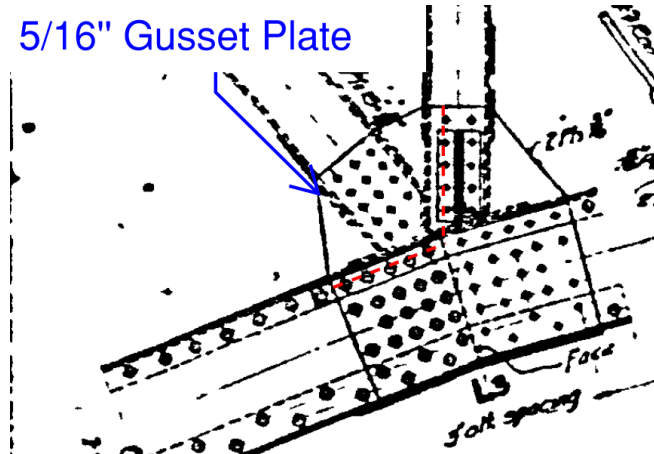
Figure 5-1 – Vertical and horizontal Partial Shear Planes for L3 Gusset

Figure 1 below shows the location of the partial shear planes assessed on the gusset connection. This check considers gross section shear yielding along the vertical and horizontal “partial” shear planes adjacent to the compression member as shown as red dotted lines the figure below.

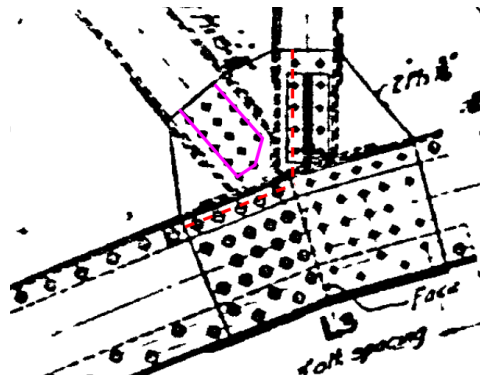
Figure 5-2 – Indicative shear block used for assessment

The Gusset Plate Tensile Capacity check has been undertaken based on block shear failure as indicated along the magenta coloured line in the figure below.

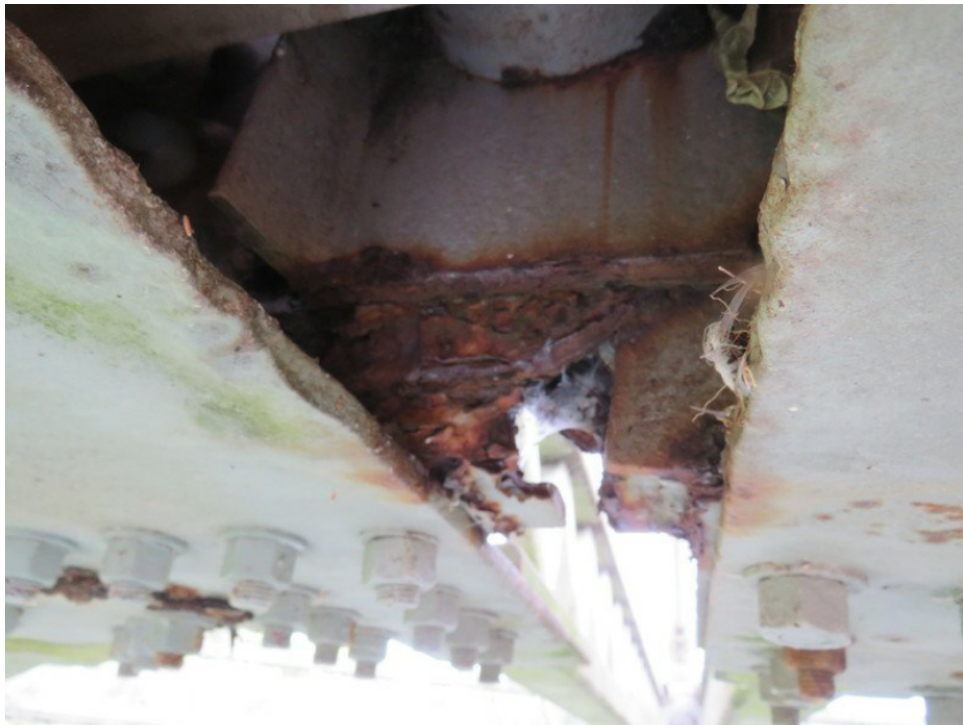
Figure 6-1 – Central Pin (viewed from below) Plate Corrosion

There is significant corrosion in the plates that connect to the pin while the pin itself appears to be in relatively good condition. The 1996 assessment report (BBO) calculated the capacity of the pin connection to be 2125kN. We understand this was based on a yield stress of 200MPa, with an allowance for deterioration in the bearing plates of 25%. The central pin joint was not considered to be the most critical component of the bridge and was reported by BBO to provide 74% of the live load demand (0.85HN), increasing to 158% of the live load demand if the deck sliding joint is assumed to have seized up.

- Remedial repair details for the original central pin bearing plates from the bottom chord should be developed to restore reliable full load transfer of the original pin bearing mechanisms, as there is a potential risk if the outer plates deteriorate further the pin assembly may become laterally unstable from eccentric loading. As these are at load bearing interfaces, the repair will not be straight forward.

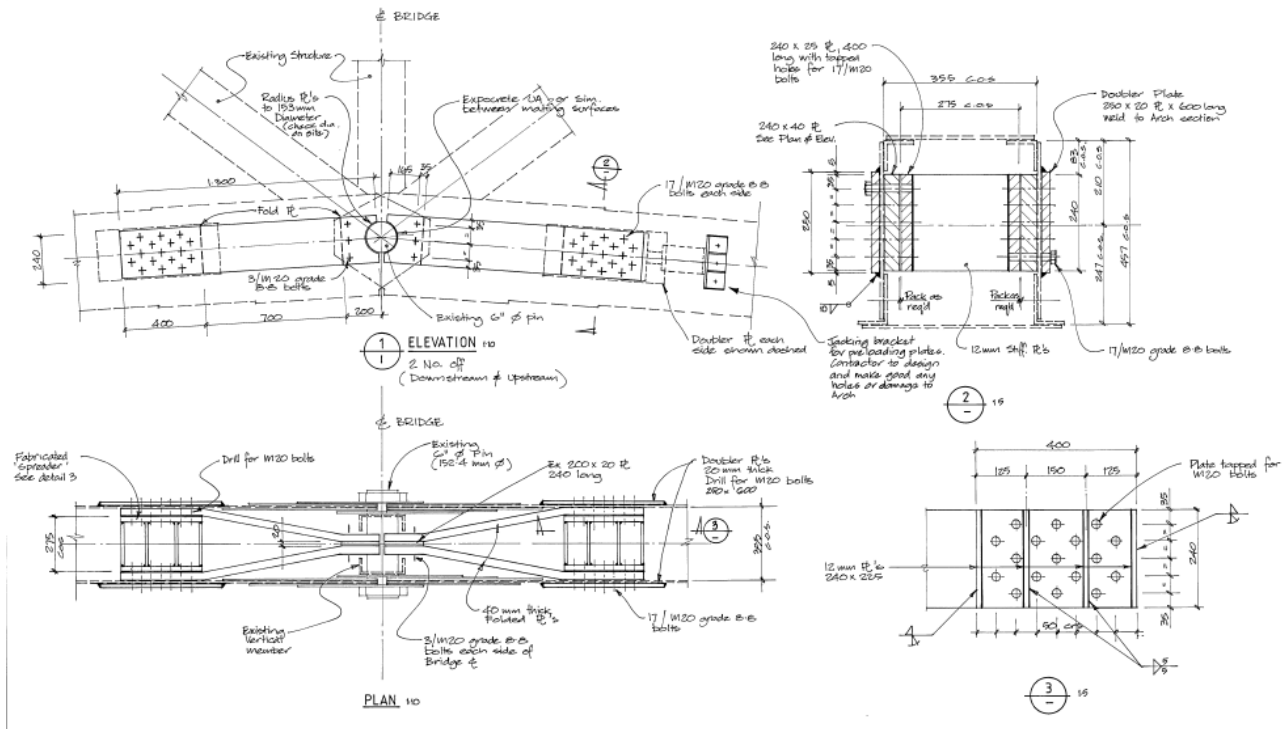
Figure 6-3 – Central Pin Upgrade Details (1998)

In 1998 (approximately) additional plates were installed at the central pin joints to improve the capacity of the connection, although it is not clear if these plates were designed to take the full design load or a portion of it.

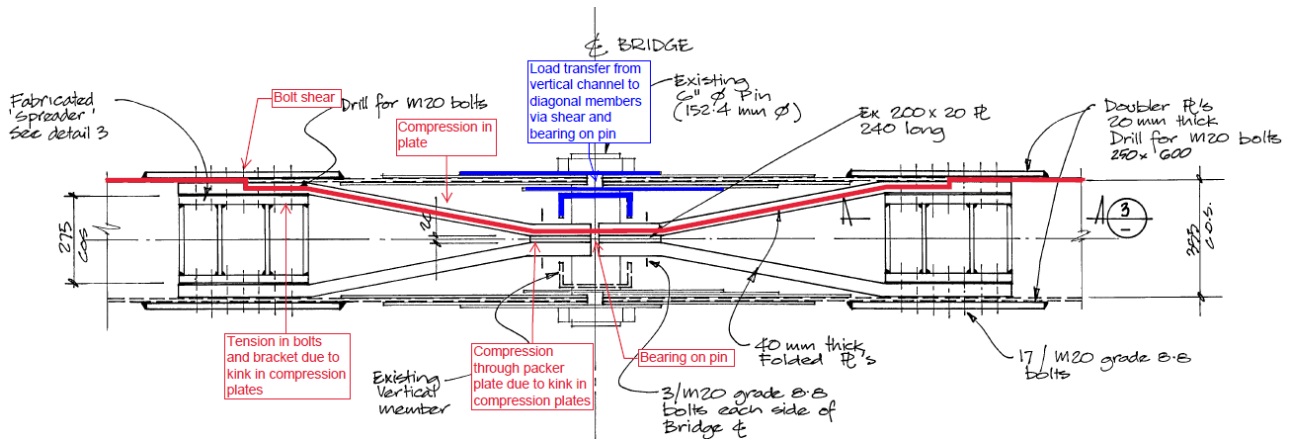
Figure 6-4 – Load path for axial loads in arch members(plan view)

The 1998 pin upgrade plates transfer compression between the main arch members either side of the joint. The load path through these plates is indicated in red in Figure 6-4 below. If the original load path is compromised due to corrosion the load will divert to the upgrade plates. The load path through the additional upgrade plates has been determined to have a capacity of 2700kN. This is based on an assumed yield strength of 200MPa for the original arch truss elements and 250MPa for the upgrade plates. The assessment considered pin shear, pin bearing, plate axial section capacity, plate axial member capacity and combined bolt shear and tension. No allowance has been made for deterioration (wear or corrosion) in the

Compression in the vertical members above the pin transfers to the diagonal members and arch chord members via the original bearing plates. The load path through these plates is indicated in blue in Figure 6-4 below. If the load path via the original plates is compromised by corrosion in the plates the load could transfer to the arch chord via the upgrade plates, however, this will result in bending and shear in the pin due to the offset between the plates. The pin bending and shear capacity is calculated to be adequate for the ULS Case 1 (cars) demands in the vertical and diagonal members, should these loads need to transfer to the upgrade plates. Note however that if the axial loading in the vertical arch members cannot transfer to the pin due to excessive corrosion in the attachment plates, then the load carrying capacity of the bridge deck structure would be compromised. Hence the integrity of the connection between the vertical channels and the pin needs to be maintained.

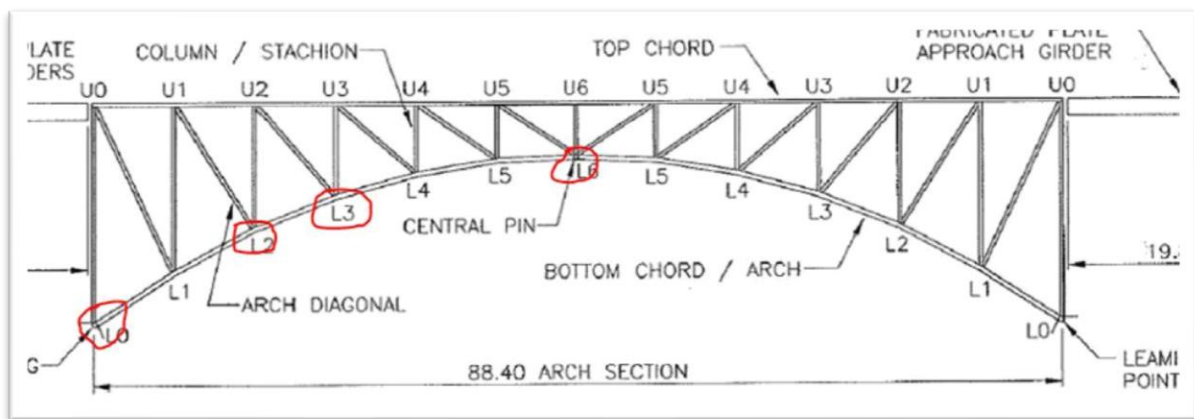
Inspection Locations

A visual assessment of the predetermined structural elements on the Victoria Bridge, Cambridge was carried out in June 2021 by Lumen. Components that were inspected were at connection points of the bottom arch on L0, L2 (upstream and downstream), L3 (upstream and downstream) and L6/Central Pin (upstream and downstream). Multiple steel member measurements, a visual assessment of corrosion and metal loss as well as other potential defects were inspected and recorded.
