Shakespeare Street / Cook Street Roundabout

Post Construction Safety Assessment

Project title	Shakespeare Street/Cook Street Roundabout
Document type	Post Construction Safety Assessment
Report number	2408021
Revision number	1

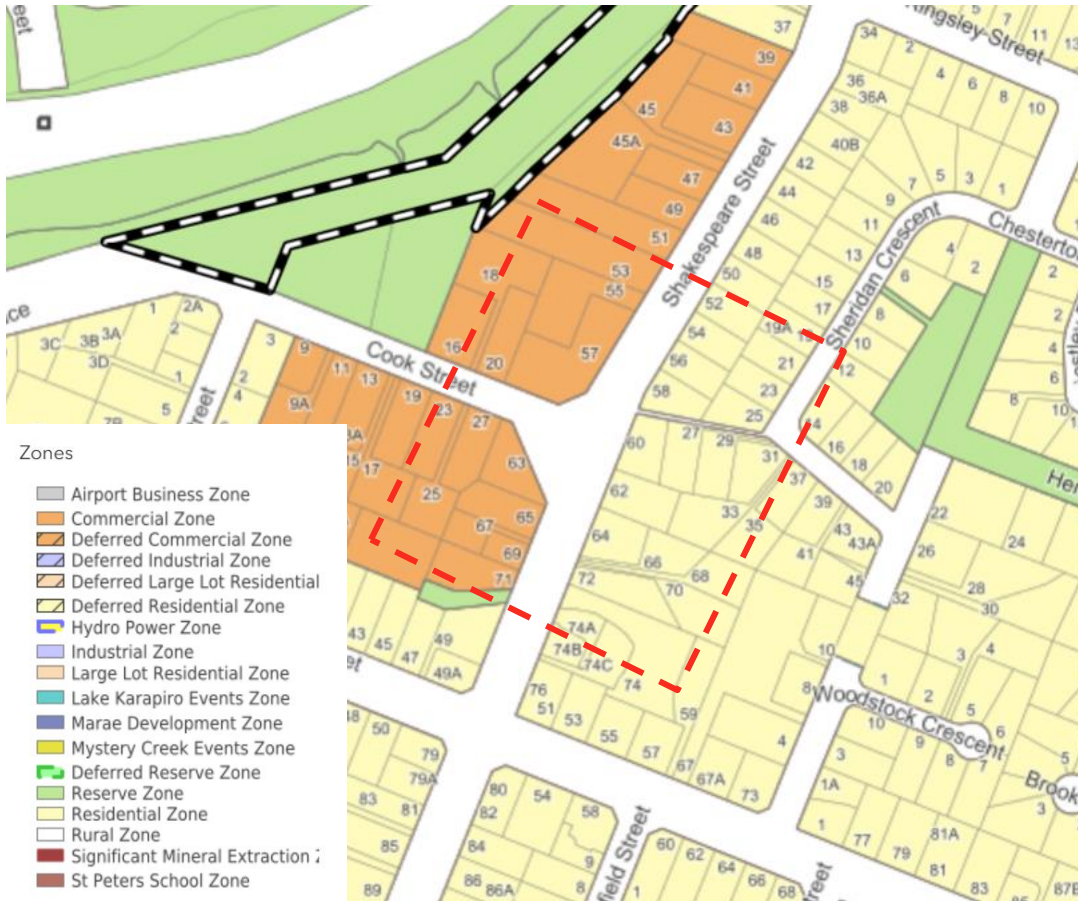
Figure 3: Land Use Around the Project Site (Source: Waipa District Plan)

According to the Waipa District Plan (revision 7 June 2024), as shown in **Figure 3**, the project site is surrounded by the Commercial Zone and the Residential Zone. It is also in close proximity to number of Reserve Zone.

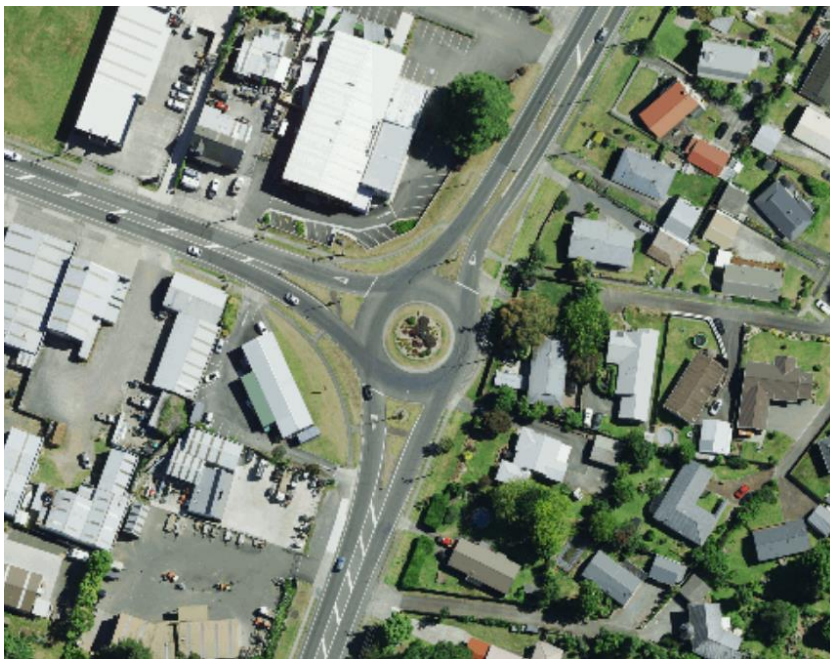
Figure 4: Shakespeare Street/Cook Street Roundabout: Pre-Construction

Features ⁴	Shakespeare Street (N)	Shakespeare Street (S)	Cook Street
Approach lane Width (m)	5.8	6.5	6.2
Exit Lane Width (m)	5.1	6.8	6.3
Footpath Widths (m)	Eastern: 1.1 Western: 1.1	Eastern: 1.1 Western: 1.5	Northern: 1.7 Southern: 1.5
Pedestrian Refuge Depth ⁵ (m)	1.9	6.1	4.6

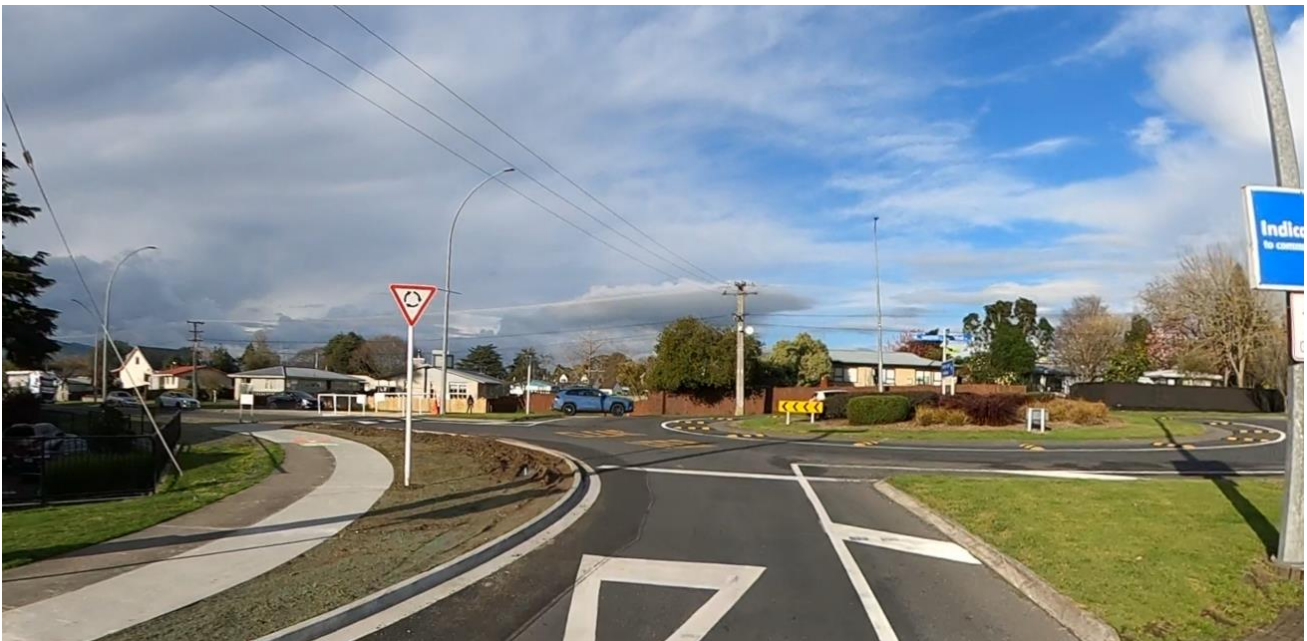
Figure 5: Shakespeare Street/Cook Street Roundabout: Post-Construction

- Widening of roundabout apron using rubber speed humps
- Implementing 'Keep Clear' marking
- Kerb buildout at the northwestern corner to reduce vehicle turning speed
- Staggered Swedish-styled pedestrian crossing at the northern approach with traffic island, footpath refuge median realignment, 'Pedestrian Give Way to Traffic' signs, pedestrian rail, and tactile studs.
- Swedish-styled pedestrian crossing
- Footpath widening to 2.5 m to accommodate the shared-use path
- Shared path marking and signages
- Crossing location allows one vehicle space to stop in front.

The proposed interim design aims to calm traffic speeds at the roundabout by increasing deflection and enhancing the visibility of the crossing point. Additional measures include further calming traffic at the crossing point and providing adequate refuge space at the traffic medians for cyclists and pedestrians, which is currently lacking, particularly for cyclists, as it forces them to encroach into traffic lanes. These changes are designed to improve safety without compromising the potential for future comprehensive redesign efforts.

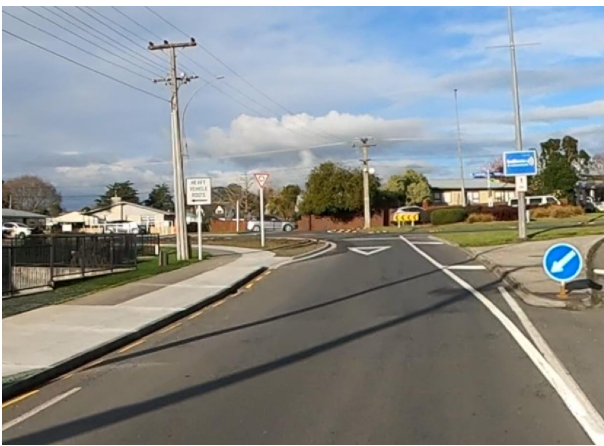
Figure 6: Kerb buildout constructed at the northwestern corner of the roundabout

- Reduced circulating speed by all vehicles due to the improved horizontal deflections.
- Slower turning speeds for left turning vehicles from Cook Street due to the kerb buildouts.

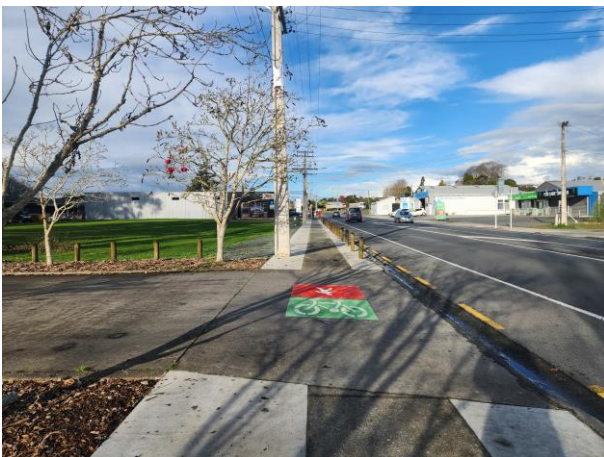
Figure 7: Widened shared path at the northern side of Cook Street

- Improved path spacing and path markings on the northern side of Cook Street to encourage the shared use by path users.

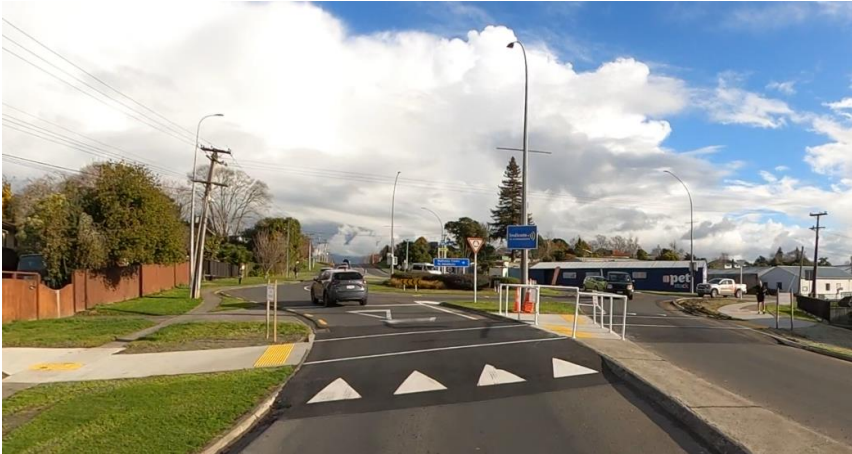
Figure 8: Swedish-Styled pedestrian crossing point Swedish-styled pedestrian crossing point on the northern approach of the roundabout

- Vehicles approaching the Swedish-styled pedestrian crossing point on the northern approach to this roundabout travel at a slower speed due to the raised platform and the kerb buildout.

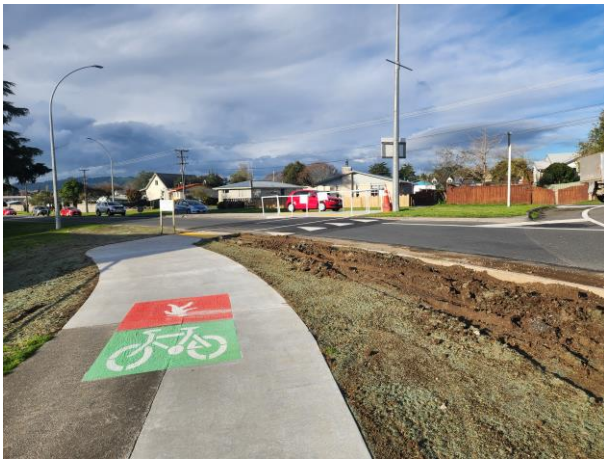
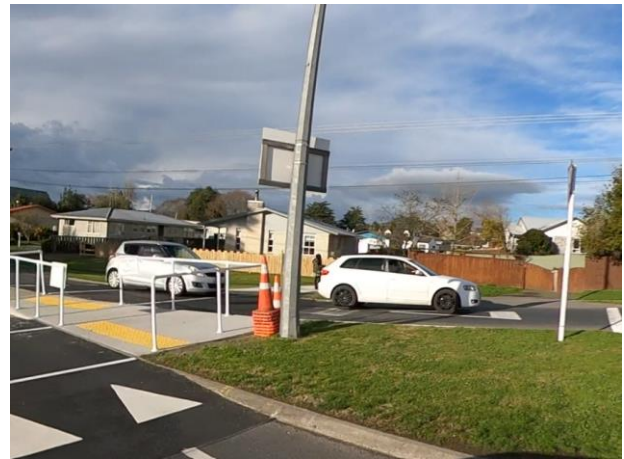
Figure 9: One vehicle space allowed before or after the Swedish-styled pedestrian crossing point on the northern approach of the roundabout

- The traffic median islands have been realigned with a staggered pedestrian walkthrough and pedestrian fence to discourage pedestrians from crossing the road without checking, as well as, providing sufficient stacking space for one car length before or after the crossing point to prevent cars from overhanging onto the circulating lane or crossing point. The widened traffic median island can also accommodate a bicycle at an angle, with the fence reducing the likelihood of bicycles from encroaching onto the traffic lane.

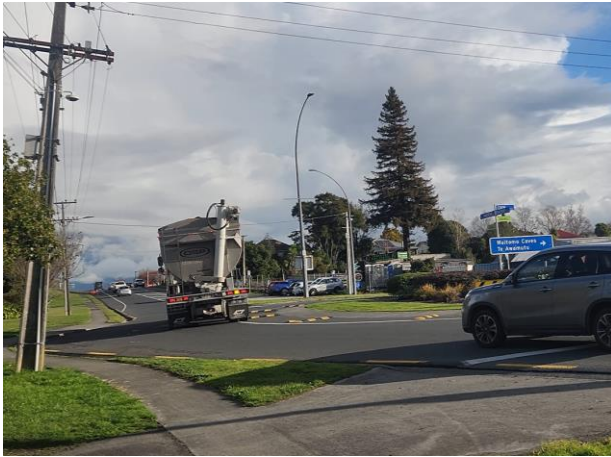
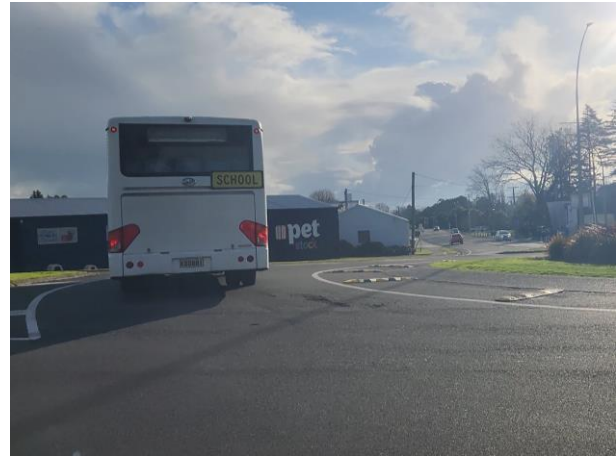
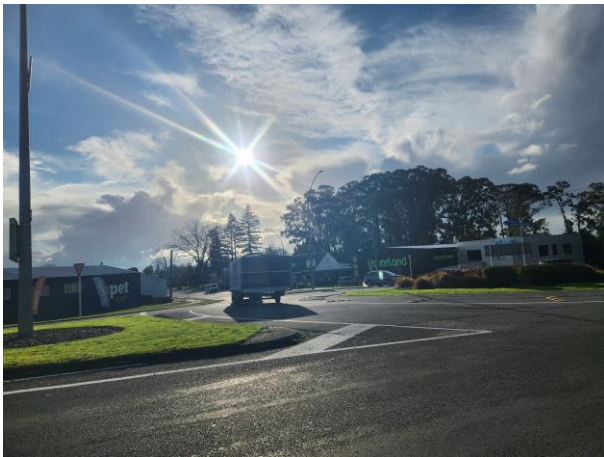
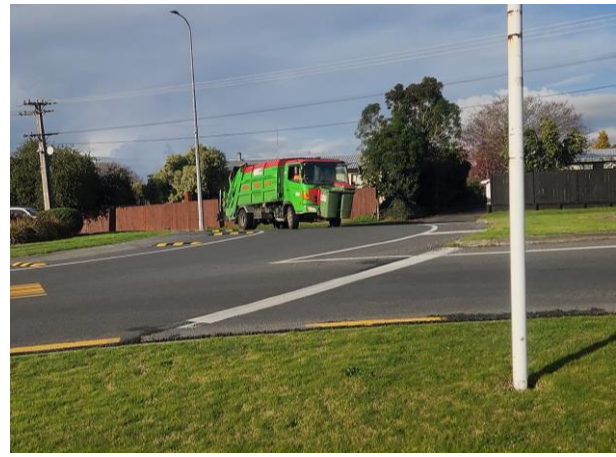
Figure 11: Various Heavy Commercial Vehicles Navigating the Roundabout Without Issues

During post-construction observations, 22-m trucks and trailers, buses, and other heavy commercial vehicles were observed navigating through the roundabout at a slow speed with minimal need to mount the rubber speed humps (Figure 11). However, wheel tracks were observed on the berm of the northwestern corner of the roundabout (Figure 12). Safe System Solutions were informed by Waipa District Council that this was caused by a house mover, which had mistakenly taken the wrong route around the roundabout.

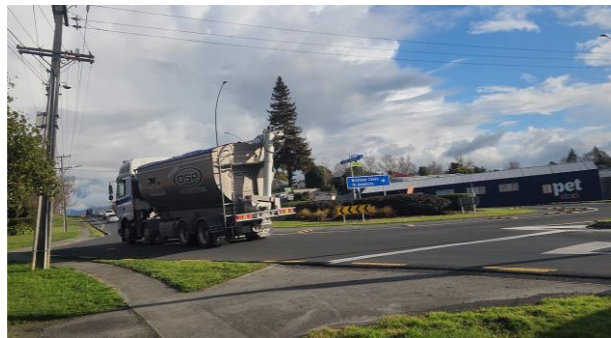
#	Category	Safety Findings	Level of Safety Risk	Recommendation	Effectiveness	Cost
1.	Vehicle Operations	<p>During the site visit, reviewers noted that rubber speed hump modules were used as an extension to the mountable apron area, with spacing of approximately 2-3 m. While most vehicles, including the 22 m truck and trailer was observed to navigate around the speed humps without mounting onto the humps, several safety concerns were identified as follow:</p>

<p>Figure 13: Heavy Commercial Vehicle Navigating the Roundabout Without Mounting the Rubber Speed Humps</p> <p>I. Rubber speed humps are typically used in low-volume, low-speed environments. While they are sometimes installed at light industrial vehicle accesses, they are generally not as durable as concrete or asphalt aprons. Furthermore, rubber speed humps are designed to be oriented perpendicularly to the traffic flow. When vehicles enter or mount the speed humps at an angle, it can cause the front wheels to rise and fall not concurrently, potentially leading to instability and affect the safe operation of larger vehicles such as buses and heavy commercial vehicles. Additionally, the interlocking modules and fixings of the rubber speed humps are not designed for the heavy loads with high turning and mounting movements, this can reduce the speed humps durability. During the site visit, some damaged speed humps and broken pieces were observed. These damaged speed humps and fragments could pose hazards to vehicles, increasing the risk of loss-of-control crashes, especially for motorcyclists</p>	Medium	Consider undertaking vehicle tracking checks on as-built drawings or post-construction survey to verify whether the largest vehicles that commonly use this roundabout require to mount the rubber speed hump area.	N/A	N/A

If vehicles are expected to use the rubber speed hump area, consider using more robust materials that can be recommended by the manufacturer, or replacing it with a concrete or asphalt apron to withstand the mounting and turning impacts from the high volume of heavy commercial vehicles at this roundabout.	High	High
				If vehicles are not expected to use the rubber speed hump area, consider replacing the speed humps with more substantial features that discourage vehicle use, such as modular speed cushions, a semi-mountable kerb apron or concrete blocks. Careful consideration should be given when selecting the replacing measures to prevent the shifting of risk type.	Medium	Low to High
				Consider extending or realigning edge-line markings at the approaches of the roundabout based on tracking checks to provide more horizontal deflections	Low	Low

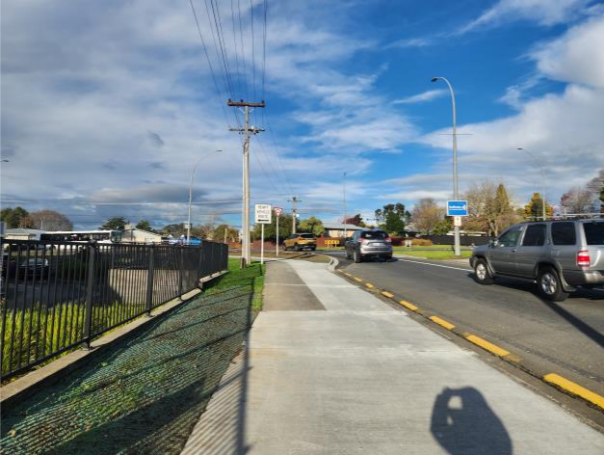
2.	Walking and Cycling	<p data-bbox="471 911 1412 1209">Even though the approach sight distance assessment previously conducted on the preliminary design drawing (Appendix A) and during the post-construction site visit shows compliance. However, the close proximity of the Swedish-styled pedestrian crossing to the roundabout, combined with the potential distraction of drivers on Cook Street focusing on other roundabout approaches, may decrease awareness of the raised safety platform and increase the risk of abrupt braking and rear-end crashes. Furthermore, the lack of W14-4 'Hump' signs at the new raised platform, as recommended by the NZTA Pedestrian Network Guide (PNG), results in insufficient warning for approaching vehicles regarding the vertical displacement device hazard.</p>

<p data-bbox="471 1654 1383 1717">Figure 15: Pedestrian Crossing Point Visible but Not Prominent for Approaching Vehicles on Cook Street</p>	Medium	<p data-bbox="1620 911 2510 1008">Consider installing W16-1 'Non-Motorised Users Pedestrians – Pedestrians' sign with supplementary 'On Left' sign on Cook Street, to provide advance warning for approaching eastbound vehicles.</p>

<p data-bbox="1620 1318 2510 1381">Consider installing W14-4 'Hump' sign at the Swedish-styled pedestrian crossing to ensure drivers are aware of the vertical displacement device hazard.</p>

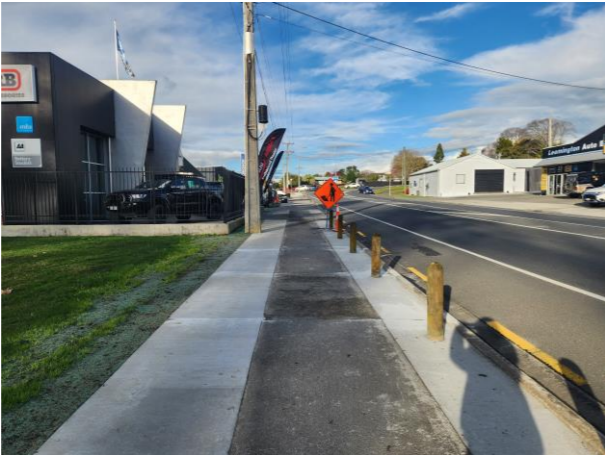
<p>Source: NZTA PNG</p>		
3.	Walking and Cycling	<p>The shared path on the northern side of Cook Street has been widened and enhance the safety and reduce conflicts between path users. Additional improvements can be considered at the path's narrow or pinch points due to timber bollards, power poles, and portable shop signs, to avoid the risks of:</p> <ul style="list-style-type: none"> • path users to steering abruptly to avoid these obstacles, increasing the risk of conflicts with other path users, • conflicting with the street furniture due to unawareness, or • cyclists striking street furniture with their pedals, increasing the risk of losing control or falling.

<p>Figure 16: Timber Bollards and Power Pole Create Pinch Point</p>	Low	<p>Consider relocating the street furniture to prevent them from posing a snagging hazard to path users.</p> <p>Should the above recommendation deemed infeasible due to budget constraints, consider path marking as per NZTA Access Control Devices on Paths Guidelines, to provide sufficient advance warning and tapering to avoid abrupt steering or conflicts with street furniture.</p>	High	High

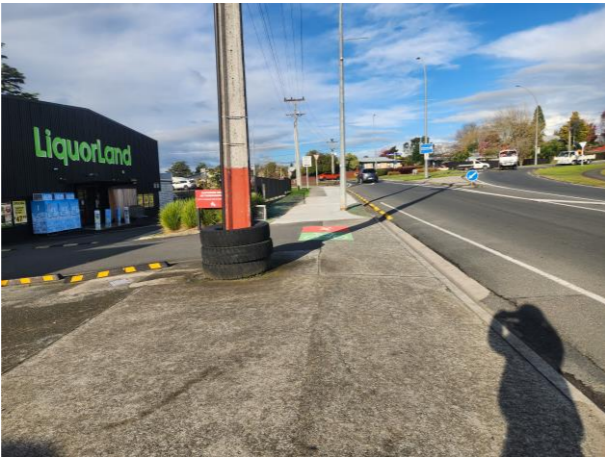
<p data-bbox="471 1339 1184 1367">Figure 18: Power Pole and Street Light Pole Create Pinch Point</p>				
4.	Walking and Cycling	There are large number of commercial driveways on Cook Street, which conflicted with the shared path. This could increase the conflicts between vehicles accessing the driveways and path users.	Medium	Consider implementing the NZTA 'High-Use Driveway Treatment' across these driveways to highlight the presence of high conflict zone	Medium	Low

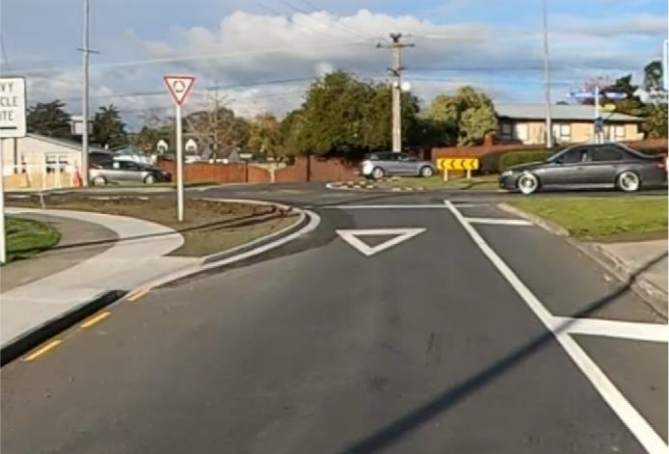
5.	Vehicle Operations	<p data-bbox="471 905 1412 1100">The kerb buildout was constructed at the northwestern corner of the roundabout to improve the vehicle approach angle closer to 90° as recommended by Austroads Guide to Road Design Part4B, which enhances driver’s visibilities and reduces turning speeds. However, it was observed that the approaching lane width on Cook Street has reduced substantially, which this may impact vehicular movement, and vehicles may mount onto the kerb buildout or traffic median island.</p>

<p data-bbox="471 1568 1175 1596">Figure 20: Narrowed Approaching Lane Width on Cook Street</p> <p data-bbox="471 1633 1412 1759">As discussed in Section 4.2, wheel tracks were observed at the northwestern corner during the site visit, and the reviewers were informed that they were caused by a house-moving truck in the wrong direction, which is not a typical user of the roundabout.</p>	Medium	<p data-bbox="1620 905 2493 1066">Consider preparing as-built drawings for the post-construction phase of the intersection and identify the largest vehicle that will be using this roundabout and carry out vehicle tracking on the vehicle type to ensure that the new intersection configuration can accommodate all types of vehicles expected to use this intersection.</p> <p data-bbox="1620 1110 2493 1209">If the movement of the largest vehicle that commonly uses the roundabout is restricted, consider realigning the kerblines to accommodate the vehicle's tracking</p> <p data-bbox="1620 1253 2510 1352">If the vehicle that caused the wheel track marks is not permitted to use this route, liaise with the over dimension permitting agency for help to enforce this restriction.</p>	Low	Low

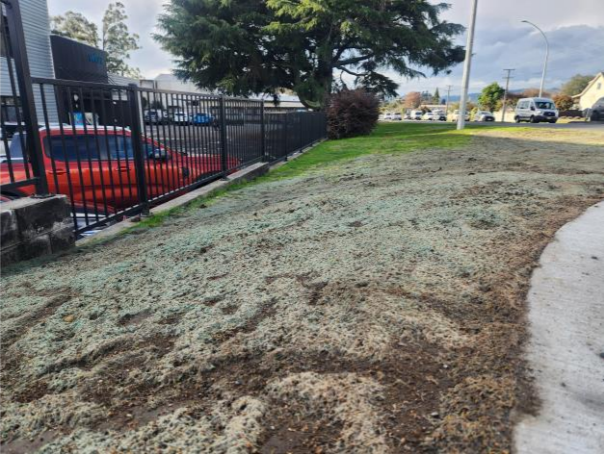
<p>Figure 22: Wheel tracks Observed on the Northern Side of the Cook Street Approach</p>				
6.	Walking and Cycling	The shared path on the western side of Shakespeare Street widens towards the back berm, which has steepened the existing batter slope to 16% and created a substantial vertical difference at the edge of the shared path and the bottom of the embankment. This could pose injury risks if a path user falls in this area.	Low	Consider a handrail or fence at the embankment side to ensure that path users are protected from the risk of drop-offs.	High	Medium

<p data-bbox="477 821 1389 884">Figure 23: Steep Embankment Slope and Significant Vertical Difference Adjacent to the Western Footpath on the Northern Approach of Shakespeare Street</p> <p data-bbox="477 919 1353 982">According to Austroads GTRD Part 6A, a fence or barrier is recommended for a slope greater than 12.5%, if the offset from the edge of the path is <1 m.</p>

<p data-bbox="477 1329 848 1360">Source: Austroads GTRD Part 6A.</p>		X (m)	Z (m)	Fence not required	<1 1 to 5	>8 >3	Partial barrier fence required	<5	1 to 3	Full barrier fence required	<5	<1				
	X (m)	Z (m)																
Fence not required	<1 1 to 5	>8 >3																
Partial barrier fence required	<5	1 to 3																
Full barrier fence required	<5	<1																
7.	Walking and Cycling	<p data-bbox="477 1434 1403 1562">A number of cyclists and pedestrians were observed traveling north of the crossing point located on the western side of Shakespeare Street's northern approach, and this observation is supported by the cycle wheel tracks shown in the photo below. However, the lack of a continuing footpath north of this crossing point could result</p>	Low	Consider constructing a footpath north of the crossing point on the western side of Shakespeare Street northern approach.	Medium	High

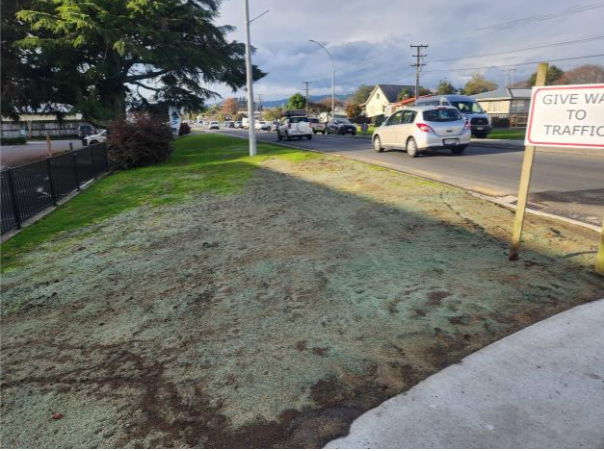
<p>Figure 24: Cycle Wheel Tracks Observed at the Grass Berm North of Pedestrian Crossing Point</p>

#	Category	Safety Findings	Level of Safety Risk	Recommendation	Effectiveness	Cost
		<p>in instability for pedestrians and cyclists, increasing the risk of falls.</p>

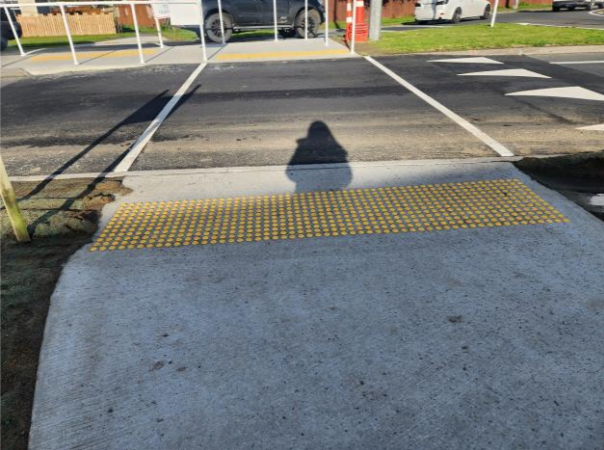
8.	Walking and Cycling	<p>Tactile studs were observed to be installed at the new crossing point on the northern approach of Shakespeare Street as warning and directional Tactile Ground Surface Indicators (TGSIs). However, these studs have been identified as a slippery hazard, particularly in wet weather conditions, leading to pedestrian slips and resulting in fractured injuries. Furthermore, some studs have also been found to be missing after a short period of time.</p>

<p>Figure 25: Tactile Studs Installed at New Crossing on Shakespeare Street Northern Approach</p>	Medium	Consider replacing the tactile studs with concrete tactile pavers, which provide better skid resistance and durability.	High	Medium

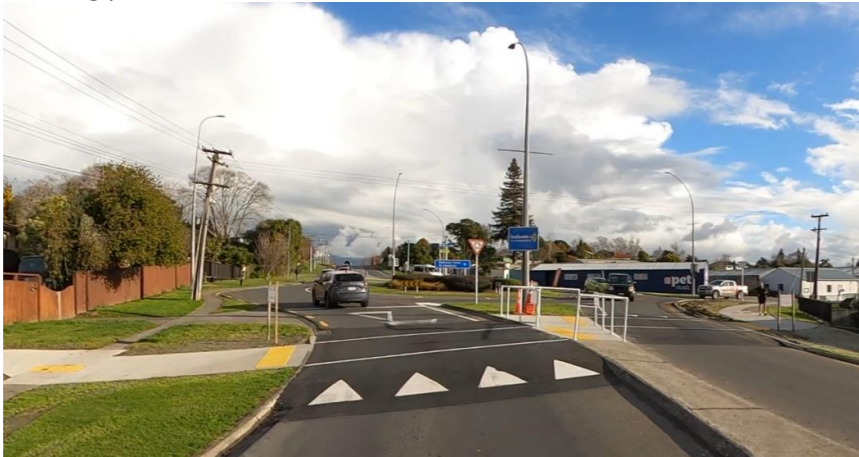
<p>Figure 26: Ramp Grade for Pedestrian Crossing Appears to be Less Than 1:15.</p>

#	Category	Safety Findings	Level of Safety Risk	Recommendation	Effectiveness	Cost
		<p>for comfortable speeds exceeding 30 km/h, which exceeds the safety threshold for vulnerable users. This is especially important at this location, as it is a pedestrian crossing point.</p>

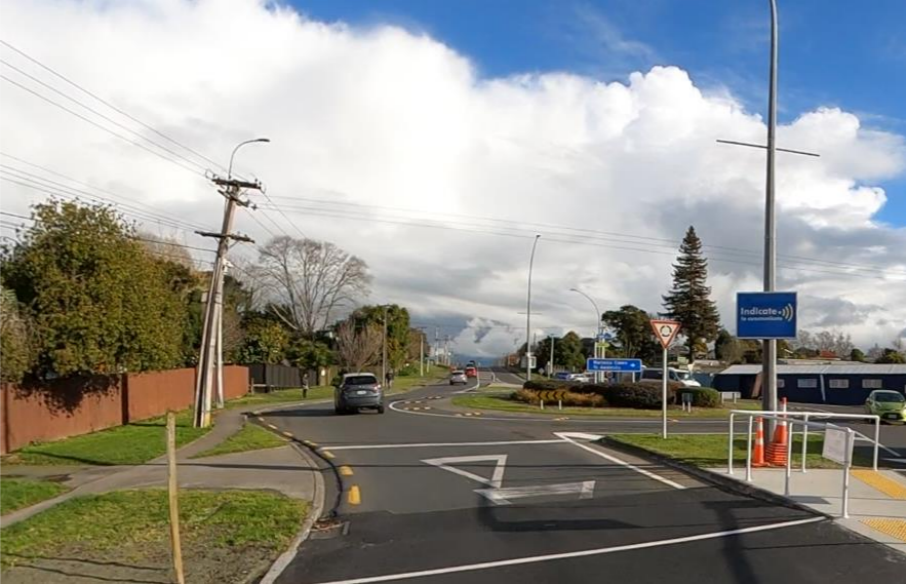
<p data-bbox="477 940 1041 972">Figure 27: Abandoned Marking Remained On-Site</p>				
13.	Vehicle Operations	<p data-bbox="477 1024 1418 1157">The new kerb buildout constructed at the northwestern corner of the roundabout could be a hazard to approaching vehicles on Cook Street, as it creates an abrupt pinch point. This risk is exacerbated during low-light conditions, as the buildout may not be as visible to drivers.</p>

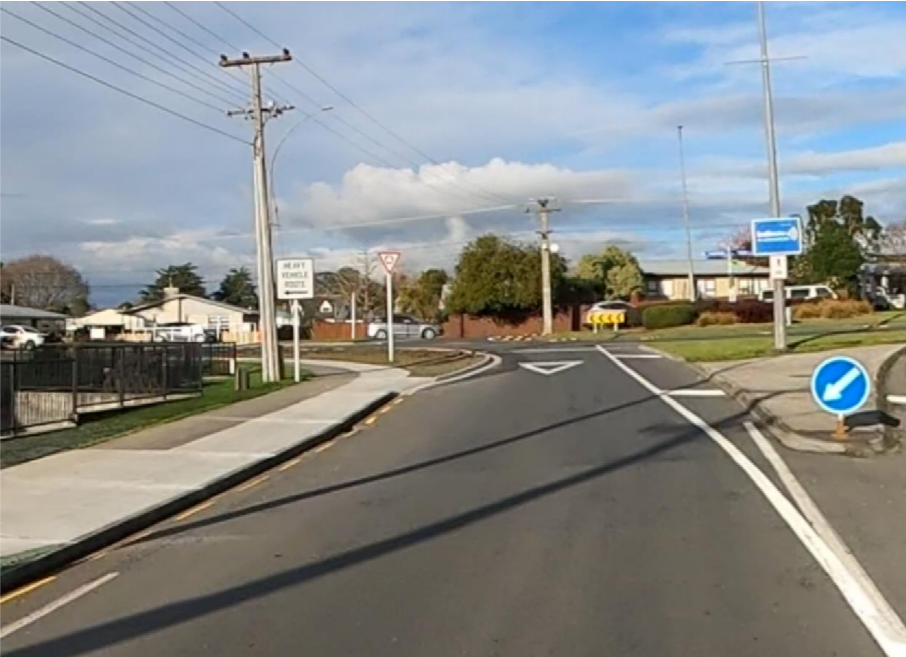
<p data-bbox="477 1843 1110 1875">Figure 28: Kerb Buildout Forming an Abrupt Pinch Point</p>	Medium	Consider improving the delineation to the kerb buildout to reduce potential conflict with the hazard and assist vehicles in better aligning when navigating the roundabout.	High	Low

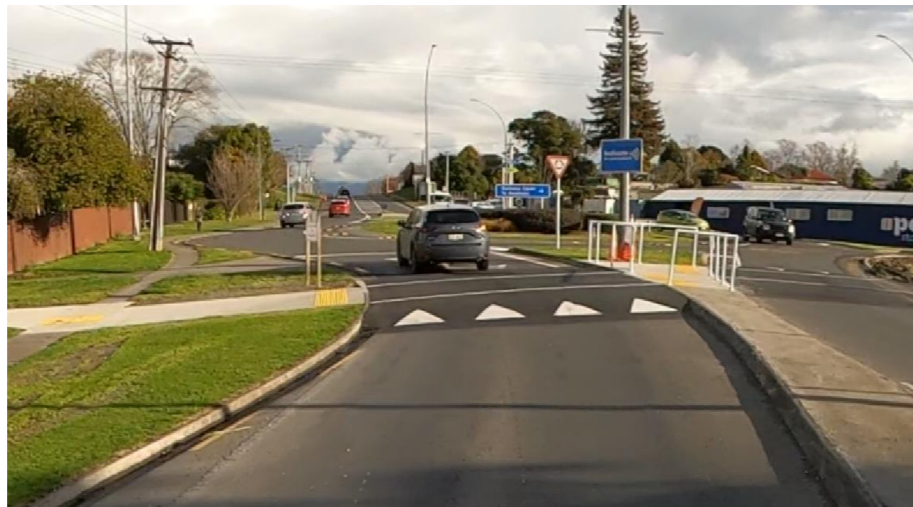
#	Category	Safety Findings	Level of Safety Risk	Recommendation	Effectiveness	Cost
14.	Vehicle Operations	<p>The R2-3 'Priority Give Way Roundabout' sign for southbound traffic on the northern approach of Shakespeare Street is missing from the left side. According to the TCD Rule, a controlled intersection sign must be installed on the left side of the approach lane to ensure a consistent message nationally and prevent potential driver confusion. Additionally, NZTA recommends installing a secondary R2-3 'Priority Give Way Roundabout' sign at the corner of the traffic median island to enhance visibility for approaching drivers.</p>

<p>Figure 29: Missing R2-3 'Priority Give Way Roundabout' Sign on the Right Side of the Approach</p>	Low	Consider installing a R2-3 'Priority Give Way Roundabout' sign on the left side of the Shakespeare Street northern approach. Additionally consider installing a R2-3 'Priority Give Way Roundabout' sign at all corners of the traffic median island.	Medium	Low

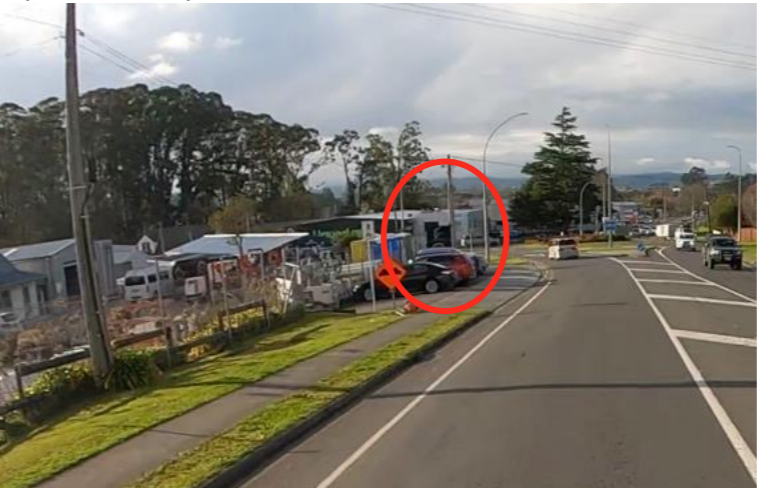
17.	Walking and Cycling	<p data-bbox="477 1176 1397 1371">Vehicles were observed parked between the footpath and the property fence outside Total Event Hire on Cook Street. This could increase the risk of conflict between pedestrians on the footpath and vehicles entering or exiting the area. Furthermore, the parked vehicles are restricting visibility between the pedestrian crossing point on Cook Street and the southbound vehicles on Shakespeare Street, increasing the risk of conflict between crossing pedestrians and vehicles.</p>	High	<p data-bbox="1623 1176 2516 1266">Consider restricting parking in this area to minimise conflict with pedestrians on the footpath and to improve visibility of the pedestrian crossing point on Cook Street.</p> <p data-bbox="1623 1312 2516 1402">Consider installing kerb buildouts or side islands at the pedestrian crossing point on Cook Street and relocating the advertising sign outside Total Event Hire to improve visibility.</p>

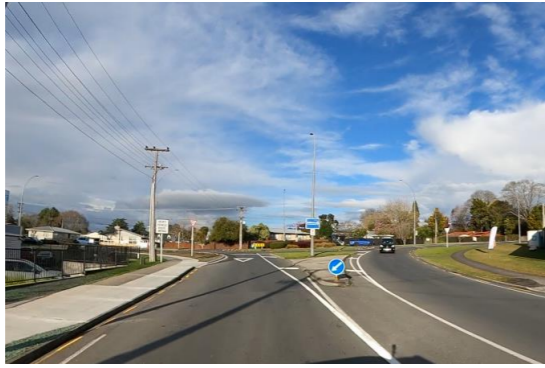
Crossing Point	Conflicted Vehicle Movement	Photo	Design Speed (km/h)	Sight Distance Achieved (m)	Crossing Sight Distance (m)				Approach Sight Distance (ASD)	
					NZTA Requirement (+3s ⁶)	Pass/Fail	NZTA Requirement (+0s ⁷)	Pass/Fail	NZTA Requirement	Pass/Fail
Shakespeare Street (N) – Western Crossing Point	Cook Street Eastbound

30	60	69	Fail (see Note 1)	43	Pass	22	Pass
Shakespeare Street (N) – Western Crossing Point	Shakespeare Street Northbound

Crossing Point	Conflicted Vehicles	Obstructed Visibility	Recommended Safety Treatments
Western side on Shakespeare Street (N)	Eastbound vehicles from Cook Street	“Heavy Vehicle Route” sign on Cook Street	Remove “Heavy Vehicle Route” sign on Cook Street

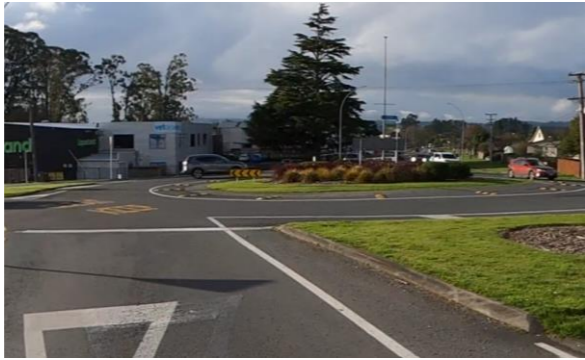
30	45	68	Fail (see Note 2)	43	Pass	23	Pass
Shakespeare Street (N) – Eastern Crossing Point	Shakespeare Street Southbound

Crossing Point	Conflicted Vehicles	Obstructed Visibility	Recommended Safety Treatments
Western side on Shakespeare Street (N)	Northbound vehicles from Shakespeare Street (S)	Plantings and Information Direction Sign in the roundabout median island	<ul style="list-style-type: none"> • Trim/replace/remove plantings • Relocate Information Direction Sign
Southern side on Cook Street	Northbound vehicles from Shakespeare Street (S)	Parked vehicles and advertising sign outside Total Event Hire	<ul style="list-style-type: none"> • Restriction/enforcement on parking • Relocate/ remove advertising sign

16.	Walking and Cycling	<p data-bbox="477 905 1397 1100">As discussed in Section 4.3.1, the sight distance between the pedestrian crossing point at the western side of Shakespeare Street northern approach and the northbound vehicles on Shakespeare Street is restricted by the plantings and Information Direction Sign at the roundabout median island, which reduce driver's awareness of the crossing point increasing the risk of conflict between crossing pedestrians and vehicles.</p>	Medium	<p data-bbox="1623 905 1730 932">Consider:</p> <ul data-bbox="1665 957 2487 1125" style="list-style-type: none"> • Relocate the Information Direction Sign, • removing the planting in the roundabout island, • replacing the planting with low-level plantings that are below driver's eye level, or • trim plantings to improve visibilities 	Medium	Medium

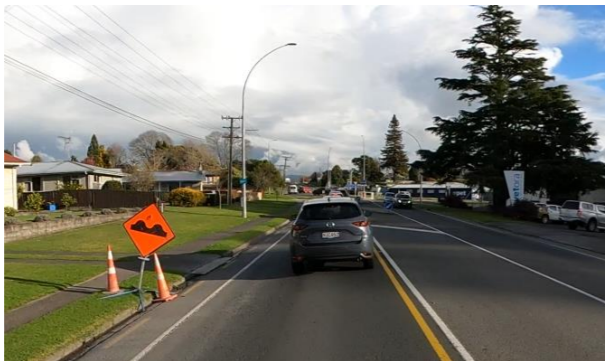
50	>150	73	Pass	48	Pass	21	Pass

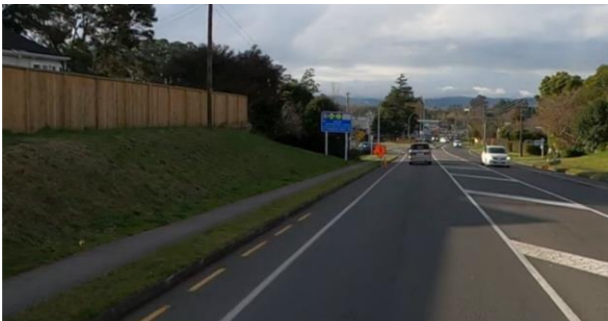
Crossing Point	Conflicted Vehicle Movement	Photo	Design Speed (km/h)	Sight Distance Achieved (m)	Crossing Sight Distance (m)				Approach Sight Distance (ASD)	
					NZTA Requirement (+3s ⁸)	Pass/Fail	NZTA Requirement (+0s ⁹)	Pass/Fail	NZTA Requirement	Pass/Fail
Cook Street – Northern Crossing Point	Cook Street Eastbound	 	50	>115	111	Pass	69	Pass	48	Pass
Cook Street – Southern Crossing Point	Shakespeare Street Northbound	 	30	65	80	Fail (see Note 3)	55	Pass	22	Pass
Shakespeare Street (S) – Western Crossing Point	Shakespeare Street Northbound

50	>150	133	Pass (see Note 4)	91	Pass	47	Pass

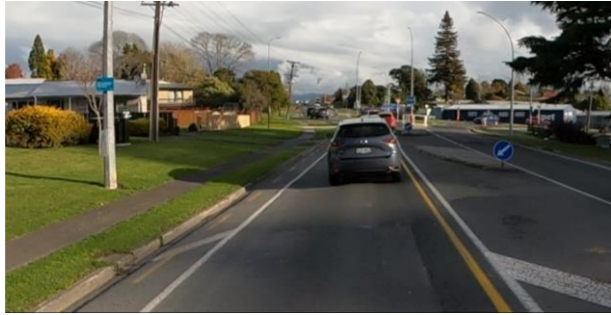
Crossing Point	Conflicted Vehicle Movement	Photo	Design Speed (km/h)	Sight Distance Achieved (m)	Crossing Sight Distance (m)				Approach Sight Distance (ASD)	
					NZTA Requirement (+3s ⁸)	Pass/Fail	NZTA Requirement (+0s ⁹)	Pass/Fail	NZTA Requirement	Pass/Fail
Shakespeare Street (S) – Eastern Crossing Point	Shakespeare Street Southbound

50	>150	134	Pass	93	Pass	39	Pass

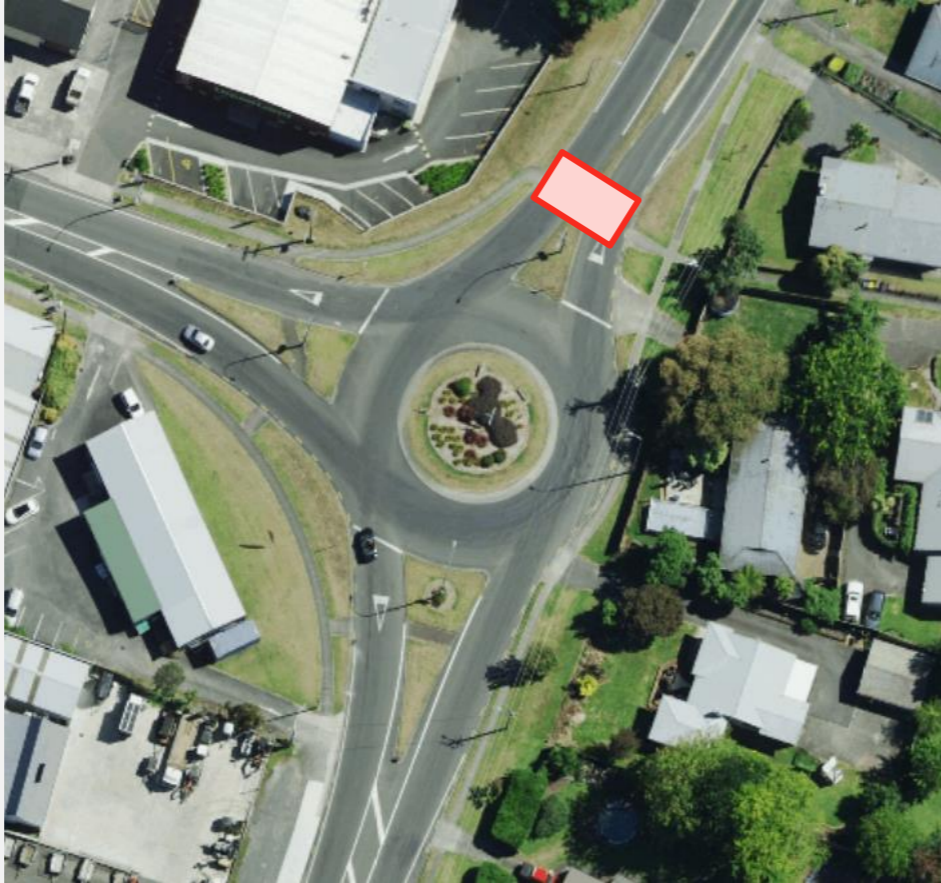
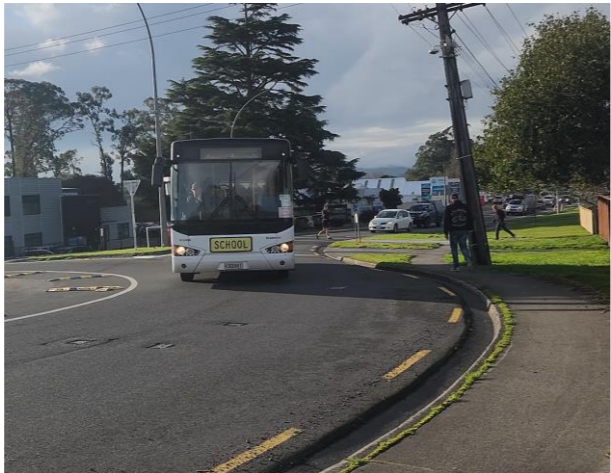
Option 1 – Northern Approach (Current)	Option 2 – Southern Approach
Crossing Location

Benefits	<ul style="list-style-type: none"> • More pedestrians and cyclists were observed crossing here due to the close proximity of the access that connects Sheridan Crescent and Shakespeare Street, as well as the shared path located on the northern side.

<ul style="list-style-type: none"> • More pedestrians and cyclists from Cambridge Primary were observed using this crossing. • Cyclists using the shared path on the northern side of Cook Street can access the eastern side of Shakespeare Street without needing to cross Cook Street. 	<ul style="list-style-type: none"> • The very wide median island can accommodate cyclists without the need to wait at an angle. • The crossing only requires pedestrians to check for traffic from one direction at each stage. • Compliant visibility.

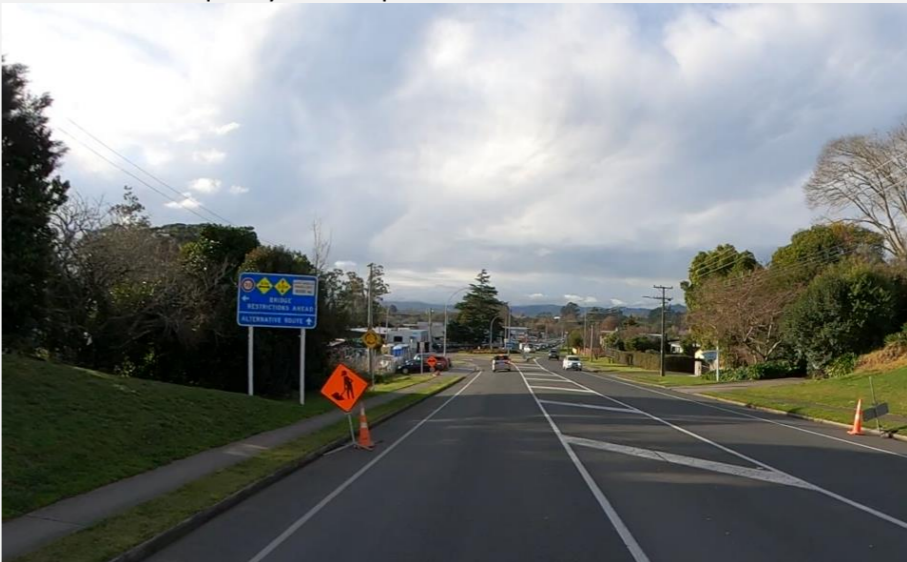
Option 1 – Northern Approach (Current)	Option 2 – Southern Approach
	<ul style="list-style-type: none"> • The vertical terrain at this section of Shakespeare Street is flatter, leading fewer speeding vehicles and reduced stopping distances. • Vehicles approaching from Cook Street and the southern approach of Shakespeare Street will be travelling at a slower speed due to the improved horizontal deflections from the recent upgrades. • Sufficient stacking space for one car length in both directions prevents cars from overhanging into the circulating lane or crossing point, reducing the risk of conflicts with vehicles and pedestrians. • Compliant approach sight distances. • Shorter crossing distances (6.2-6.9 m). 	
<p>Implications</p>	<ul style="list-style-type: none"> • The width of the median island requires cyclists to wait at an angle. • Pedestrians crossing from the western side will have to check for traffic from two directions: Cook Street and Shakespeare Street southern approach. • Even though the intervisibility between vehicles approaching from Cook Street and pedestrians crossing from the western side is compliant, the presence of the crossing is not obvious to traffic on Cook Street. 	<ul style="list-style-type: none"> • Cyclists using the shared path on the northern side of Cook Street are required to cross at Cook Street to access the crossing point, increasing exposure to conflict with vehicles. • Fewer pedestrians were observed using this crossing during both pre-construction and post-construction site visits. • Wider crossing distance (7.9-8.0 m). • The vertical terrain at this section of Shakespeare Street is significantly steeper. Northbound traffic was observed travelling at high speeds towards the roundabout, increasing the risk of abrupt braking if a pedestrian steps out without checking. This may lead to pedestrian crashes at higher than survivable speed threshold and /or increased rear end crashes. High-friction surfacing can be considered to improve skid resistance. However, the high volume of heavy commercial vehicles at this location could increase wear and tear on the high-friction surfacing and deteriorate quickly after implementation.

<ul style="list-style-type: none"> • Path is not on the pedestrian desire line. This can lead to an increase of pedestrians crossing at locations without safety infrastructure to limit risk.
