**T2 GROWTH CELL PROPOSED PRIVATE PLAN
CHANGE**

GEOTECHNICAL DESKTOP REPORT

Sanderson Group Limited

Ref: HAM2020-0016AD/0043ABRev 0

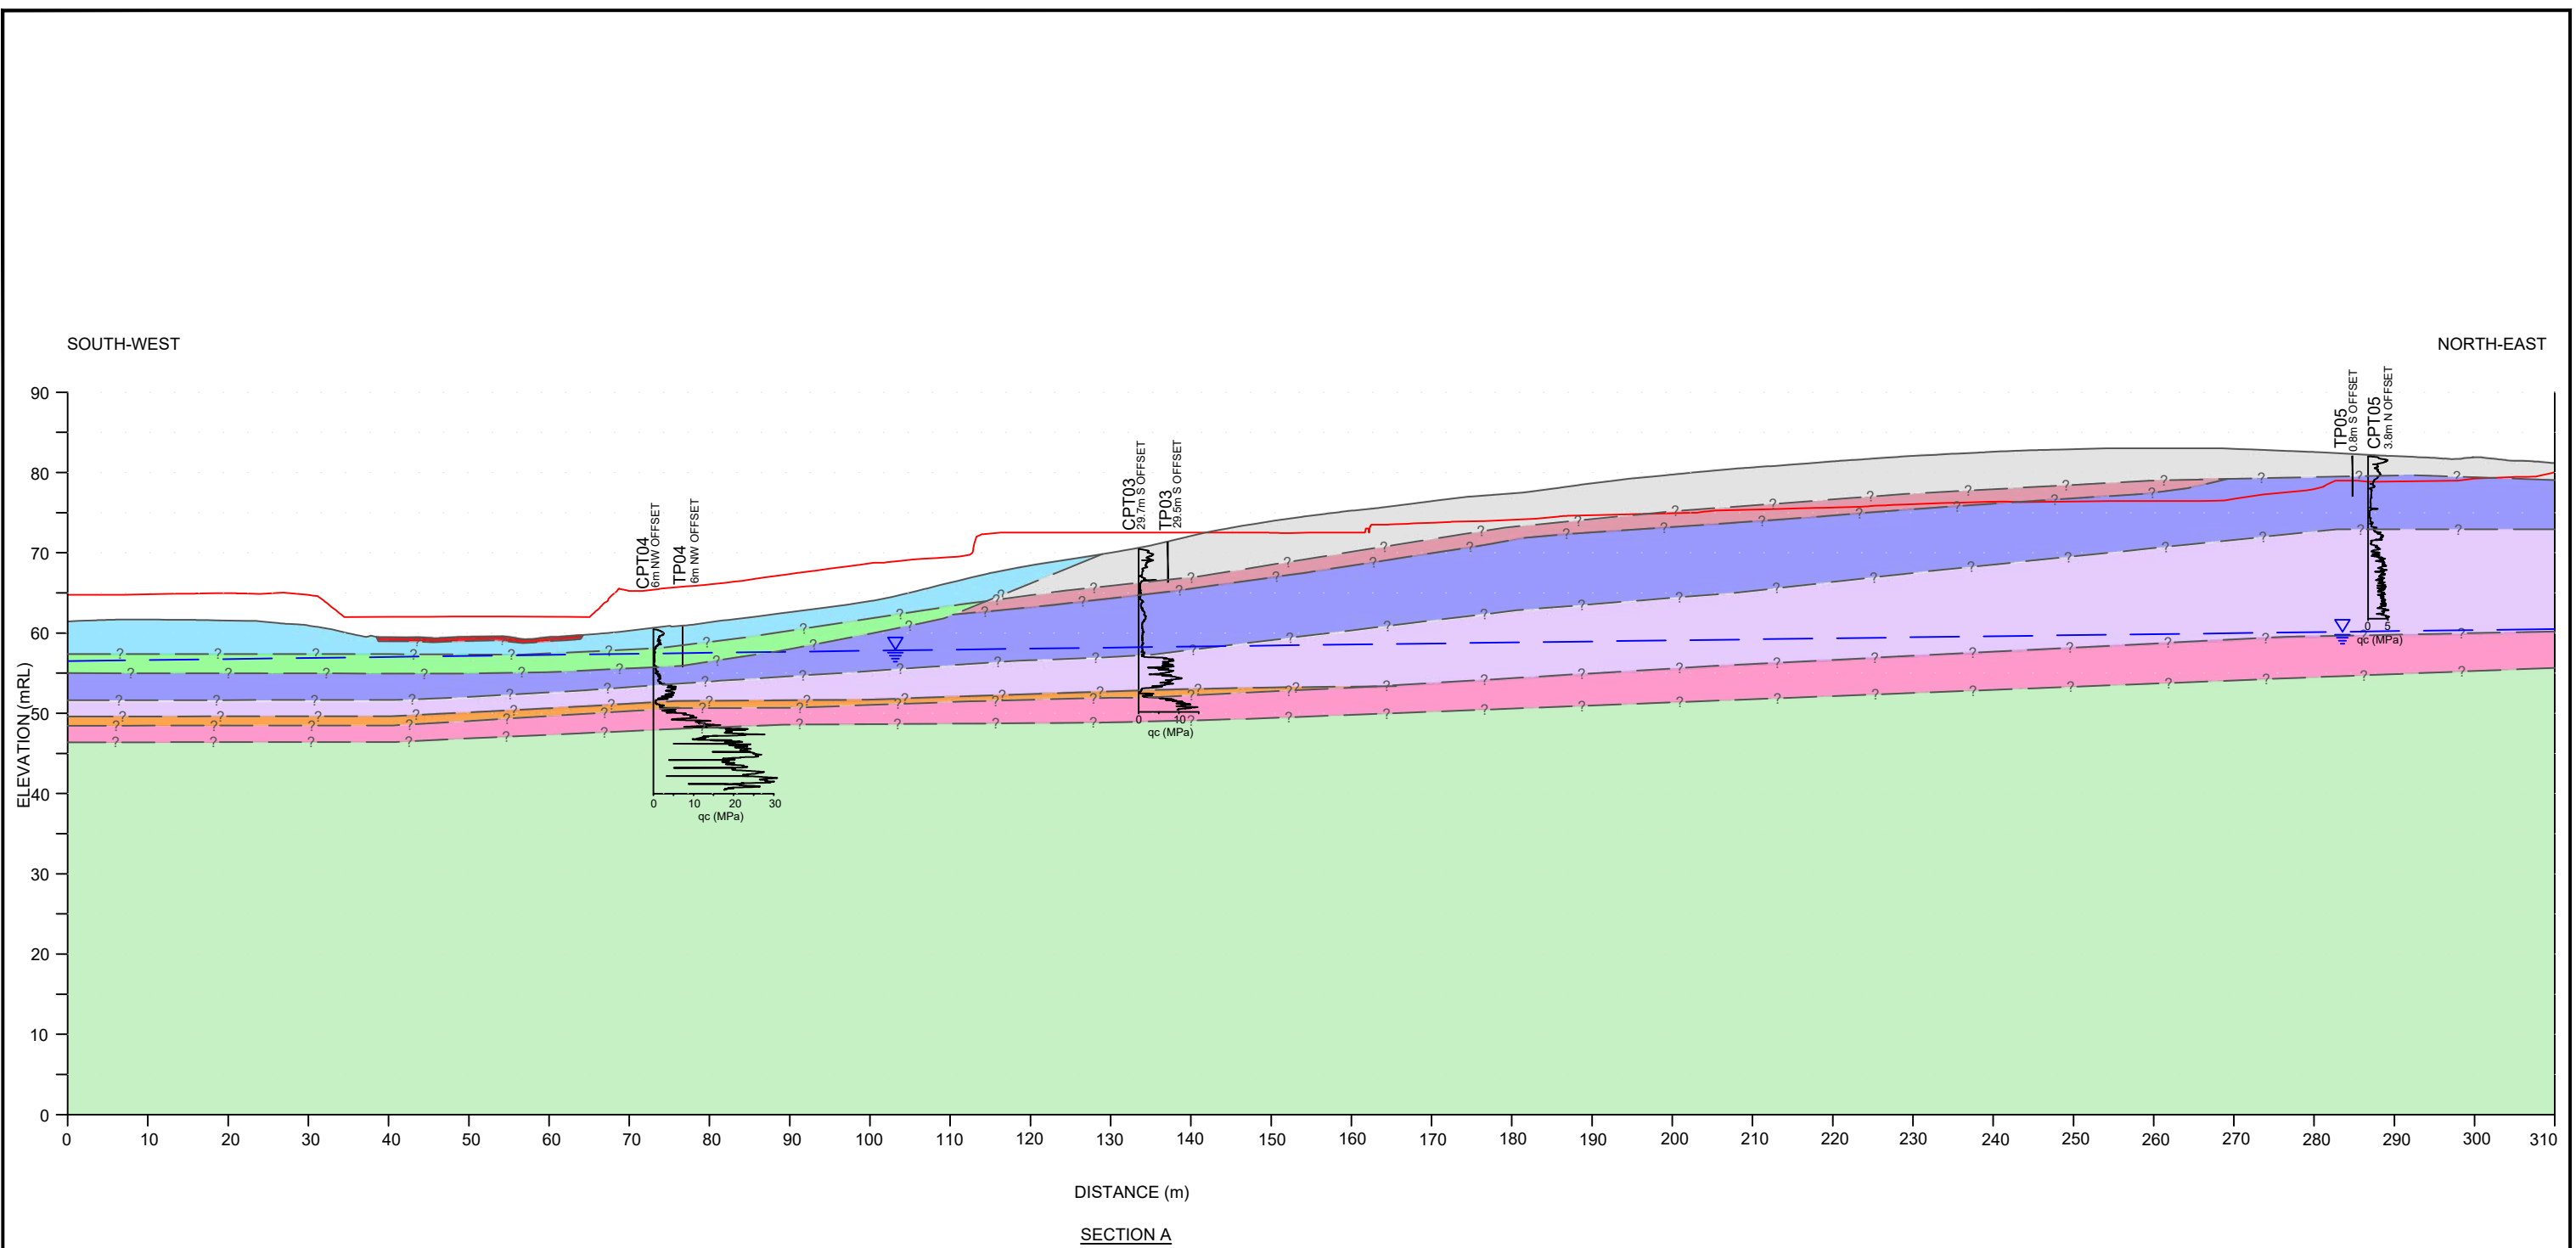
CLIENT:	SANDERSON GROUP	DRAWN:	WPJ	PROJECT No:	HAM2020-0016
PROJECT:	TE AWAMUTU COUNTRY CLUB, FRONTIER ROAD, TE AWAMUTU	CHECKED:	AS	DRAWING:	02
TITLE:	SECTION A	REVISION:	D	SCALE:	1:800
		DATE:	22/04/2020	SHEET:	A3
