Preliminary site investigation and Detailed site investigation

Te Awamutu Country Club

Te Awamutu

Sanderson Group Limited

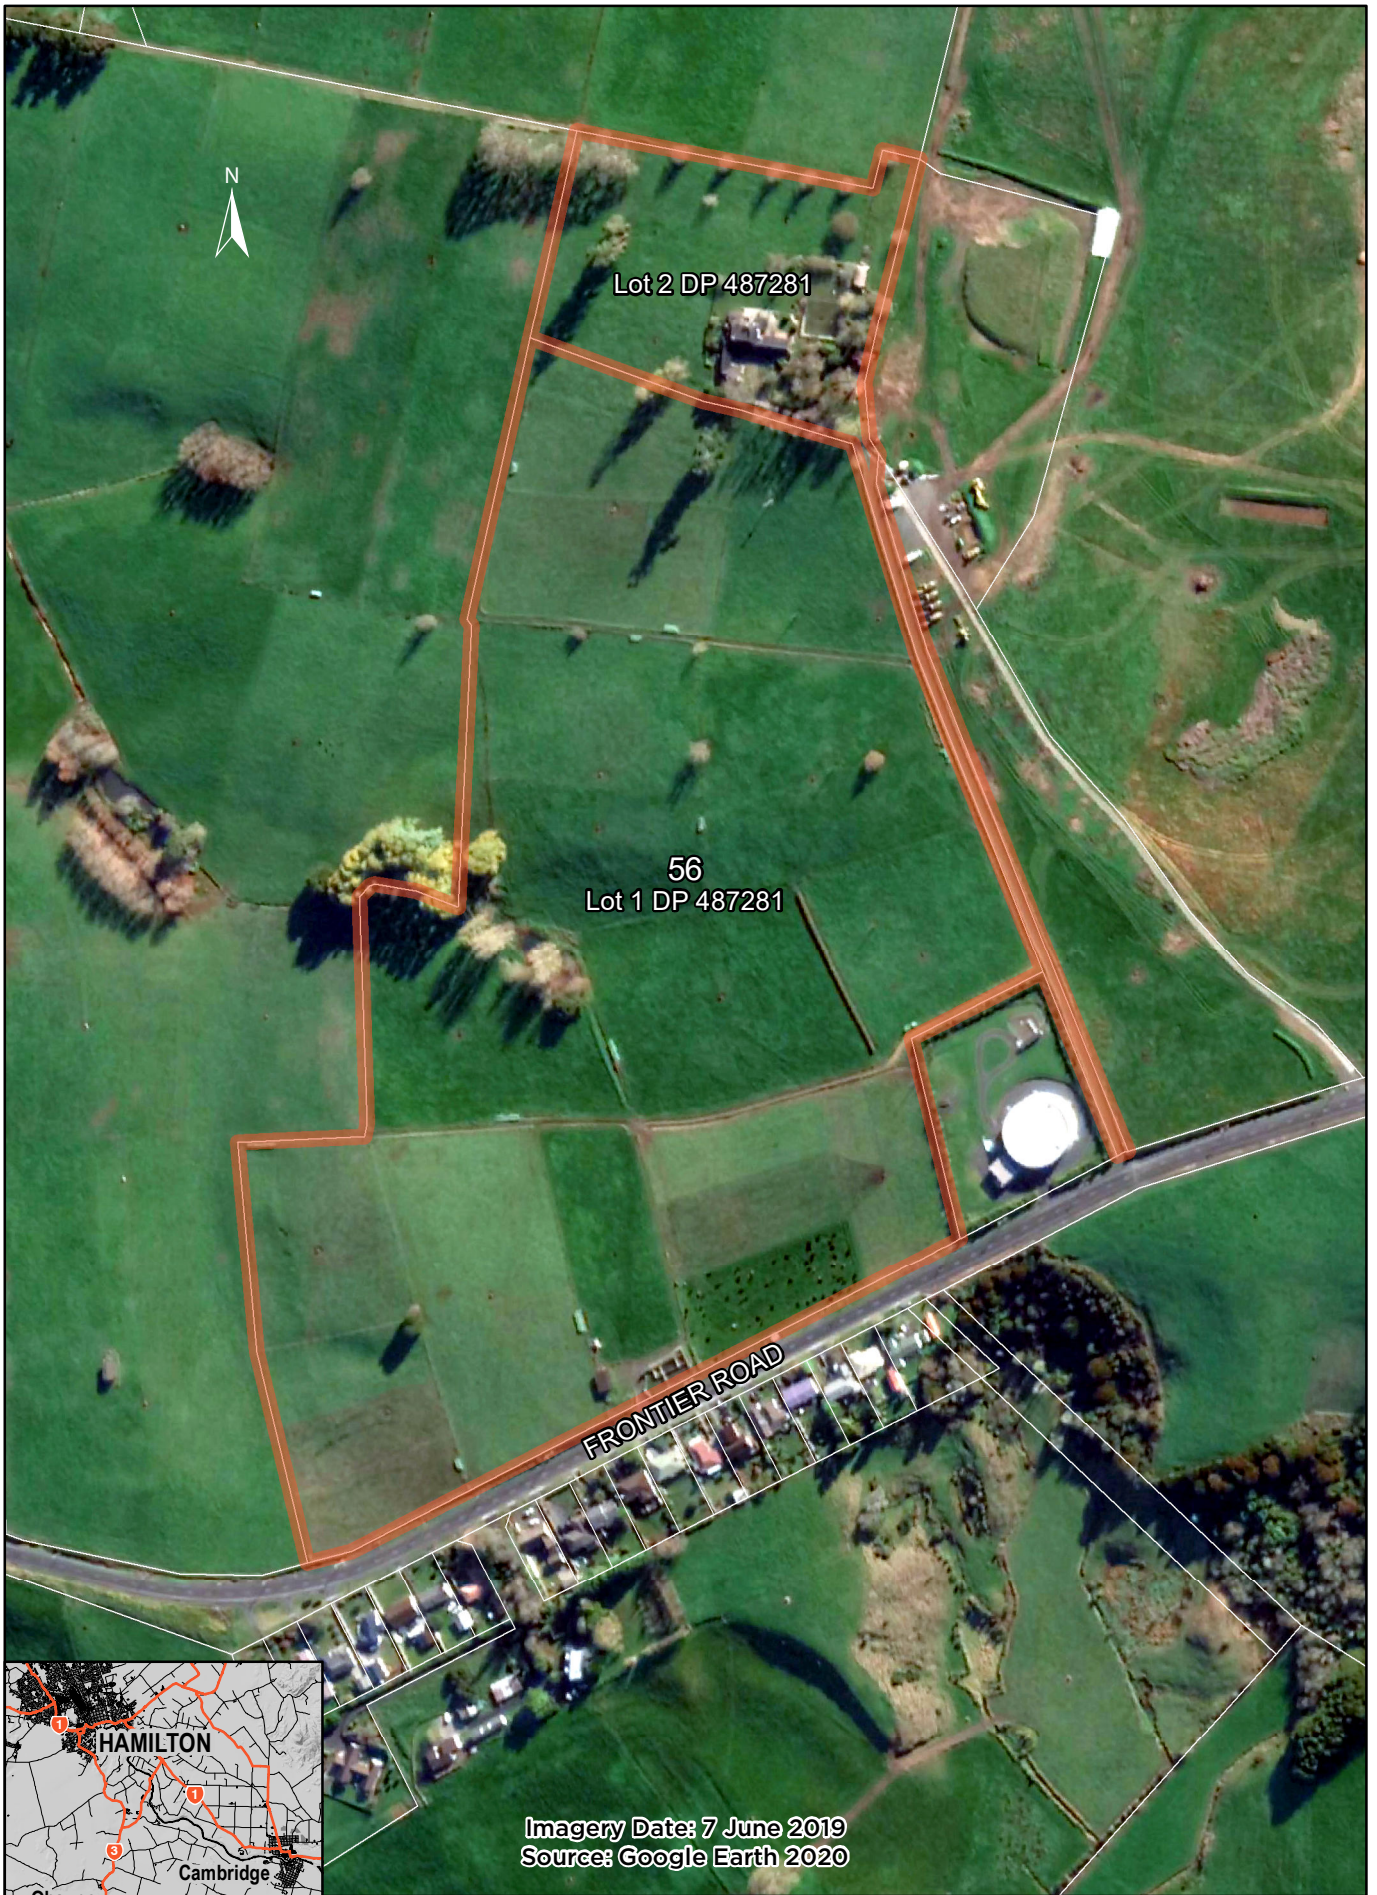
Figure 2 - Site Layout Plan
56 Frontier Road, Te Awamutu

A site walkover was completed by HAIL Environmental on 30 April 2020. The layout was generally consistent with Figure 2. The following observations were noted during the inspection. Site photographs are provided in Appendix B.

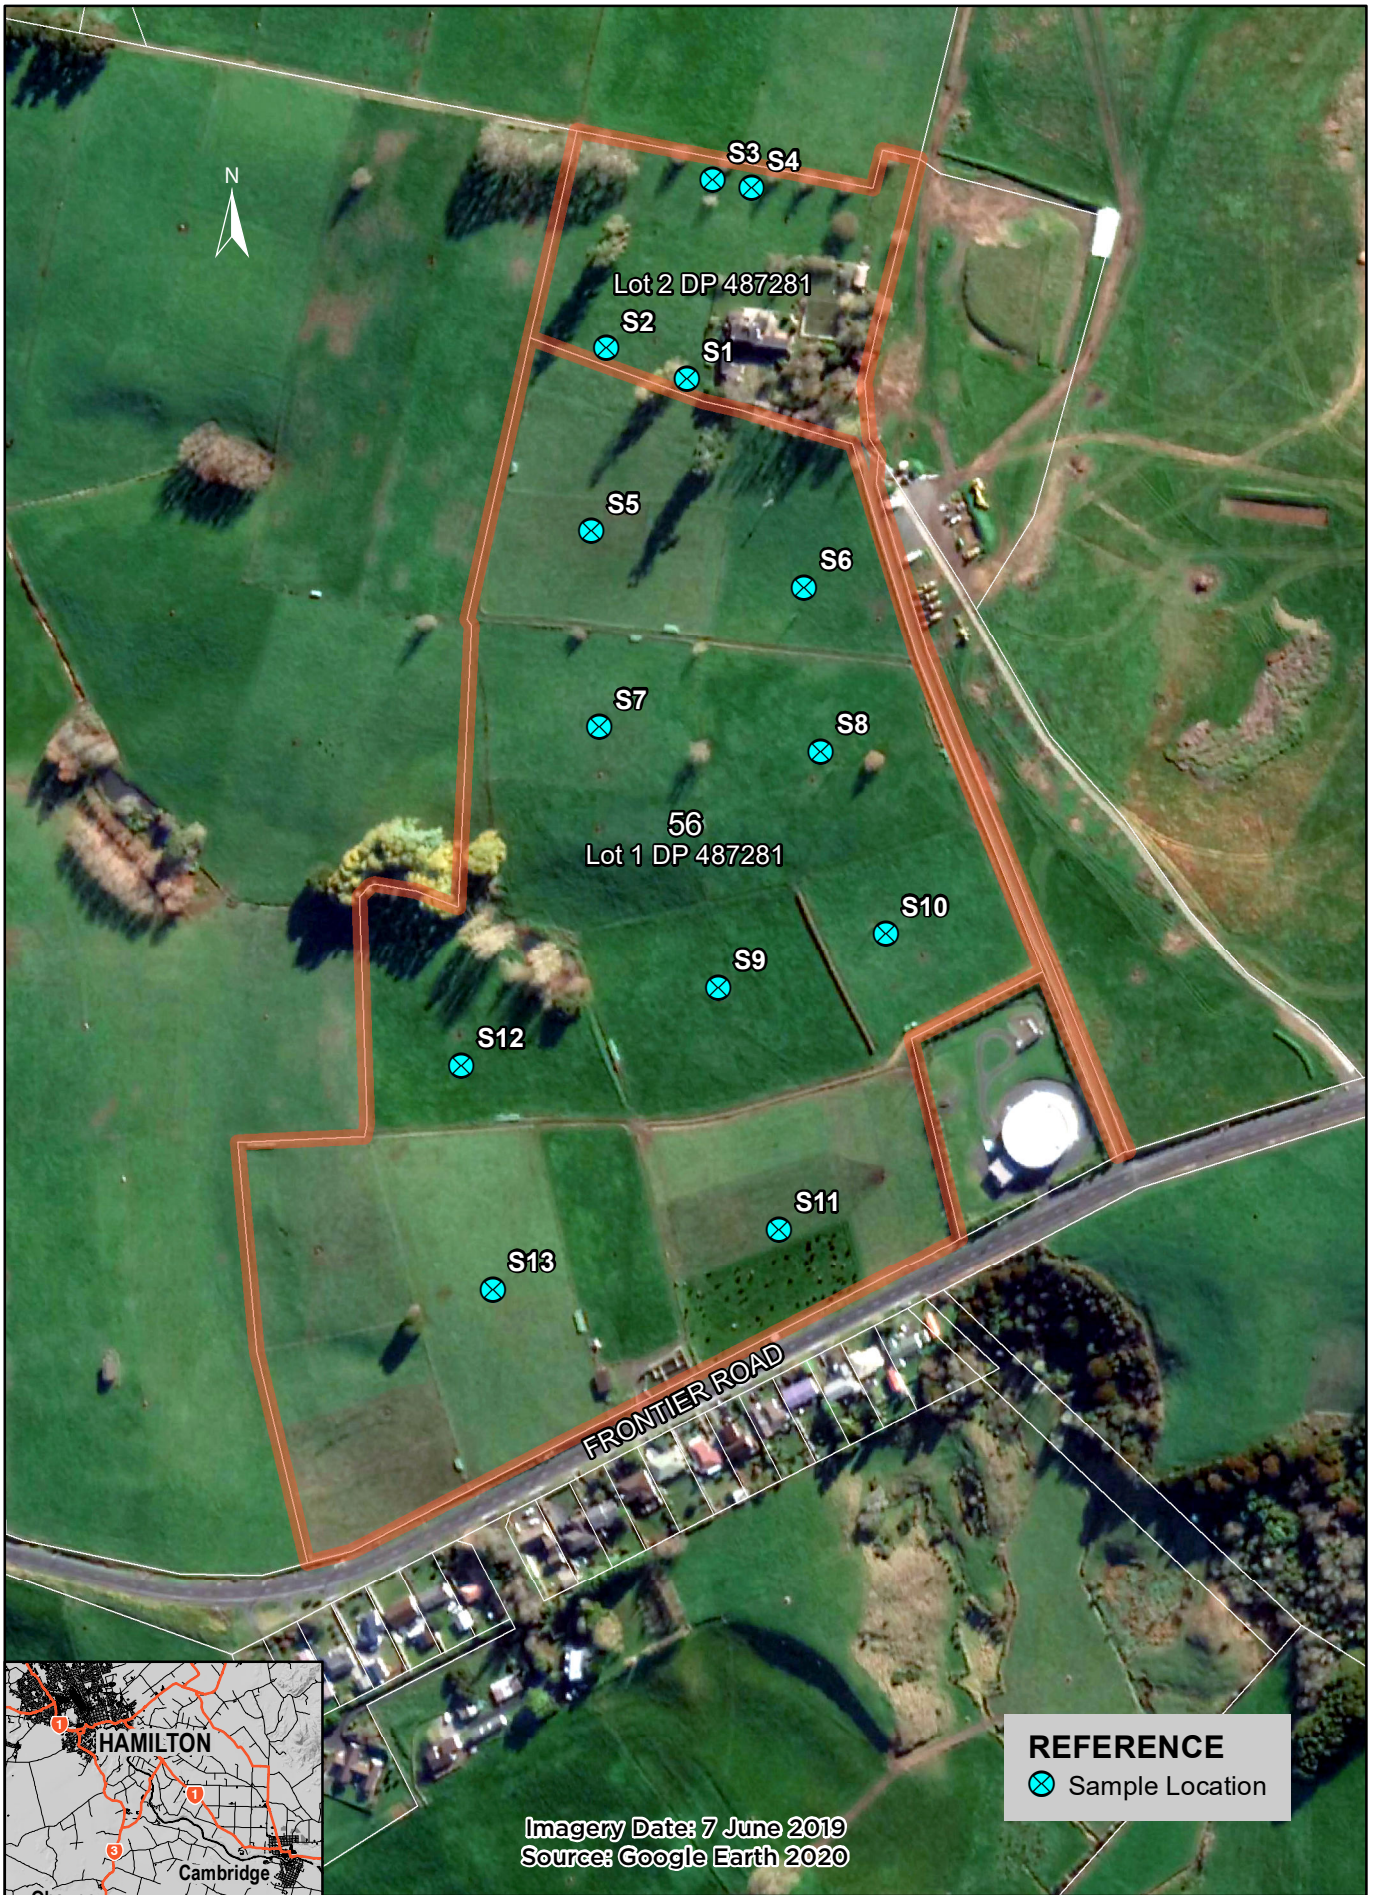
Figure 3 - Site Sampling Plan
 56 Frontier Road, Te Awamutu

Soil samples were collected using from shallow test pits excavated with a stainless-steel spade, which was decontaminated between sampling points by washing with Decon-90® detergent and rinsing with tap water. Each sample was handled with dedicated disposal gloves. Soil was placed directly into laboratory supplied containers. Samples were held chilled and couriered to the laboratory, Analytica Laboratories Limited (Analytica), under chain of custody documentation. Chain of custody documentation is included in Appendix F.

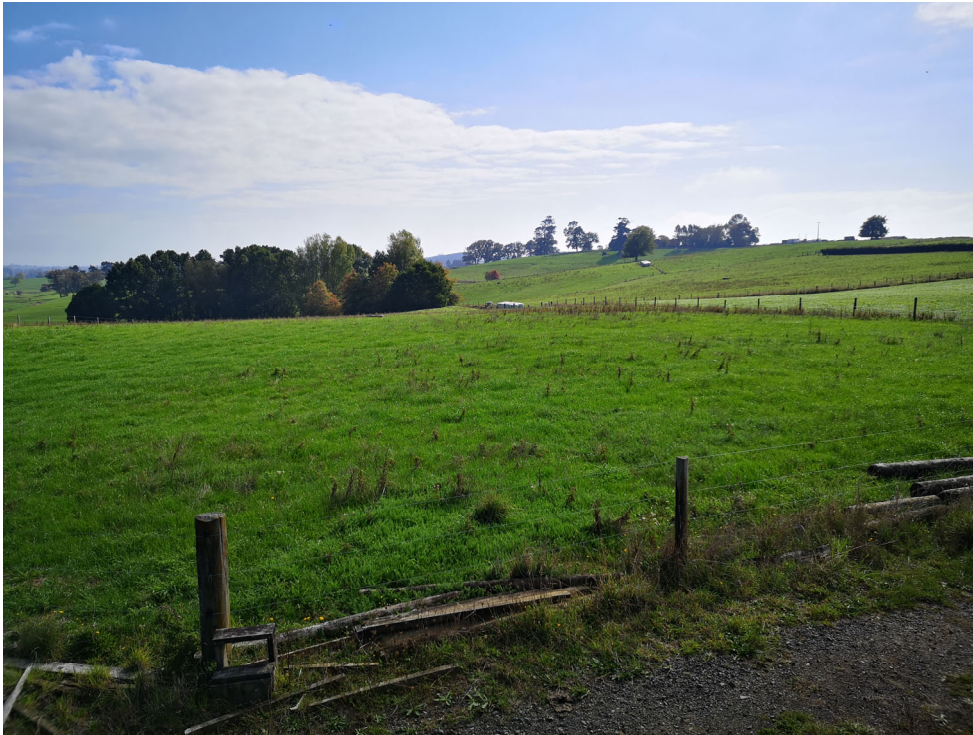
Image from southern site boundary facing north

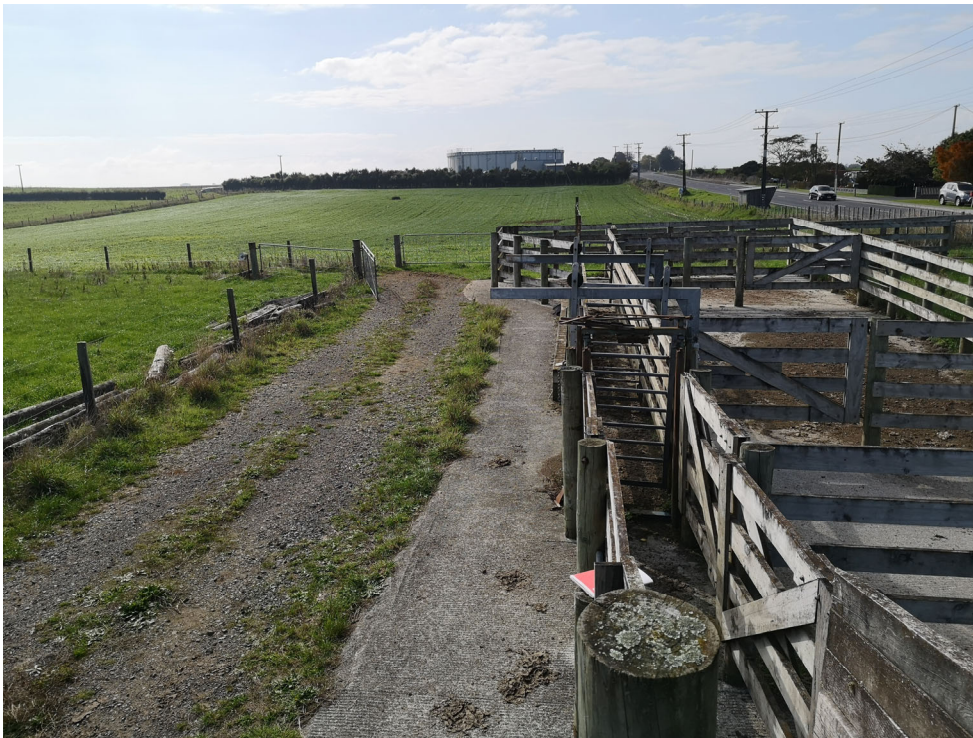
Image taken near southern site boundary facing east. Frontier Road is visible on the right with the water reservoir in the background

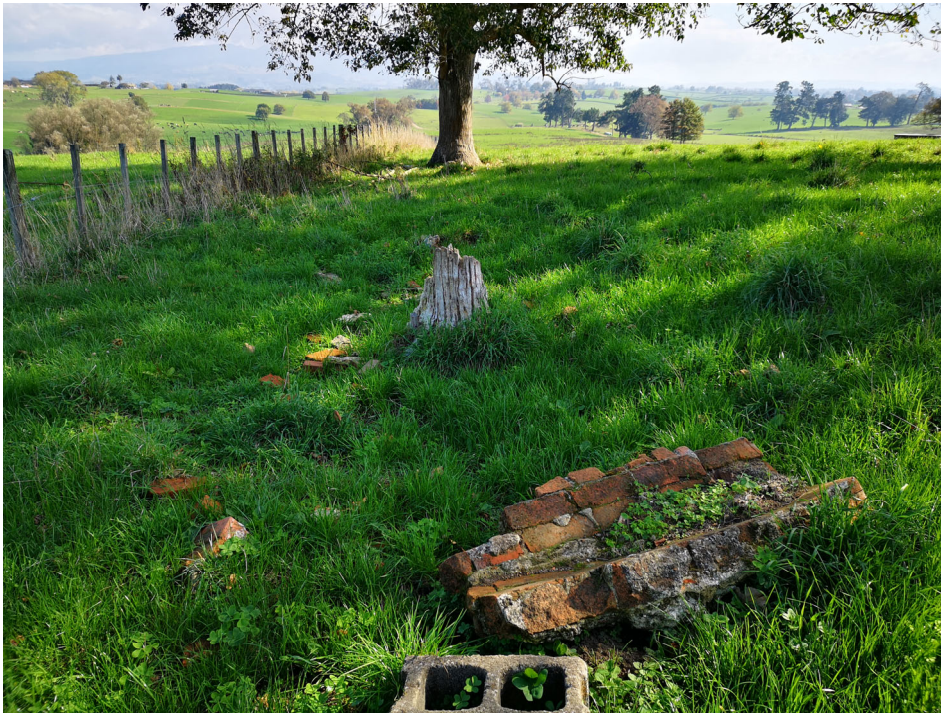
- The remainder of this property comprises pastoral grazing, with some mature macrocarpa and oak trees.
- Some old bricks were noted to the west of the residential dwelling in the location of the former residential dwelling evident in historical aerials, circa 1940-70. Several hand excavated test pits were advanced in this area. No ACM or other anthropogenic waste was observed with the exception of ash and charcoal.

Building materials near the former residential dwelling

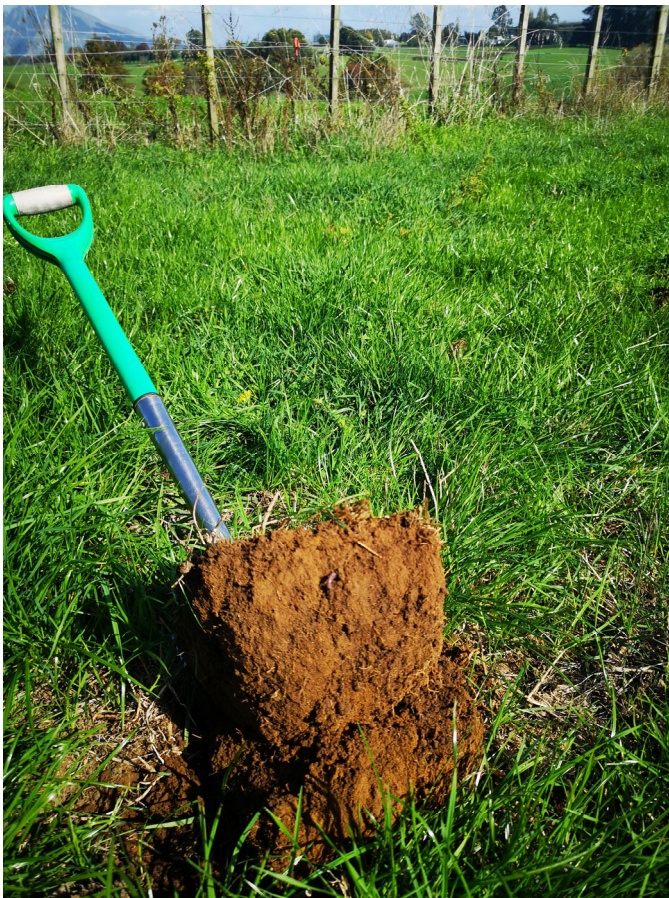
- With the exception of a mound of gravel located near the northern boundary the test pits advanced on the property revealed a dark brown silty loam with some charcoal fragments extending to around 0.3 m below ground level.

Shallow soil profile in sample location S2

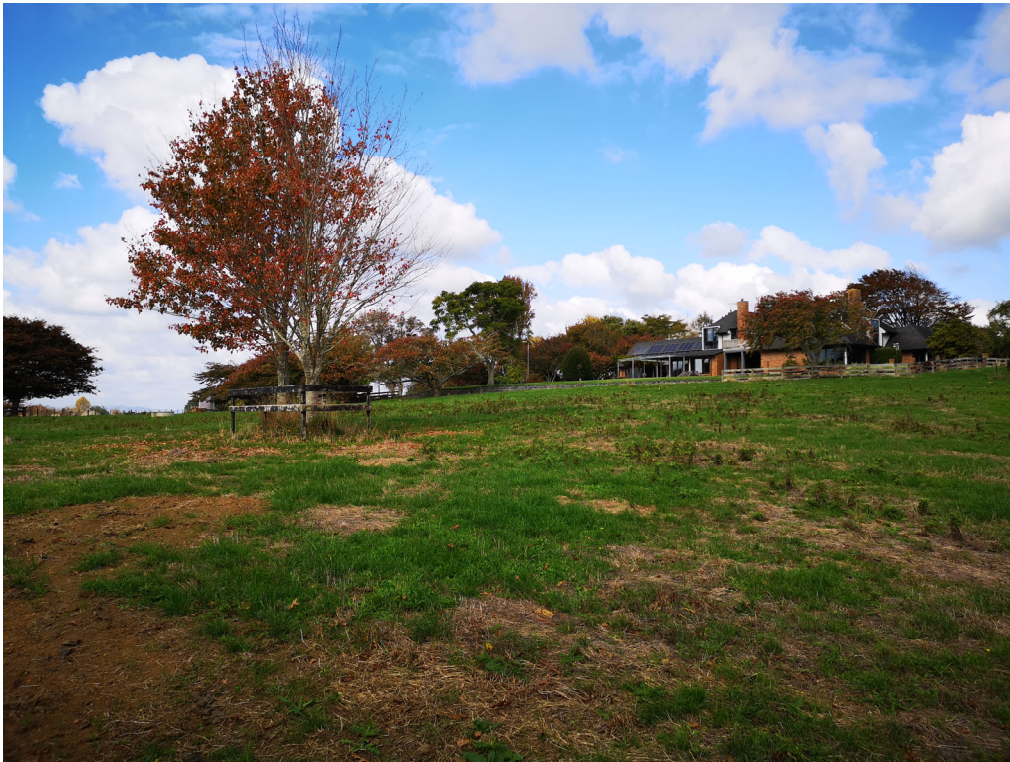
Image taken near northern boundary facing south towards the existing residential dwelling

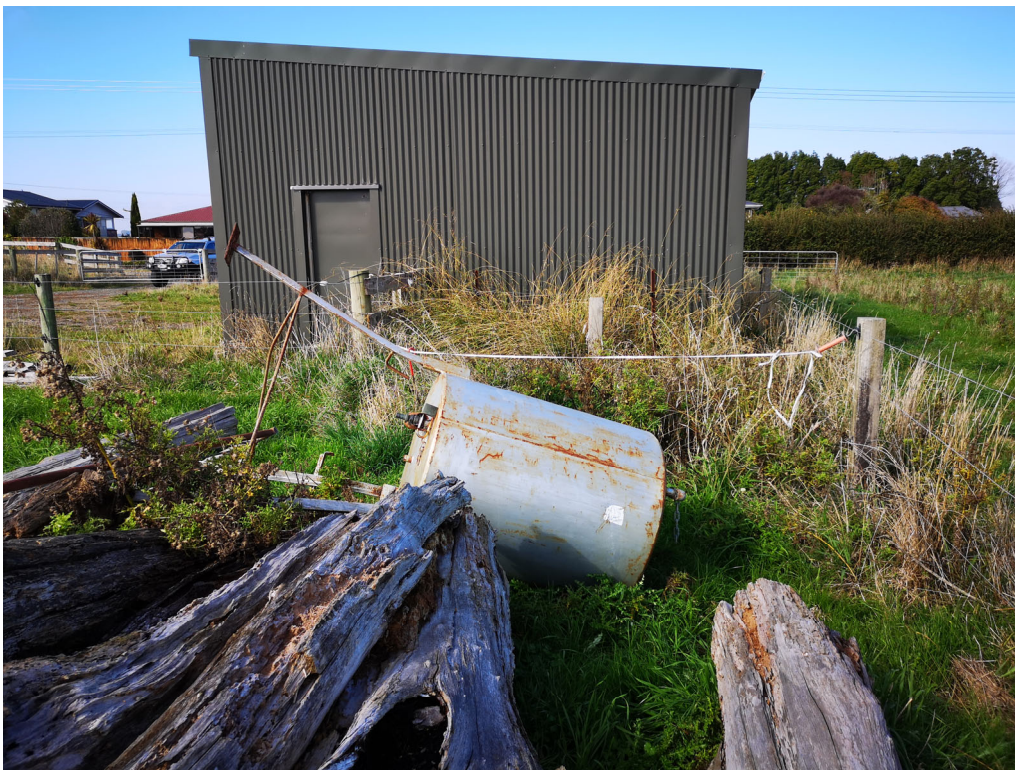
- A disused 500 L above ground fuel storage tank (AST) was located near the northern side of the shed. The tank was lying on the ground. Further inspection revealed the AST was empty. No spilled fuel, staining or odour was noted around the tank or the shed.

Image taken near locked implement shed located on southern boundary. Disused AST is visible in foreground.
