Environmental Site Assessment: Detailed Site Investigation for Proposed Plan Change and Future Development at Fonterra Hautapu, 185 Swayne Road, Cambridge

Rev B 11 March 2024 Job No. 230599

ENVIRONMENTAL SITE ASSESSMENT: DETAILED SITE INVESTIGATION FOR PROPOSED PLAN CHANGE AND FUTURE DEVELOPMENT AT 185 SWAYNE ROAD, CAMBRIDGE

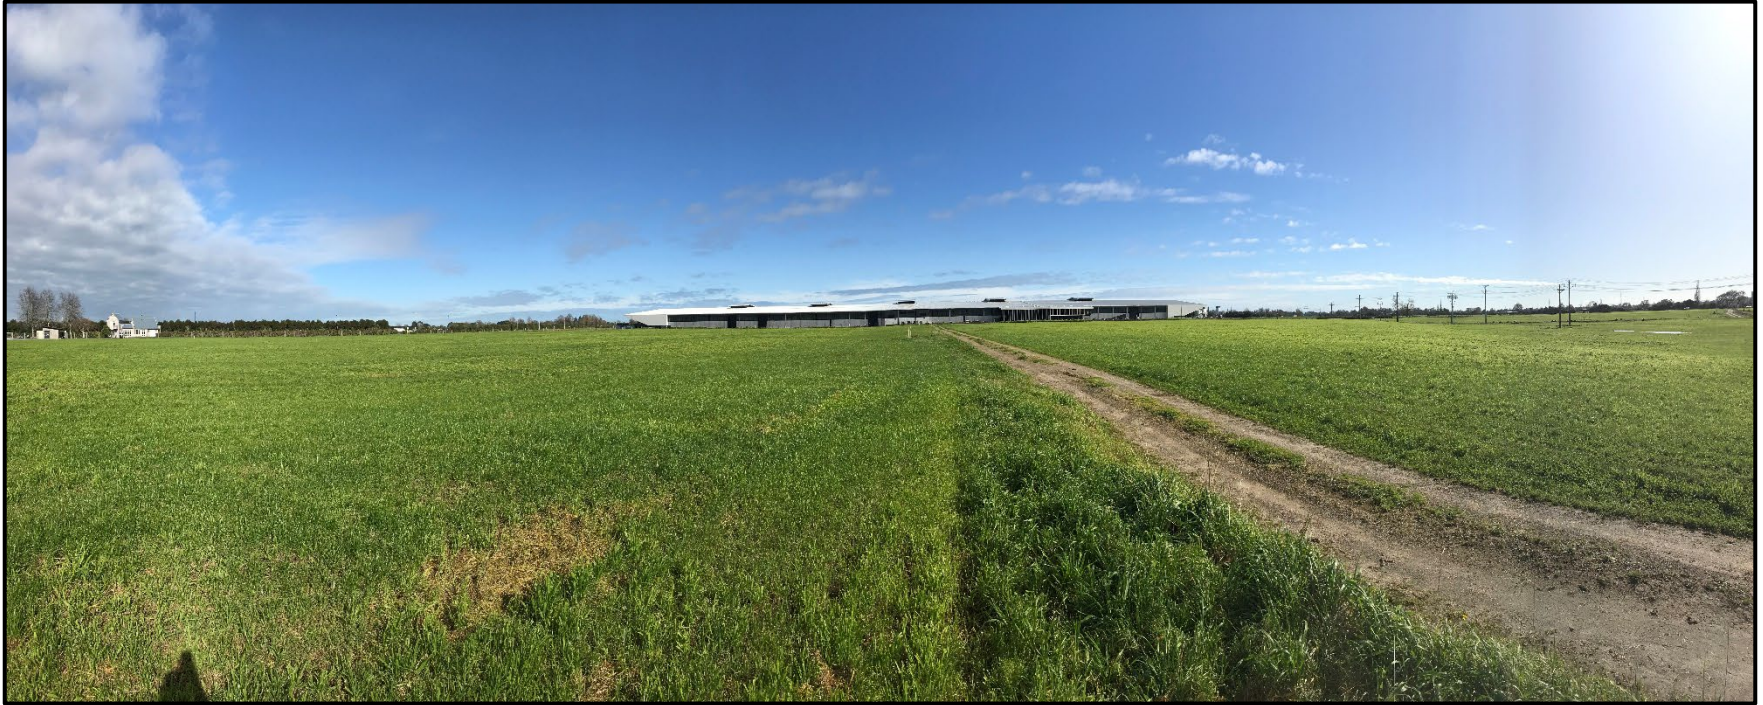
Photo 1: View from eastern boundary (Swayne Road) looking west across the southern part of the site towards the ADL Manufacturing Limited facility in the distance. The site is utilised as pastureland, powerlines are visible on the right side of the photograph running northwest to southeast across the centre of the site. Surface water ponding is visible to the right side of the photograph beneath the powerlines.

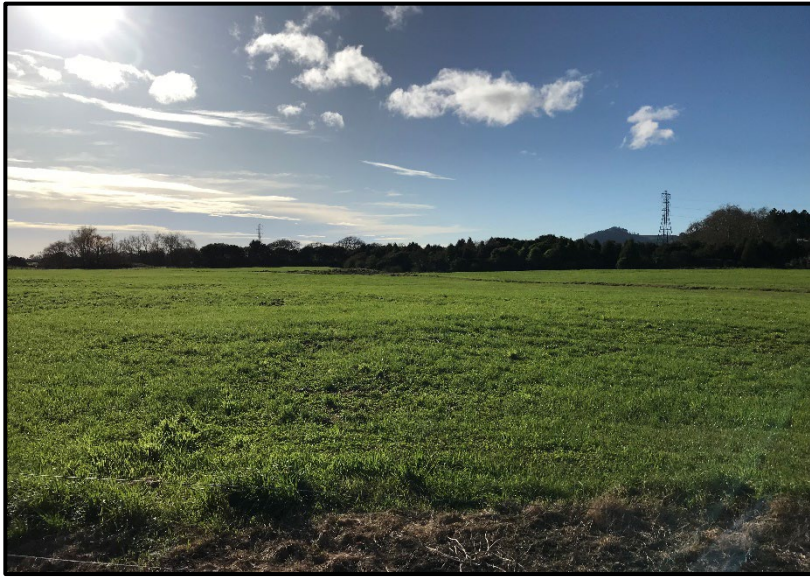
Photo 2: View from the dwelling on the eastern boundary of the site looking towards the north, the Mangaone Stream is located amongst the vegetated area in the centre of the photograph, flowing west to east just inside the site's northern boundary.

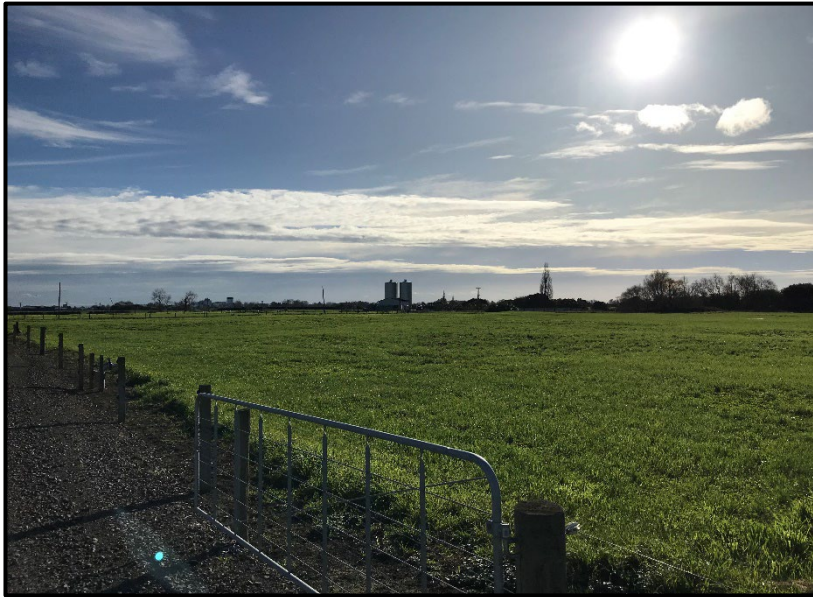
Photo 3: View from the dwelling on the eastern boundary of the site looking towards the northwest, the water treatment plant is visible by the two silos in the centre of the photograph, the Fonterra Hautapu site is beyond to the northwest.

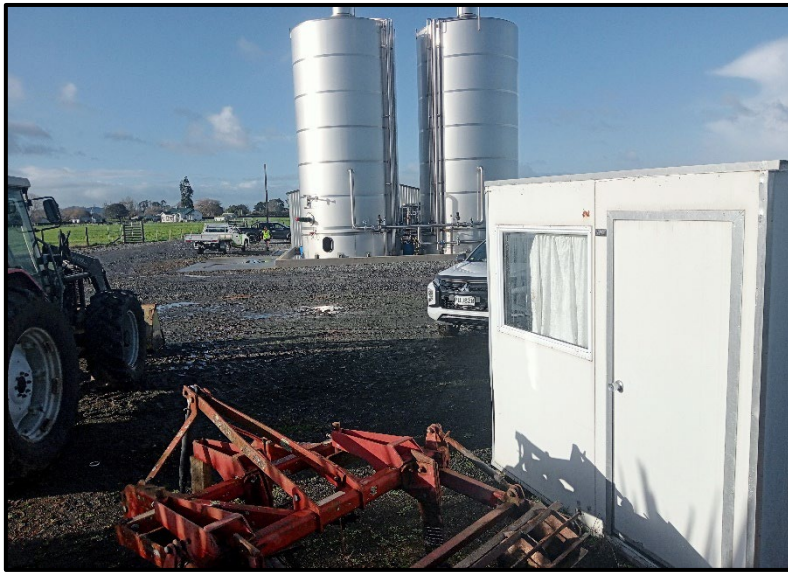
Photo 4: View from the water treatment plant looking east towards the dwelling and Swayne Road.

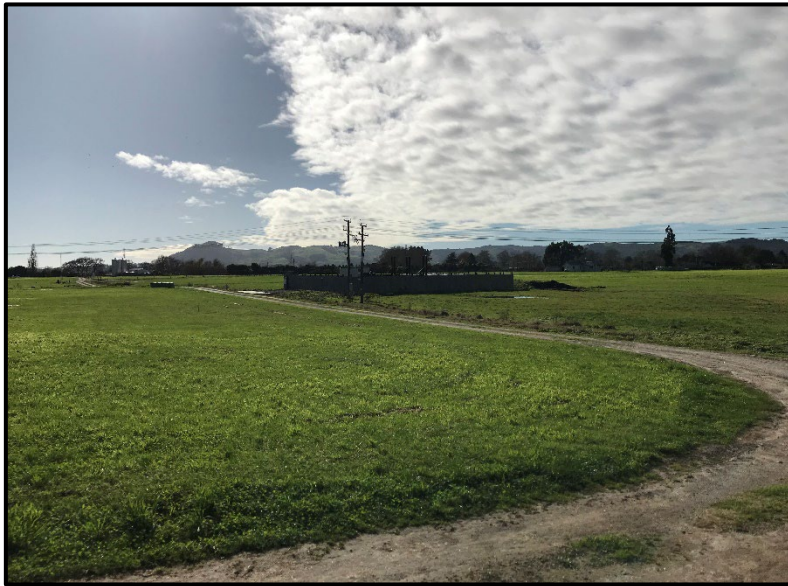
Photo 5: View from near the southern boundary of the site looking north towards the substation and the powerlines that run northwest to southeast across the centre of the site.

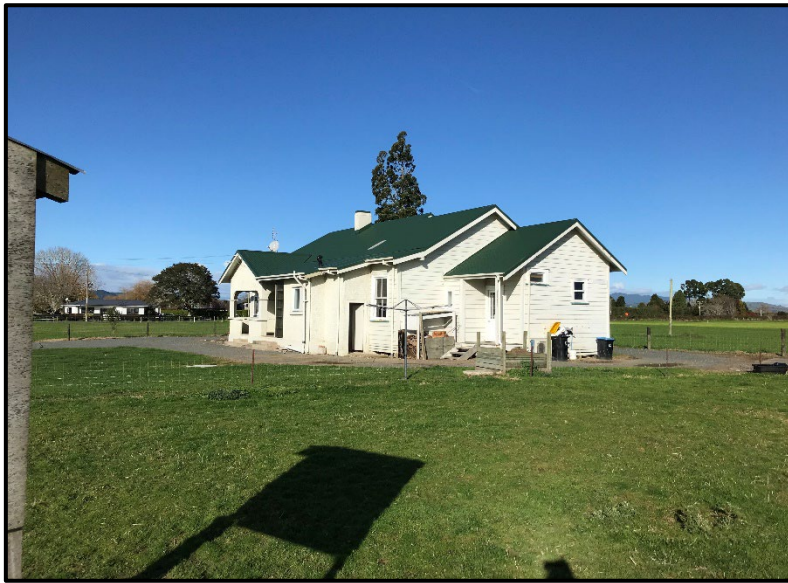
Photo 6: View of dwelling located on the eastern boundary of the site (Swayne Road). The sign (obscured) to the left of the photograph is the entry information to the Bardowie Farm irrigation site.

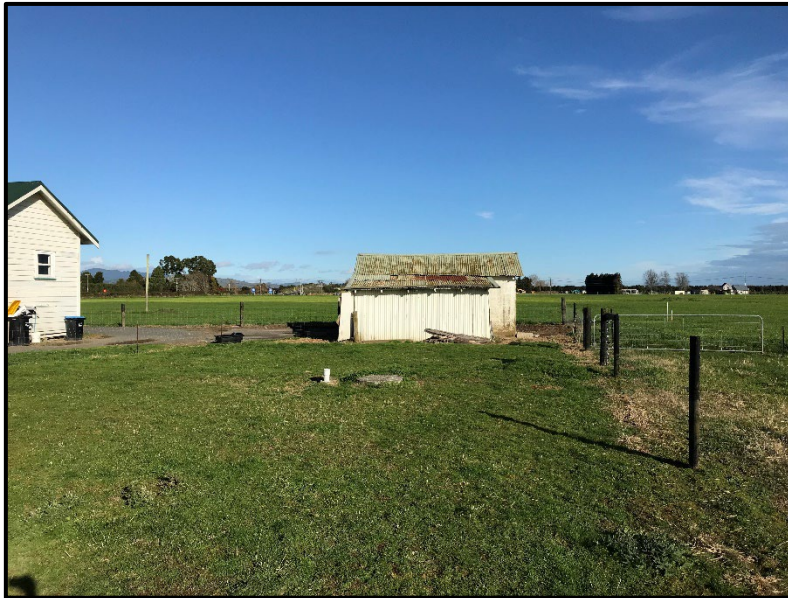
Photo 7: View of the associated structure (garage) to the dwelling above in Photo 6, located immediately west of the dwelling.

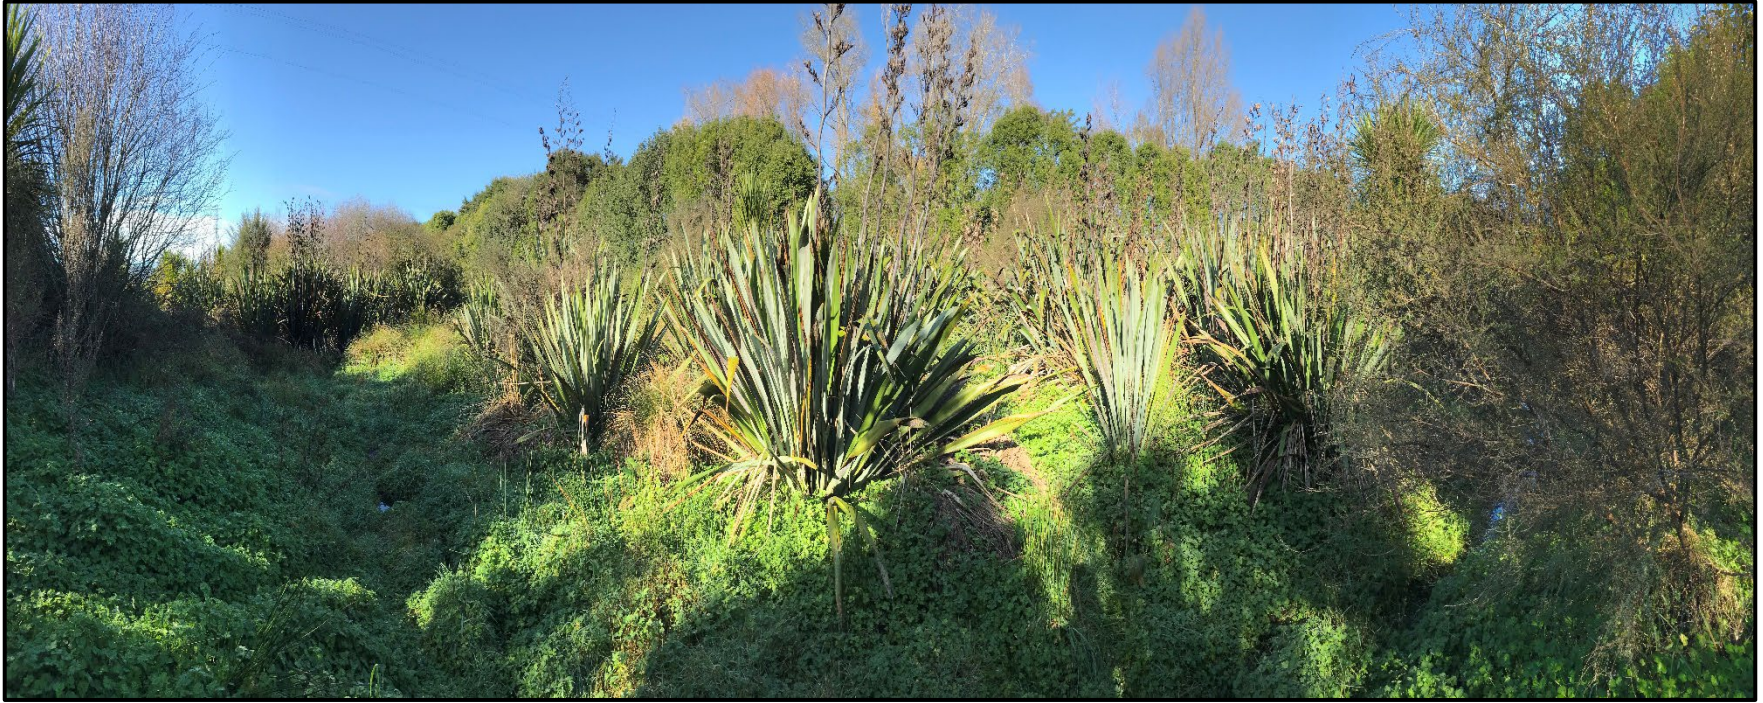
Photo 8: View of a section of the Mangaone Stream, the flow appears to be light and / or possibly impeded by vegetation growth in the watercourse. The banks of the stream are healthy with native plants abundant along the riparian margin.
