## Geotechnical Investigation for Proposed Plan Change at Fonterra Hautapu, 195 Swayne Road, Cambridge

Rev C

15 March 2024

Job No. 230322

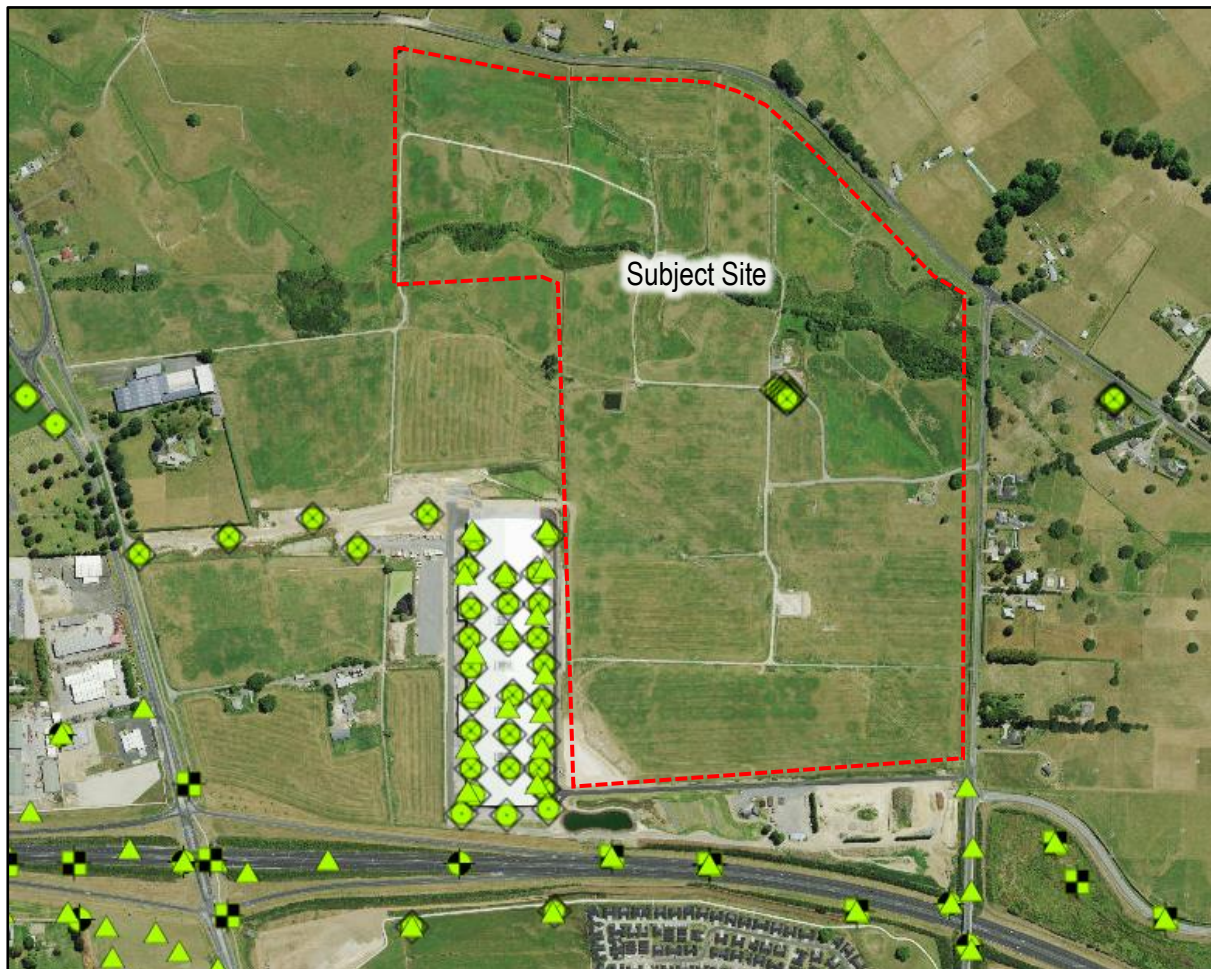
Figure 3: NZGD Test Locations (Source: New Zealand Geotechnical Database)

The tests to the west of the site, largely within the footprint of the industrial building, includes Cone Penetration Test (CPT) and hand augerhole data. Further tests comprising CPTs, testpits, and machine boreholes are also present to the south of the site associated with the Waikato Expressway.

The available data from within the subject site comprises seven hand augerholes carried out by HD Geo in November 2019. These appear to have been undertaken to support the design and construction of the pump station. The augerholes encountered loose to medium-dense gravelly sand (Hinuera Formation) to the termination depths of the holes between 2.8m and 3.0m below ground level (bgl). Groundwater was encountered in four of the locations at depths ranging between 2.5m and 2.8m bgl.

The hand augerhole logs show similar conditions to those encountered at the pump station within the subject site, typically loose to medium dense (Hinuera Formation) sands with lesser amounts of silt and gravel. No organic soils are noted in the logs. Groundwater was encountered at depths ranging between 1.4m and 3.0m bgl, however was not encountered at several test locations.

The CPT data indicates the loose to medium dense sands (as encountered in the augerholes) extend to depths of approximately 10m to 11m bgl. From this depth the silt and clay content of the soils increases to comprise intermixed silts, sands, and clays to the termination depths of the tests at 20m bgl. A single CPT was terminated at 12m depth bgl due to tip resistance exceeding 35MPa. Groundwater was measured within the CPT holes at depths ranging between 1.3m and 3.0m bgl.

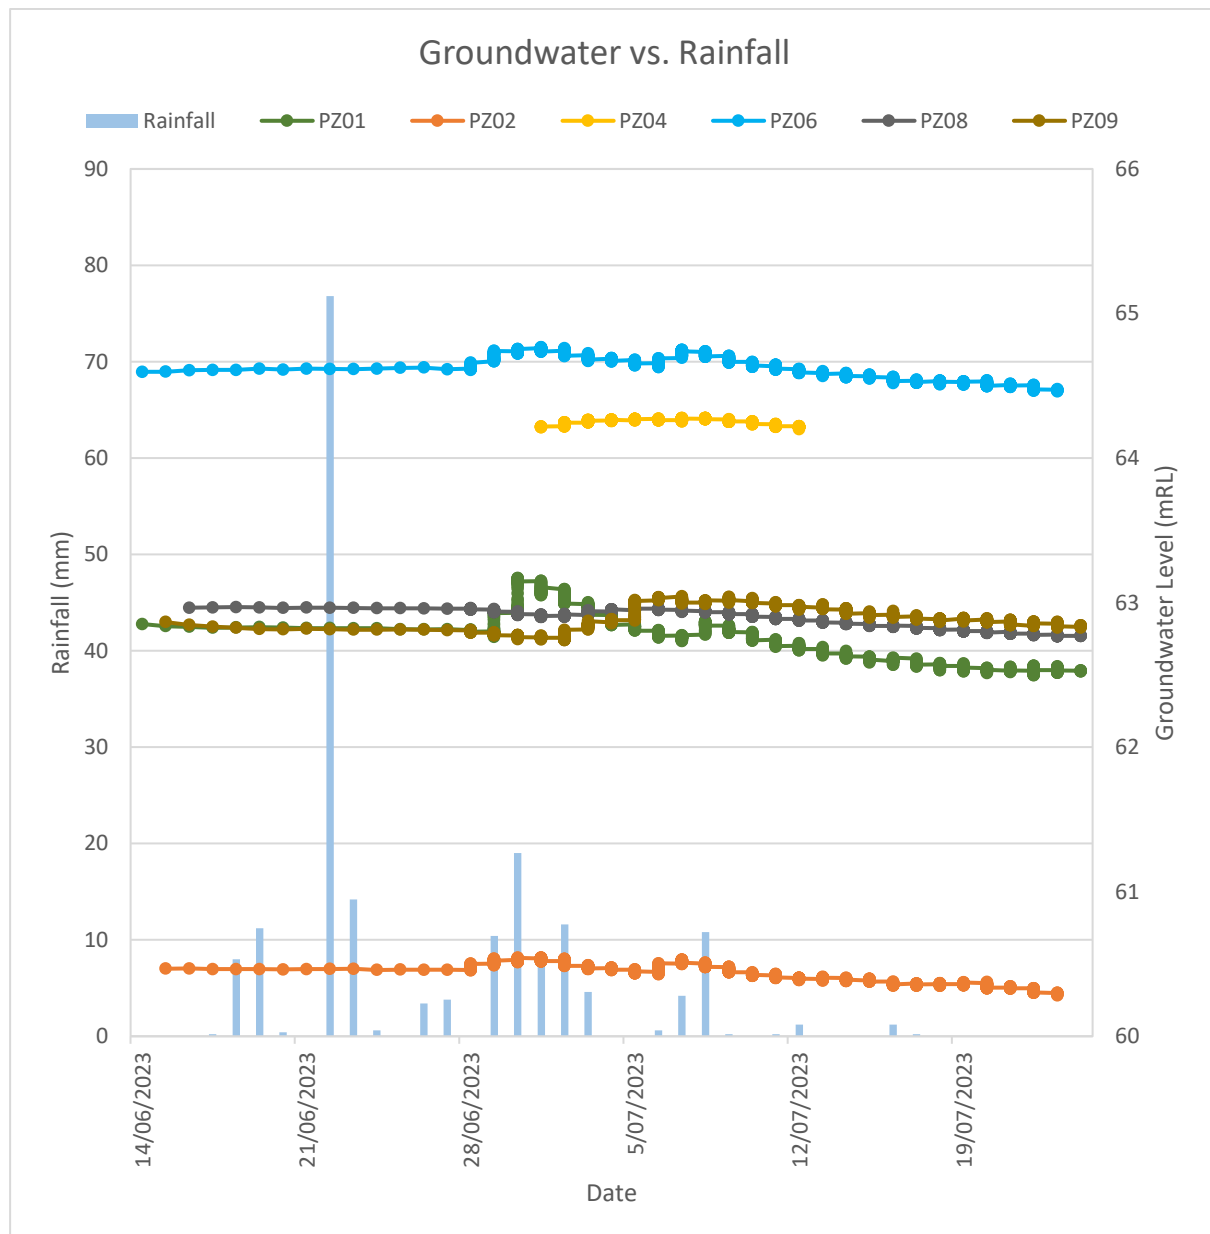
Figure 4: Hydrograph (Recorded Groundwater Levels and Rainfall)

Groundwater monitoring was carried out in mid-winter and whilst it may be expected that the upper limit of groundwater levels would occur during winter conditions, given the nature of the Waikato basin area a significant lag between high rainfall periods and groundwater levels may exist. This may result in higher groundwater levels during summer.
