# 3463 OHAUPO ROAD, RUKUHIA

# PRELIMINARY GEOTECHNICAL INVESTIGATION REPORT

McConnell Property
HAM2021-0073AC Rev 0

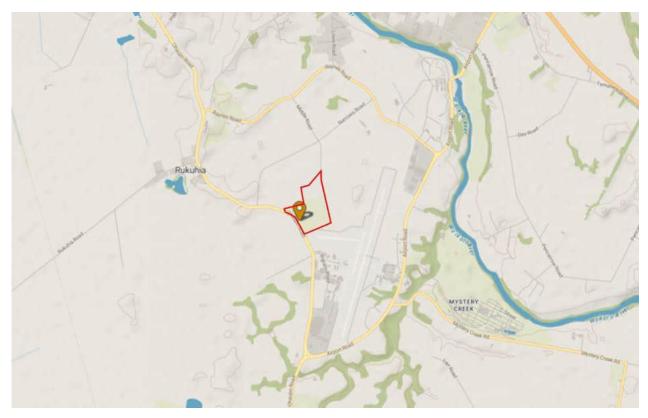
The site is legally described as Part Allot 153 Te Rapa PSH DP 493079, comprises an area of approximately 19.8ha, and is located on the eastern side of Ohaupo Road and south-west of the southern end of Middle Road as shown on *Figure 1* below.

Figure 1: Site Location Plan (LINZ Maps). Site extent shown in red.

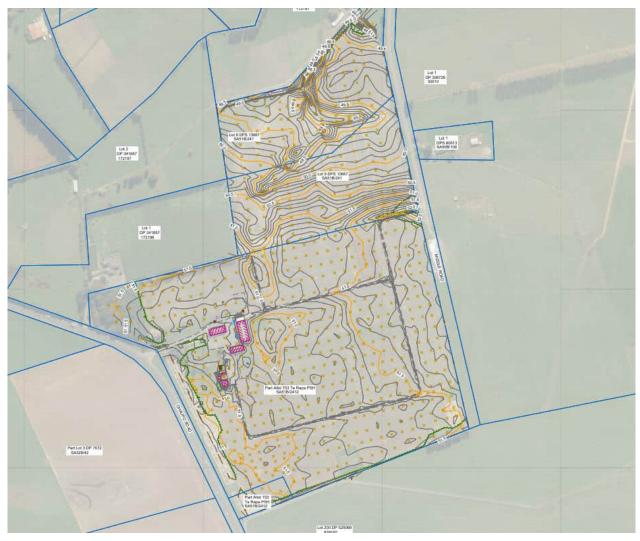
Figure 2: Topographical Survey Plan (BECA, July 2021, contours in 0.1m increments)

The current general landform, together with associated features located within and adjacent to the site is presented on the attached Site Investigation Plan (*Drawing 01*) in *Appendix A* and *Figure 2* below.

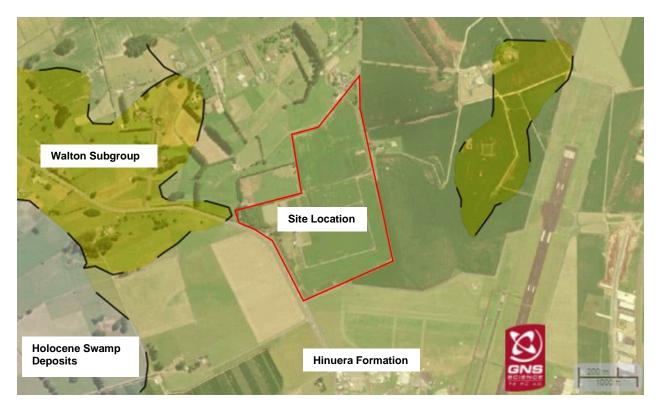
The published geological map<sup>6</sup> for the area indicates the site is underlain by Late Pleistocene aged river deposits comprising cross-bedded pumice sand, silt and gravel with interbedded peat of the Hinuera Formation as illustrated in *Figure 3* below.

Figure 3: Regional Geology (QMap)

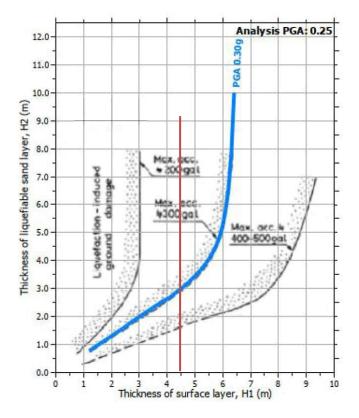
# Figure 4: Figure 88 sourced from Ishihara (1985)<sup>17</sup>

Reference to Figure 88 (Figure 4 above), sourced from Ishihara (1985), was made with respect to assessing the contribution of a non-liquefiable crust over liquefiable sands with respect to the risk of surface manifestation.

As shown in the above figure, a 4.5m thick crust is required for the ULS scenario (0.25 pga) to prevent significant liquefaction induced ground damage where underlain by greater than 5m metres of underlying liquefiable ground. The specific analysis (without an ageing factor applied) typically showed that total thicknesses of liquefiable materials across the site are greater than 5m as depicted on Cross-section A in **Appendix A**.

Referring to Figure 88 sourced from Ishihara (1985) (Figure 4 above), we expect that increasing the non-liquefiable crust thickness via the placement of engineered fills will be required to mitigate potential surface manifestation of the settlements during an ULS seismic event. The recommended thickness and extent of these fills will vary depending on the results of the tuned specific liquefaction analysis mentioned above, but generally could vary between 2.0m and 4.0m.

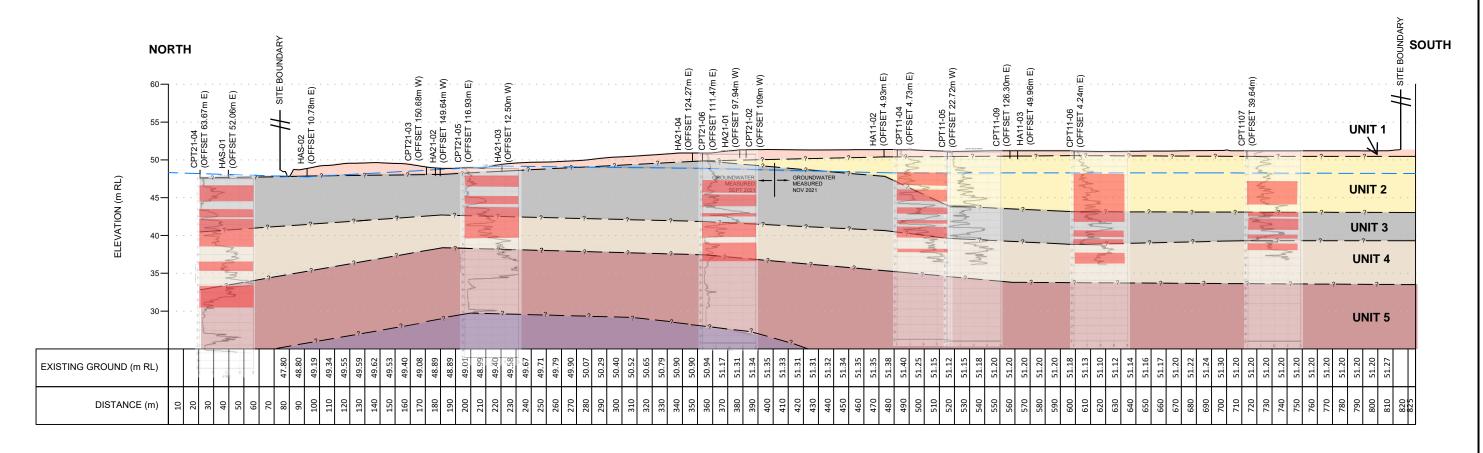
SECTION A (5x VERTICAL EXAGERATION)

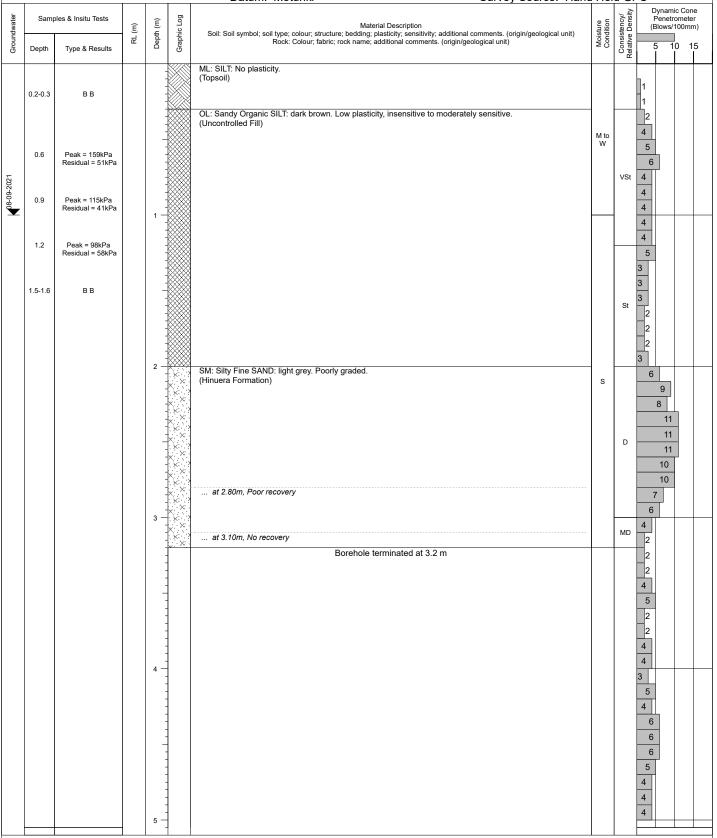
# **HAND AUGER BOREHOLE LOG - HA21-01**

Termination Reason: Hole collapse

Uncontrolled fill was encountered to depths of 2.0m and 0.4m in HA21-01 and HA21-02 respectively. These materials typically consisted of very loose to medium dense Sandy organic SILT. Peak strength shear vane values recorded in this material ranged between 98kPa and 159kPa.

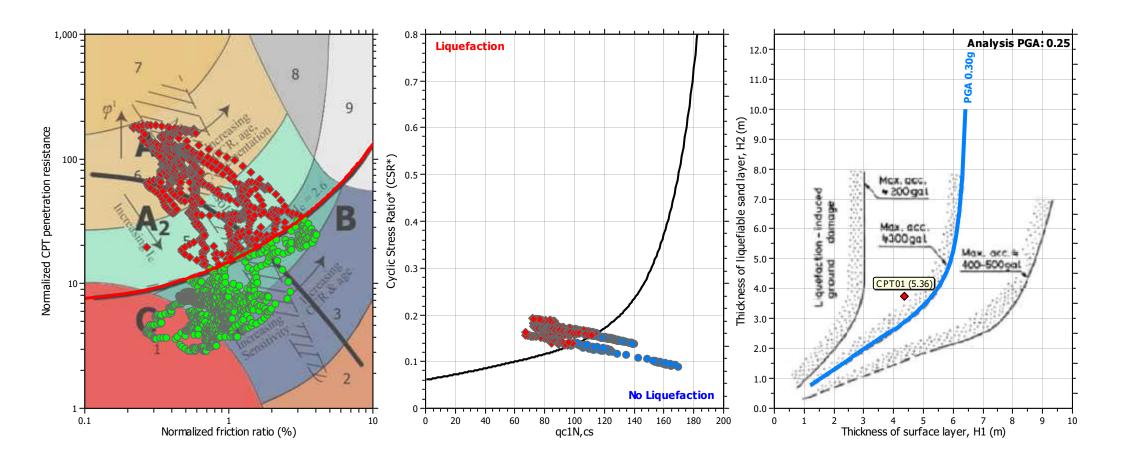
## Liquefaction analysis summary plots

Analysis method: B&I (2014) Depth to GWT (erthq.): 3.50 m Fill weight: N/A Transition detect. applied: Fines correction method: B&I (2014) Average results interval: 3 No Based on Ic value Ic cut-off value:  $K_{\sigma}$  applied: Points to test: 2.60 Yes Earthquake magnitude M<sub>w</sub>: 5.90 Unit weight calculation: Based on SBT Clay like behavior applied: Sand & Clay Peak ground acceleration: Use fill: Limit depth applied: No Depth to water table (insitu): 3.50 m Fill height: N/A Limit depth: N/A

The design ULS earthquake induces liquefaction within all the CPT traces, and shows highly variable results across the site, with potential vertical liquefaction induced settlements of between 90mm and 310mm with no applied ageing factor versus 17mm to 170mm with an applied ageing factor of 1.65. It is recommended that Seismic Cone Penetration Testing (SCPT) is undertaken to define an appropriate site-specific ageing factor. Consideration will also be given to sampling and laboratory testing of liquefaction susceptible layers to further assess the risk of liquefaction. As a general rule, noticeable differential settlements may be assumed to be in the order of one half to two thirds of the total settlements reported above.

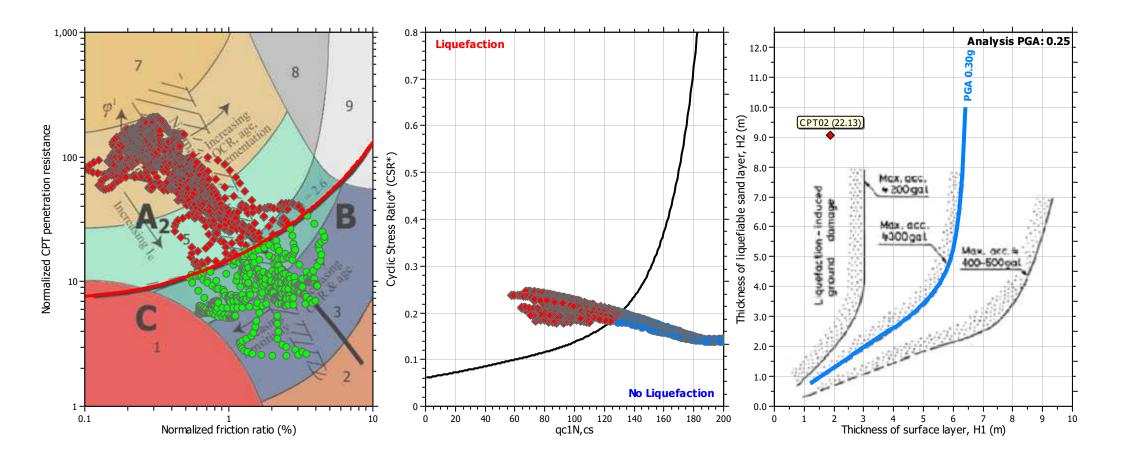
## Liquefaction analysis summary plots

Analysis method: B&I (2014) Depth to GWT (erthq.): 1.00 m Fill weight: N/A Transition detect. applied: Fines correction method: B&I (2014) Average results interval: 3 No Based on Ic value Ic cut-off value:  $K_{\sigma}$  applied: Points to test: 2.60 Yes Earthquake magnitude M<sub>w</sub>: 5.90 Unit weight calculation: Based on SBT Clay like behavior applied: Sand & Clay Peak ground acceleration: Use fill: Limit depth applied: No Depth to water table (insitu): 1.00 m Fill height: N/A Limit depth: N/A

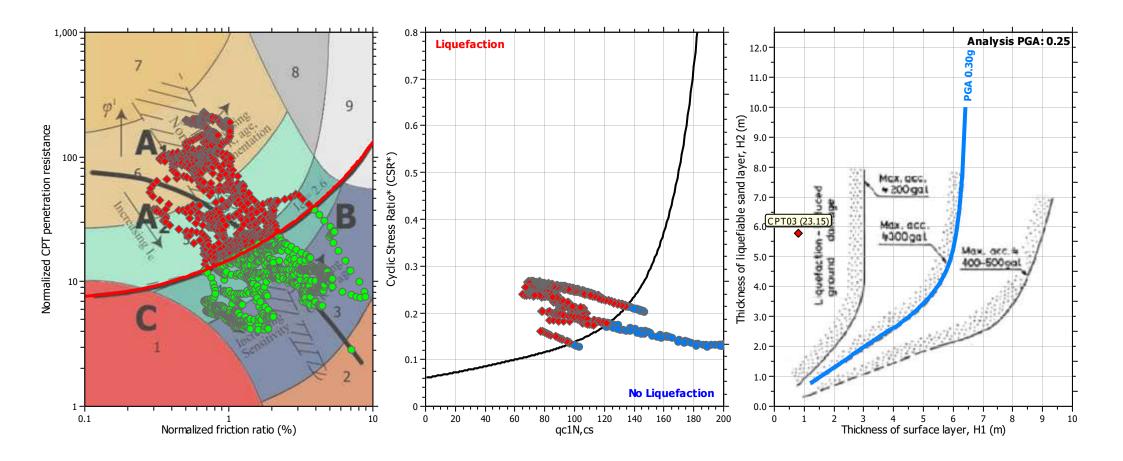
## Liquefaction analysis summary plots

Analysis method: B&I (2014) Depth to GWT (erthq.): 0.40 m Fill weight: N/A Transition detect. applied: Fines correction method: B&I (2014) Average results interval: 3 No Based on Ic value Ic cut-off value:  $K_{\sigma}$  applied: Points to test: 2.60 Yes Earthquake magnitude M<sub>w</sub>: 5.90 Unit weight calculation: Based on SBT Clay like behavior applied: Sand & Clay Peak ground acceleration: Use fill: Limit depth applied: No Depth to water table (insitu): 0.40 m Fill height: N/A Limit depth: N/A

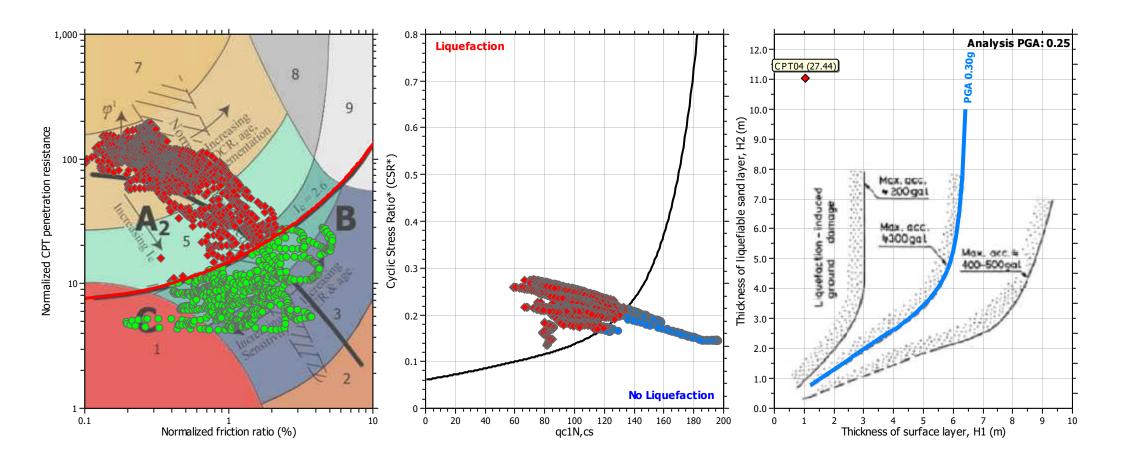
## Liquefaction analysis summary plots

Analysis method: B&I (2014) Depth to GWT (erthq.): 0.40 m Fill weight: N/A Transition detect. applied: Fines correction method: B&I (2014) Average results interval: 3 No Based on Ic value Ic cut-off value:  $K_{\sigma}$  applied: Points to test: 2.60 Yes Earthquake magnitude M<sub>w</sub>: 5.90 Unit weight calculation: Based on SBT Clay like behavior applied: Sand & Clay Peak ground acceleration: Use fill: Limit depth applied: No Depth to water table (insitu): 0.40 m Fill height: N/A Limit depth: N/A

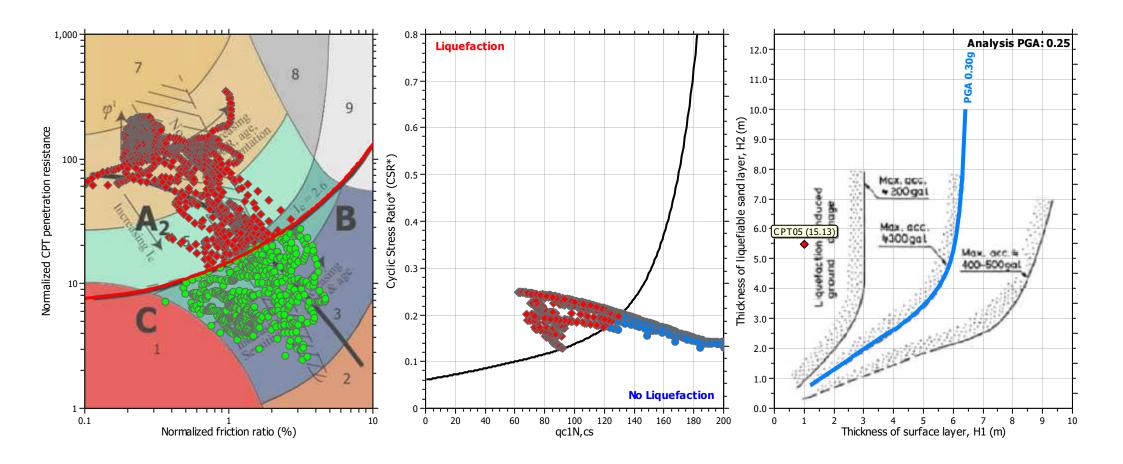
## Liquefaction analysis summary plots

Analysis method: B&I (2014) Depth to GWT (erthq.): 1.00 m Fill weight: N/A Transition detect. applied: Fines correction method: B&I (2014) Average results interval: 3 No Points to test: Based on Ic value Ic cut-off value:  $K_{\sigma}$  applied: 2.60 Yes Earthquake magnitude M<sub>w</sub>: 5.90 Unit weight calculation: Based on SBT Clay like behavior applied: Sand & Clay Peak ground acceleration: Use fill: Limit depth applied: No Depth to water table (insitu): 1.00 m Fill height: N/A Limit depth: N/A

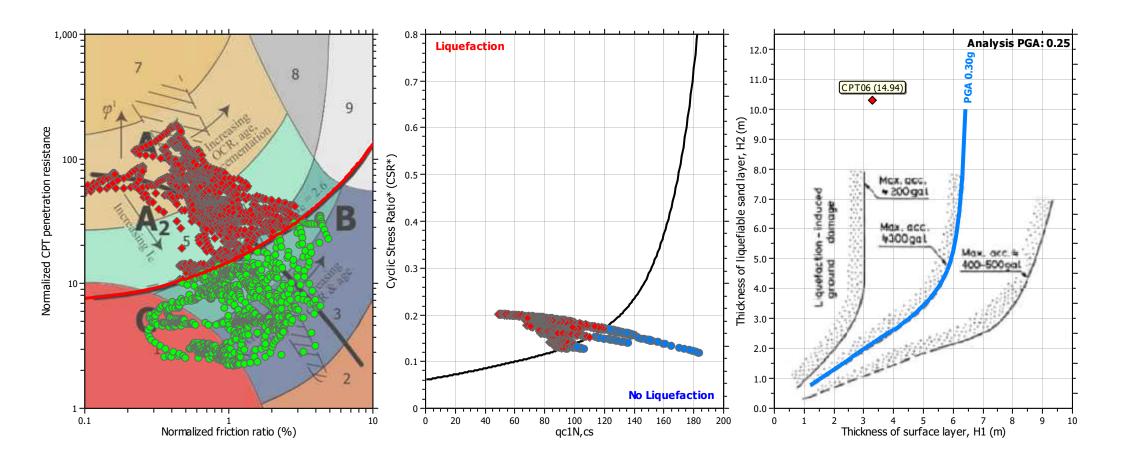
## Liquefaction analysis summary plots

Analysis method: B&I (2014) Depth to GWT (erthq.): 2.90 m Fill weight: N/A Transition detect. applied: Fines correction method: B&I (2014) Average results interval: 3 No Based on Ic value Ic cut-off value:  $K_{\sigma}$  applied: Points to test: 2.60 Yes Earthquake magnitude M<sub>w</sub>: 5.90 Unit weight calculation: Based on SBT Clay like behavior applied: Sand & Clay Peak ground acceleration: Use fill: Limit depth applied: No Depth to water table (insitu): 2.90 m Fill height: N/A Limit depth: N/A

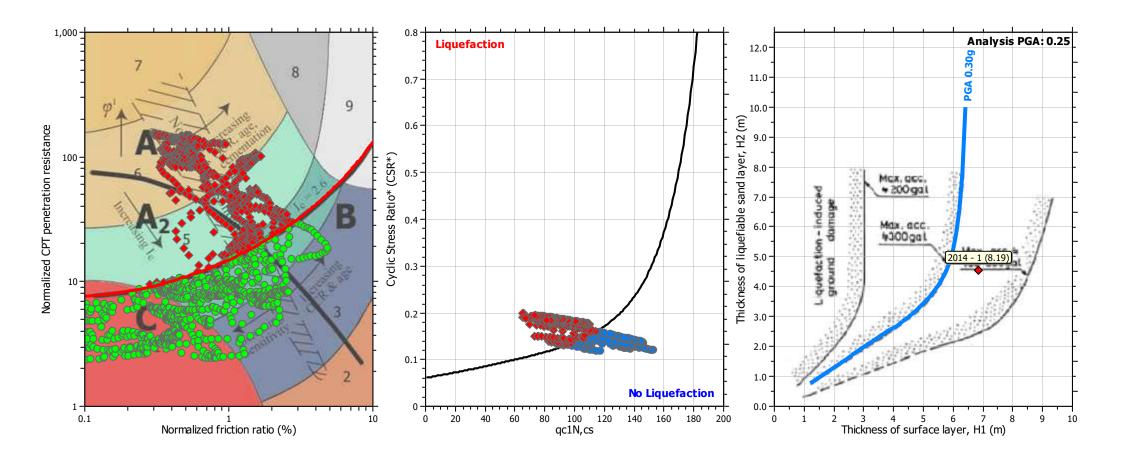
## Liquefaction analysis summary plots

Analysis method: B&I (2014) Depth to GWT (erthq.): 3.00 m Fill weight: N/A Transition detect. applied: Fines correction method: B&I (2014) Average results interval: 3 No Points to test: Based on Ic value Ic cut-off value:  $K_{\sigma}$  applied: 2.60 Yes Earthquake magnitude M<sub>w</sub>: 5.90 Unit weight calculation: Based on SBT Clay like behavior applied: Sand & Clay Peak ground acceleration: Use fill: Limit depth applied: No Depth to water table (insitu): 3.00 m Fill height: N/A Limit depth: N/A

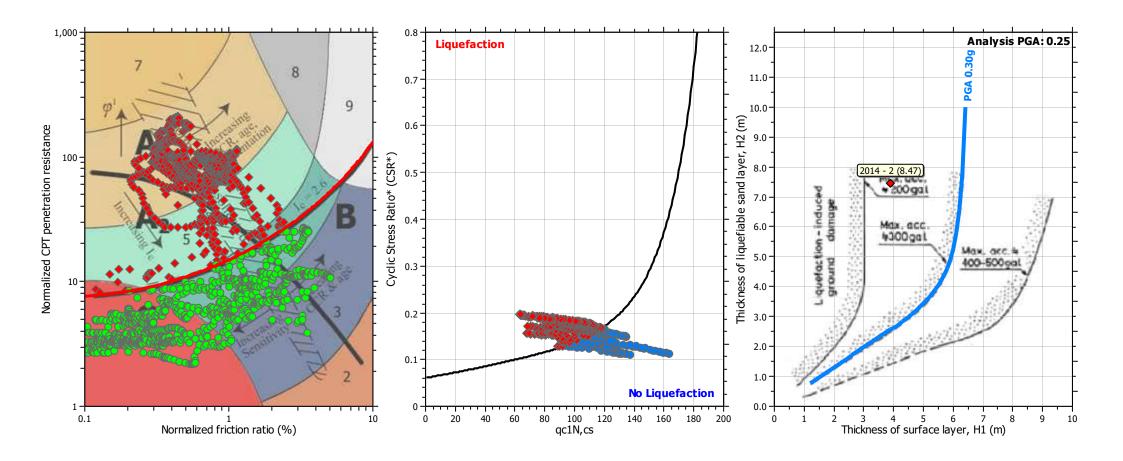
## Liquefaction analysis summary plots

Analysis method: B&I (2014) Depth to GWT (erthq.): 3.00 m Fill weight: N/A Transition detect. applied: Fines correction method: B&I (2014) Average results interval: 3 No Based on Ic value Ic cut-off value:  $K_{\sigma}$  applied: Points to test: 2.60 Yes Earthquake magnitude M<sub>w</sub>: 5.90 Unit weight calculation: Based on SBT Clay like behavior applied: Sand & Clay Peak ground acceleration: 0.25 Use fill: Limit depth applied: No Depth to water table (insitu): 3.00 m Fill height: N/A Limit depth: N/A

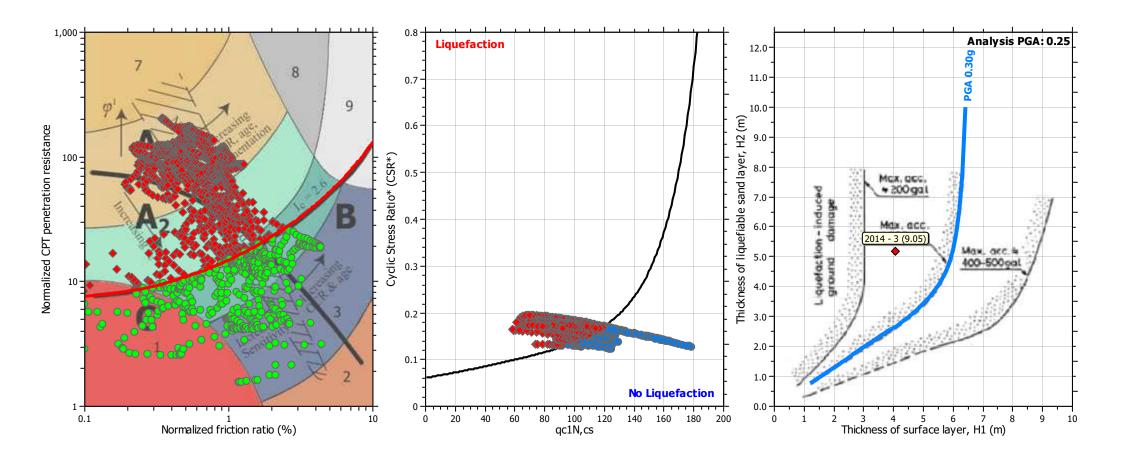
## Liquefaction analysis summary plots

Analysis method: B&I (2014) Depth to GWT (erthq.): 3.00 m Fill weight: N/A Transition detect. applied: Fines correction method: B&I (2014) Average results interval: 3 No Based on Ic value Ic cut-off value:  $K_{\sigma}$  applied: Points to test: 2.60 Yes Earthquake magnitude M<sub>w</sub>: 5.90 Unit weight calculation: Based on SBT Clay like behavior applied: Sand & Clay Peak ground acceleration: Use fill: Limit depth applied: No Depth to water table (insitu): 3.00 m Fill height: N/A Limit depth: N/A

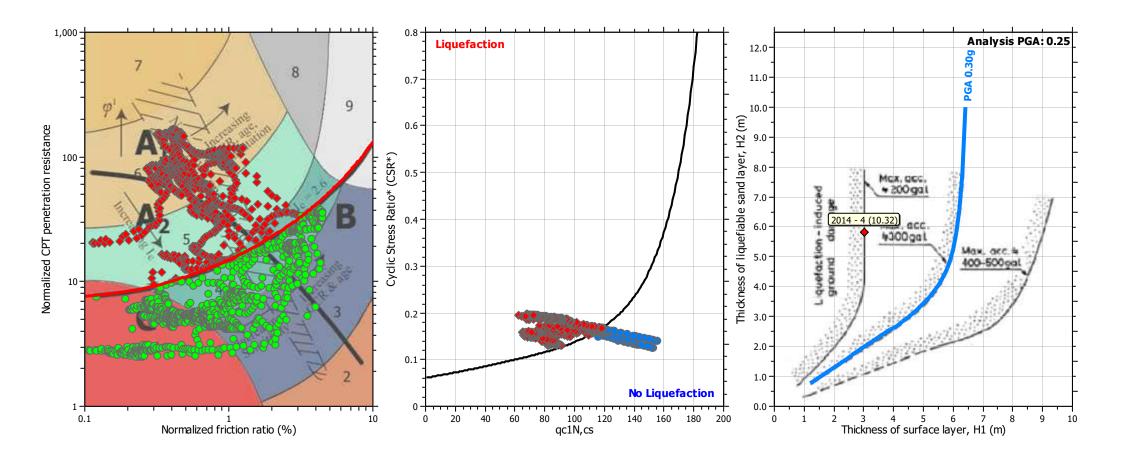
## Liquefaction analysis summary plots

Analysis method: B&I (2014) Depth to GWT (erthq.): 3.00 m Fill weight: N/A Transition detect. applied: Fines correction method: B&I (2014) Average results interval: 3 No Based on Ic value Ic cut-off value:  $K_{\sigma}$  applied: Points to test: 2.60 Yes Earthquake magnitude M<sub>w</sub>: 5.90 Unit weight calculation: Based on SBT Clay like behavior applied: Sand & Clay Peak ground acceleration: Use fill: Limit depth applied: No Depth to water table (insitu): 3.00 m Fill height: N/A Limit depth: N/A

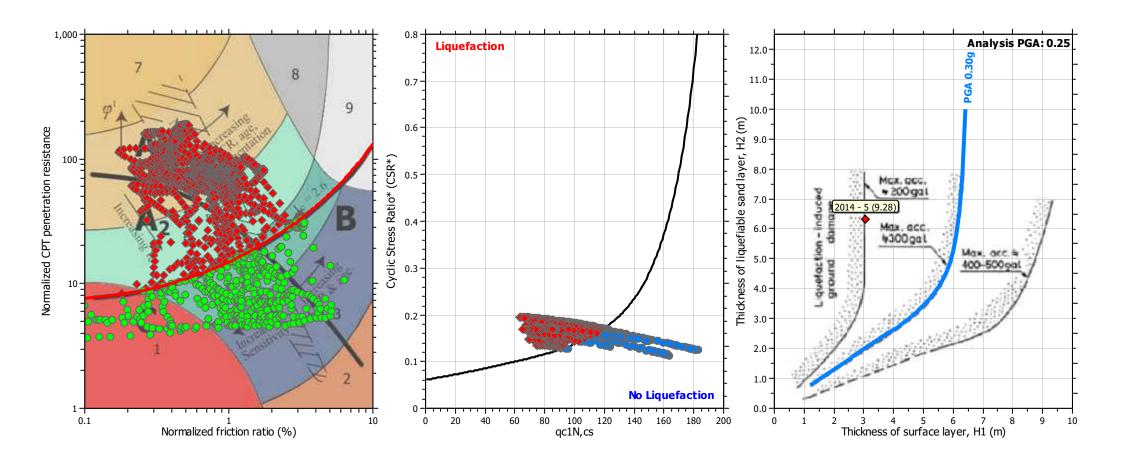
# Liquefaction analysis summary plots

Analysis method: B&I (2014) Depth to GWT (erthq.): 3.00 m Fill weight: N/A Transition detect. applied: Fines correction method: B&I (2014) Average results interval: 3 No Based on Ic value Ic cut-off value:  $K_{\sigma}$  applied: Points to test: 2.60 Yes Earthquake magnitude M<sub>w</sub>: 5.90 Unit weight calculation: Based on SBT Clay like behavior applied: Sand & Clay Peak ground acceleration: Use fill: Limit depth applied: No Depth to water table (insitu): 3.00 m Fill height: N/A Limit depth: N/A

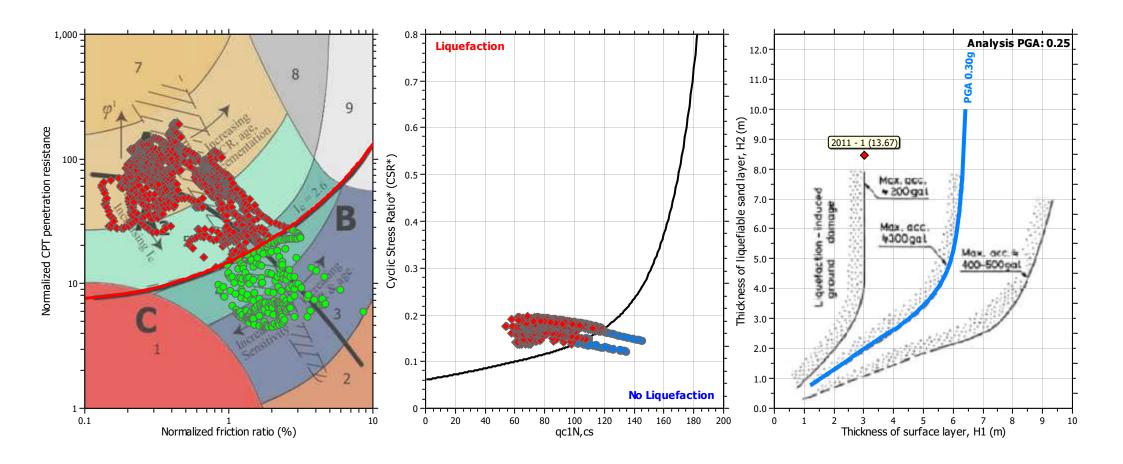
# Liquefaction analysis summary plots

Analysis method: B&I (2014) Depth to GWT (erthq.): 3.00 m Fill weight: N/A Transition detect. applied: Fines correction method: B&I (2014) Average results interval: 3 No Based on Ic value Ic cut-off value:  $K_{\sigma}$  applied: Points to test: 2.60 Yes Earthquake magnitude M<sub>w</sub>: 5.90 Unit weight calculation: Based on SBT Clay like behavior applied: Sand & Clay Peak ground acceleration: 0.25 Use fill: Limit depth applied: No Depth to water table (insitu): 3.00 m Fill height: N/A Limit depth: N/A

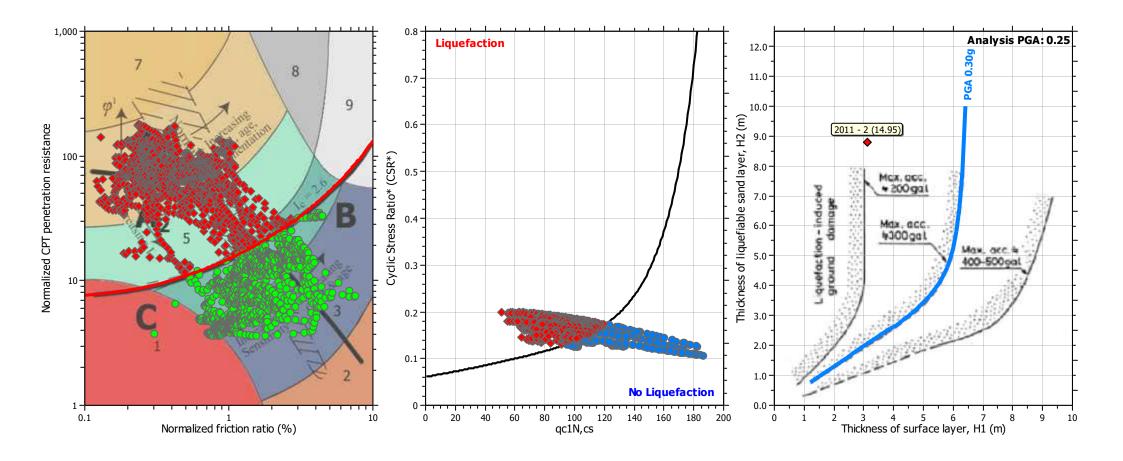
# Liquefaction analysis summary plots

Analysis method: B&I (2014) Depth to GWT (erthq.): 3.00 m Fill weight: N/A Transition detect. applied: Fines correction method: B&I (2014) Average results interval: 3 No Based on Ic value Ic cut-off value:  $K_{\sigma}$  applied: Points to test: 2.60 Yes Earthquake magnitude M<sub>w</sub>: 5.90 Unit weight calculation: Based on SBT Clay like behavior applied: Sand & Clay Peak ground acceleration: 0.25 Use fill: Limit depth applied: No Depth to water table (insitu): 3.00 m Fill height: N/A Limit depth: N/A

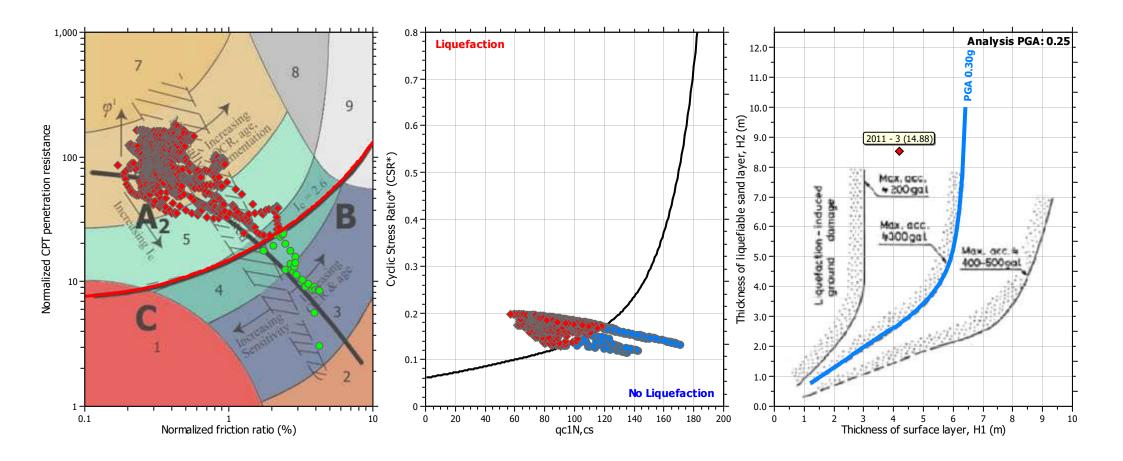
# Liquefaction analysis summary plots

Analysis method: B&I (2014) Depth to GWT (erthq.): 3.00 m Fill weight: N/A Transition detect. applied: Fines correction method: B&I (2014) Average results interval: 3 No Based on Ic value Ic cut-off value:  $K_{\sigma}$  applied: Points to test: 2.60 Yes Earthquake magnitude M<sub>w</sub>: 5.90 Unit weight calculation: Based on SBT Clay like behavior applied: Sand & Clay Peak ground acceleration: 0.25 Use fill: Limit depth applied: No Depth to water table (insitu): 3.00 m Fill height: N/A Limit depth: N/A

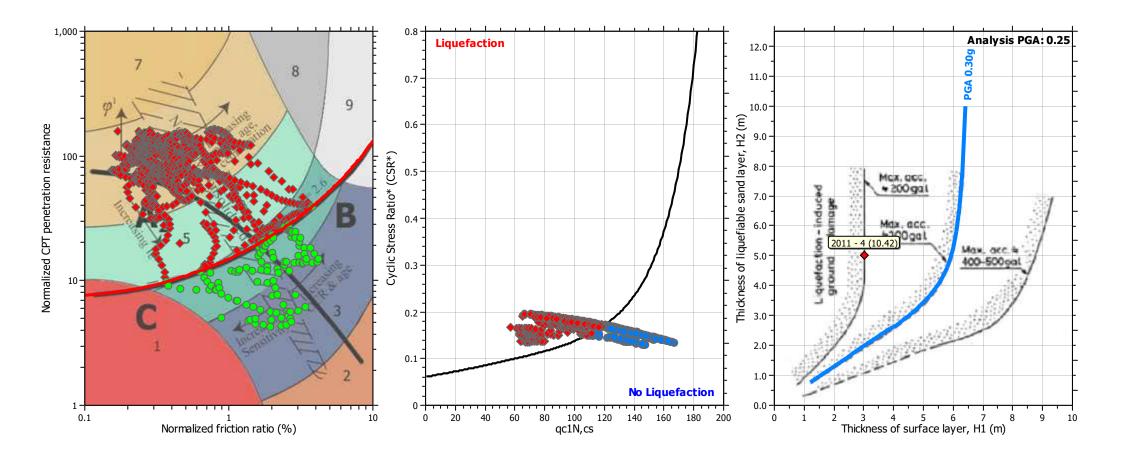
# Liquefaction analysis summary plots

Analysis method: B&I (2014) Depth to GWT (erthq.): 3.00 m Fill weight: N/A Transition detect. applied: Fines correction method: B&I (2014) Average results interval: 3 No Based on Ic value Ic cut-off value:  $K_{\sigma}$  applied: Points to test: 2.60 Yes Earthquake magnitude M<sub>w</sub>: 5.90 Unit weight calculation: Based on SBT Clay like behavior applied: Sand & Clay Peak ground acceleration: 0.25 Use fill: Limit depth applied: No Depth to water table (insitu): 3.00 m Fill height: N/A Limit depth: N/A

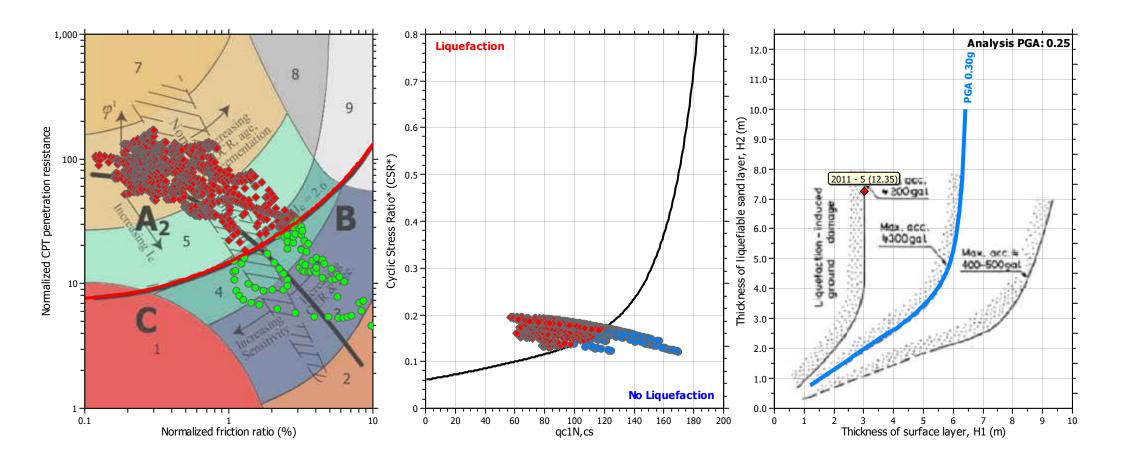
# Liquefaction analysis summary plots

Analysis method: B&I (2014) Depth to GWT (erthq.): 3.00 m Fill weight: N/A Transition detect. applied: Fines correction method: B&I (2014) Average results interval: 3 No Based on Ic value Ic cut-off value:  $K_{\sigma}$  applied: Points to test: 2.60 Yes Earthquake magnitude M<sub>w</sub>: 5.90 Unit weight calculation: Based on SBT Clay like behavior applied: Sand & Clay Peak ground acceleration: Use fill: Limit depth applied: No Depth to water table (insitu): 3.00 m Fill height: N/A Limit depth: N/A

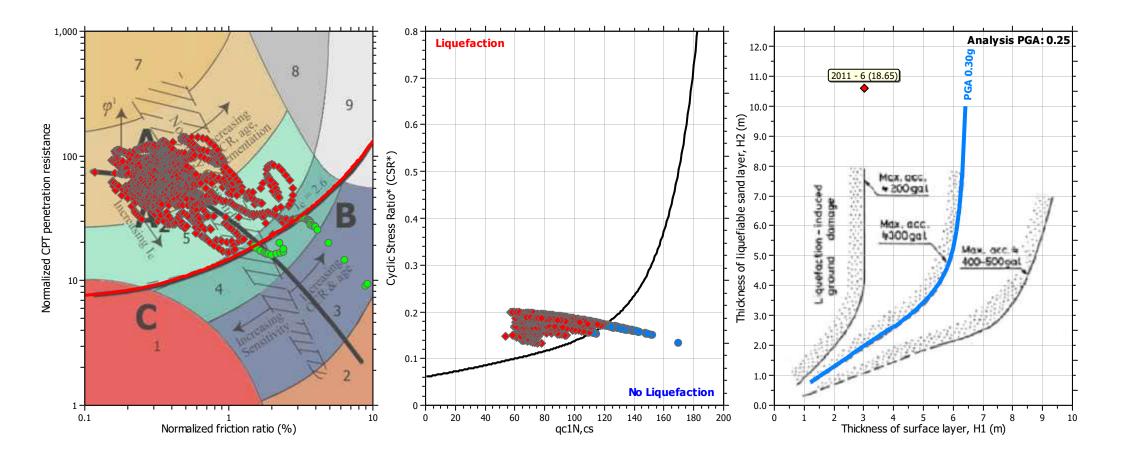
# Liquefaction analysis summary plots

Analysis method: B&I (2014) Depth to GWT (erthq.): 3.00 m Fill weight: N/A Transition detect. applied: Fines correction method: B&I (2014) Average results interval: 3 No Based on Ic value Ic cut-off value:  $K_{\sigma}$  applied: Points to test: 2.60 Yes Earthquake magnitude M<sub>w</sub>: 5.90 Unit weight calculation: Based on SBT Clay like behavior applied: Sand & Clay Peak ground acceleration: Use fill: Limit depth applied: No Depth to water table (insitu): 3.00 m Fill height: N/A Limit depth: N/A

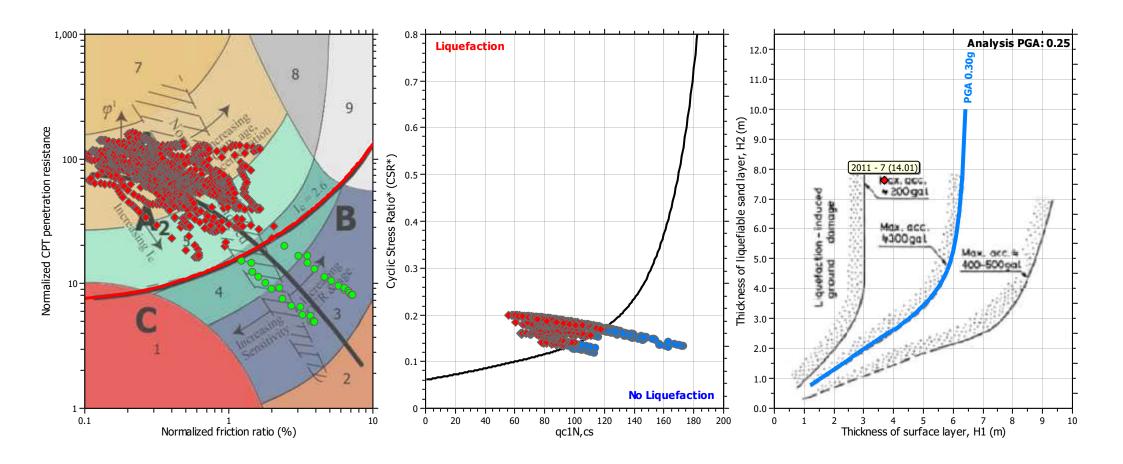
# Liquefaction analysis summary plots

Analysis method: B&I (2014) Depth to GWT (erthq.): 3.00 m Fill weight: N/A Transition detect. applied: Fines correction method: B&I (2014) Average results interval: 3 No Based on Ic value Ic cut-off value:  $K_{\sigma}$  applied: Points to test: 2.60 Yes Earthquake magnitude M<sub>w</sub>: 5.90 Unit weight calculation: Based on SBT Clay like behavior applied: Sand & Clay Peak ground acceleration: Use fill: Limit depth applied: No Depth to water table (insitu): 3.00 m Fill height: N/A Limit depth: N/A

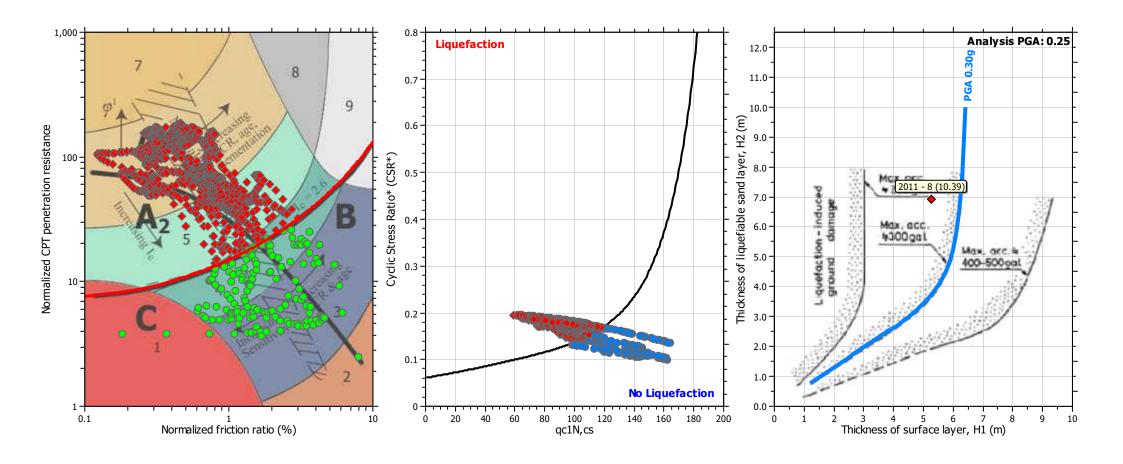
# Liquefaction analysis summary plots

Analysis method: B&I (2014) Depth to GWT (erthq.): 3.00 m Fill weight: N/A Transition detect. applied: Fines correction method: B&I (2014) Average results interval: 3 No Based on Ic value Ic cut-off value:  $K_{\sigma}$  applied: Points to test: 2.60 Yes Earthquake magnitude M<sub>w</sub>: 5.90 Unit weight calculation: Based on SBT Clay like behavior applied: Sand & Clay Peak ground acceleration: Use fill: Limit depth applied: No Depth to water table (insitu): 3.00 m Fill height: N/A Limit depth: N/A

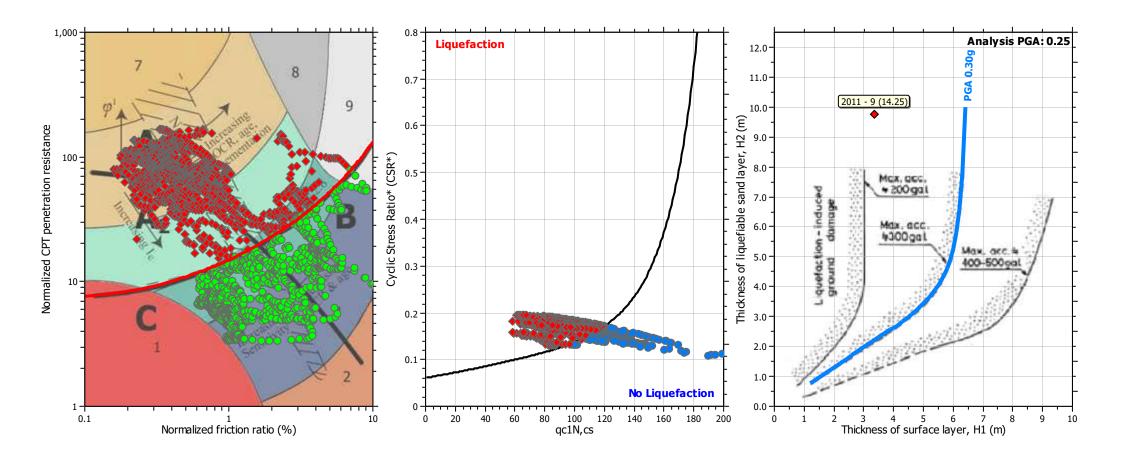
# Liquefaction analysis summary plots

Analysis method: B&I (2014) Depth to GWT (erthq.): 3.00 m Fill weight: N/A Transition detect. applied: Fines correction method: B&I (2014) Average results interval: 3 No Based on Ic value Ic cut-off value:  $K_{\sigma}$  applied: Points to test: 2.60 Yes Earthquake magnitude M<sub>w</sub>: 5.90 Unit weight calculation: Based on SBT Clay like behavior applied: Sand & Clay Peak ground acceleration: 0.25 Use fill: Limit depth applied: No Depth to water table (insitu): 3.00 m Fill height: N/A Limit depth: N/A

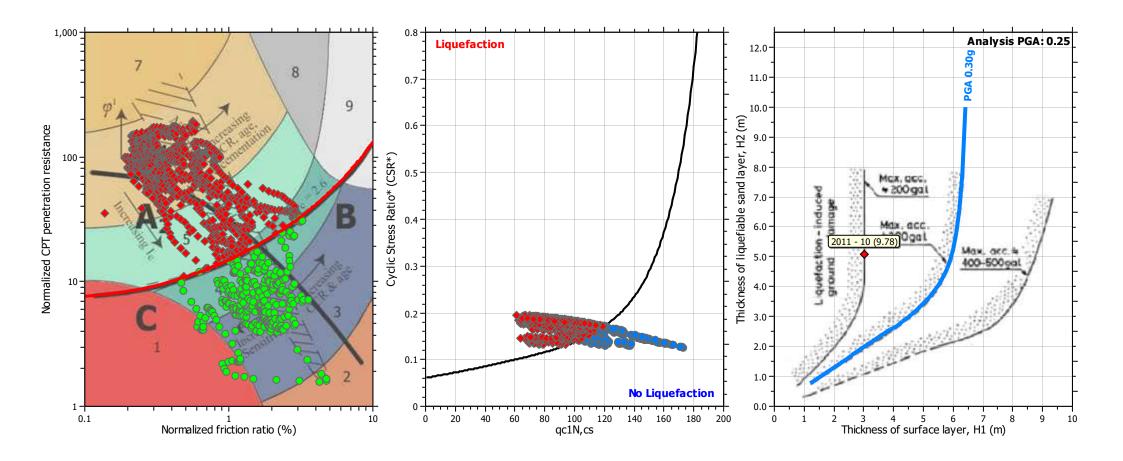
# Liquefaction analysis summary plots

Analysis method: B&I (2014) Depth to GWT (erthq.): 3.00 m Fill weight: N/A Transition detect. applied: Fines correction method: B&I (2014) Average results interval: 3 No Based on Ic value Ic cut-off value:  $K_{\sigma}$  applied: Points to test: 2.60 Yes Earthquake magnitude M<sub>w</sub>: 5.90 Unit weight calculation: Based on SBT Clay like behavior applied: Sand & Clay Peak ground acceleration: 0.25 Use fill: Limit depth applied: No Depth to water table (insitu): 3.00 m Fill height: N/A Limit depth: N/A

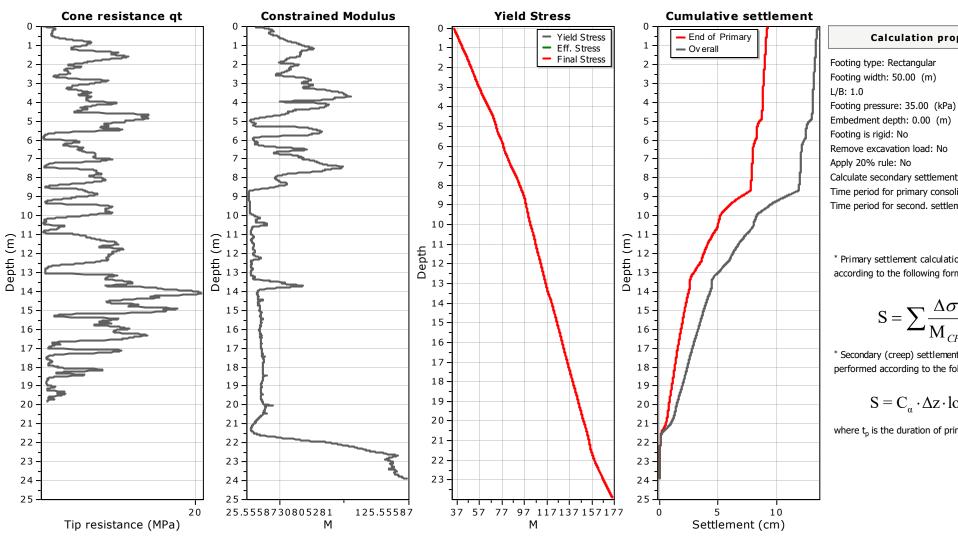
## Settlements calculation according to theory of elasticity\*

Calculate secondary settlements: Yes

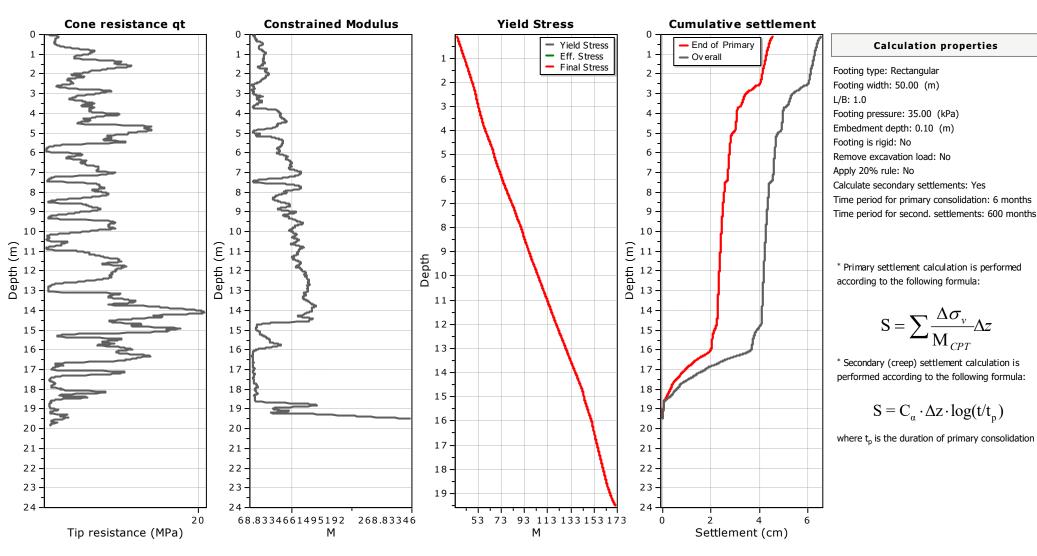
## Settlements calculation according to theory of elasticity\*

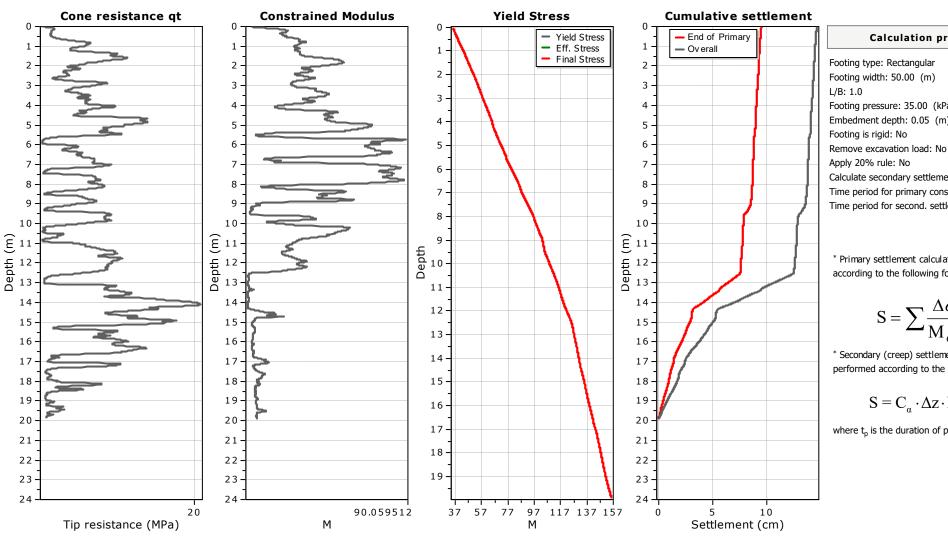
## Settlements calculation according to theory of elasticity\*

#### Calculation properties

Footing pressure: 35.00 (kPa) Embedment depth: 0.05 (m)

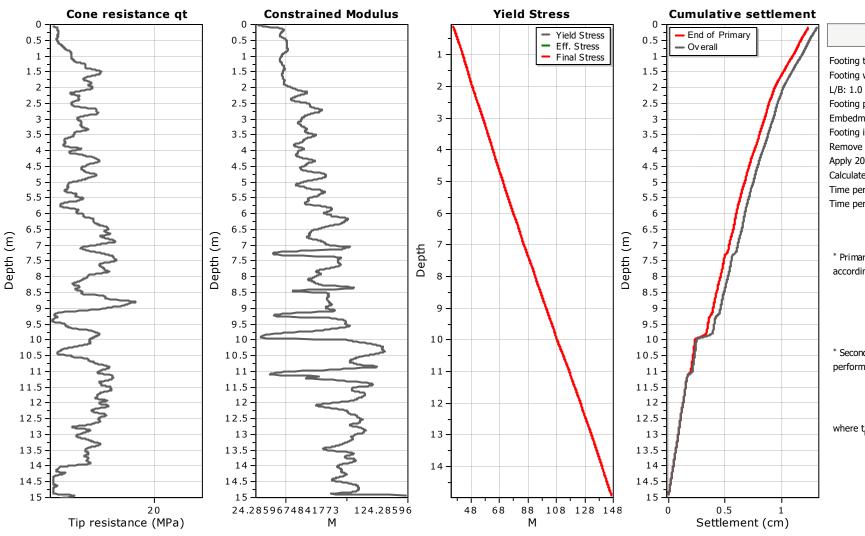
## Settlements calculation according to theory of elasticity\*

#### Calculation properties

Total depth: 14.92 m, Date: 20/09/2021

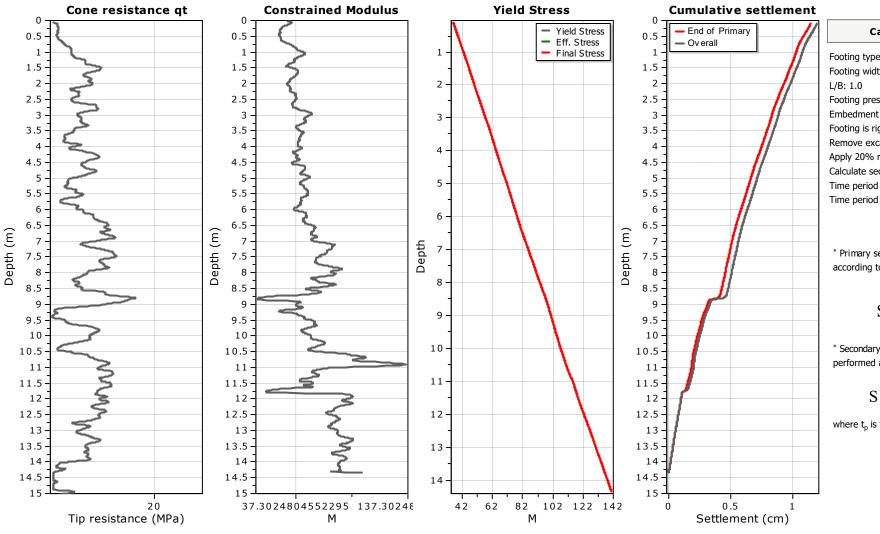
## Settlements calculation according to theory of elasticity\*

### Calculation properties

Total depth: 14.34 m, Date: 20/09/2021
