**77 NEWCOMBE
ROAD,
CAMBRIDGE**

**PRELIMINARY
GEOTECHNICAL
REPORT**

PROJECT NO: HD1684
RS SAND
REFERENCE: PGR REV 2
08 AUGUST 2022

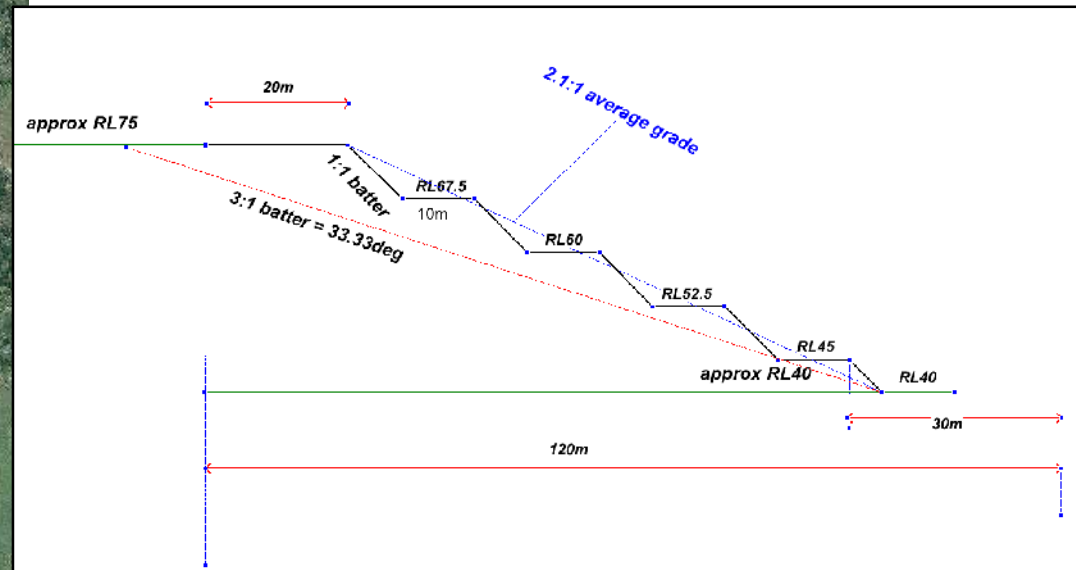
Key points

- Yellow lines indicative only
- Batters on the yellow lines reflect interim batters (see figure below)
- Batters on the outer edges which = the contours shown are 3:1
- Sales are estimated at 300,000tpa
- Sand density used = 1.8t/m³
- Have assumed RL 67.5 = top of sand everything above this is a 50-50 split between overburden and pit sand
- Balance = concrete sand approx. 27.5m

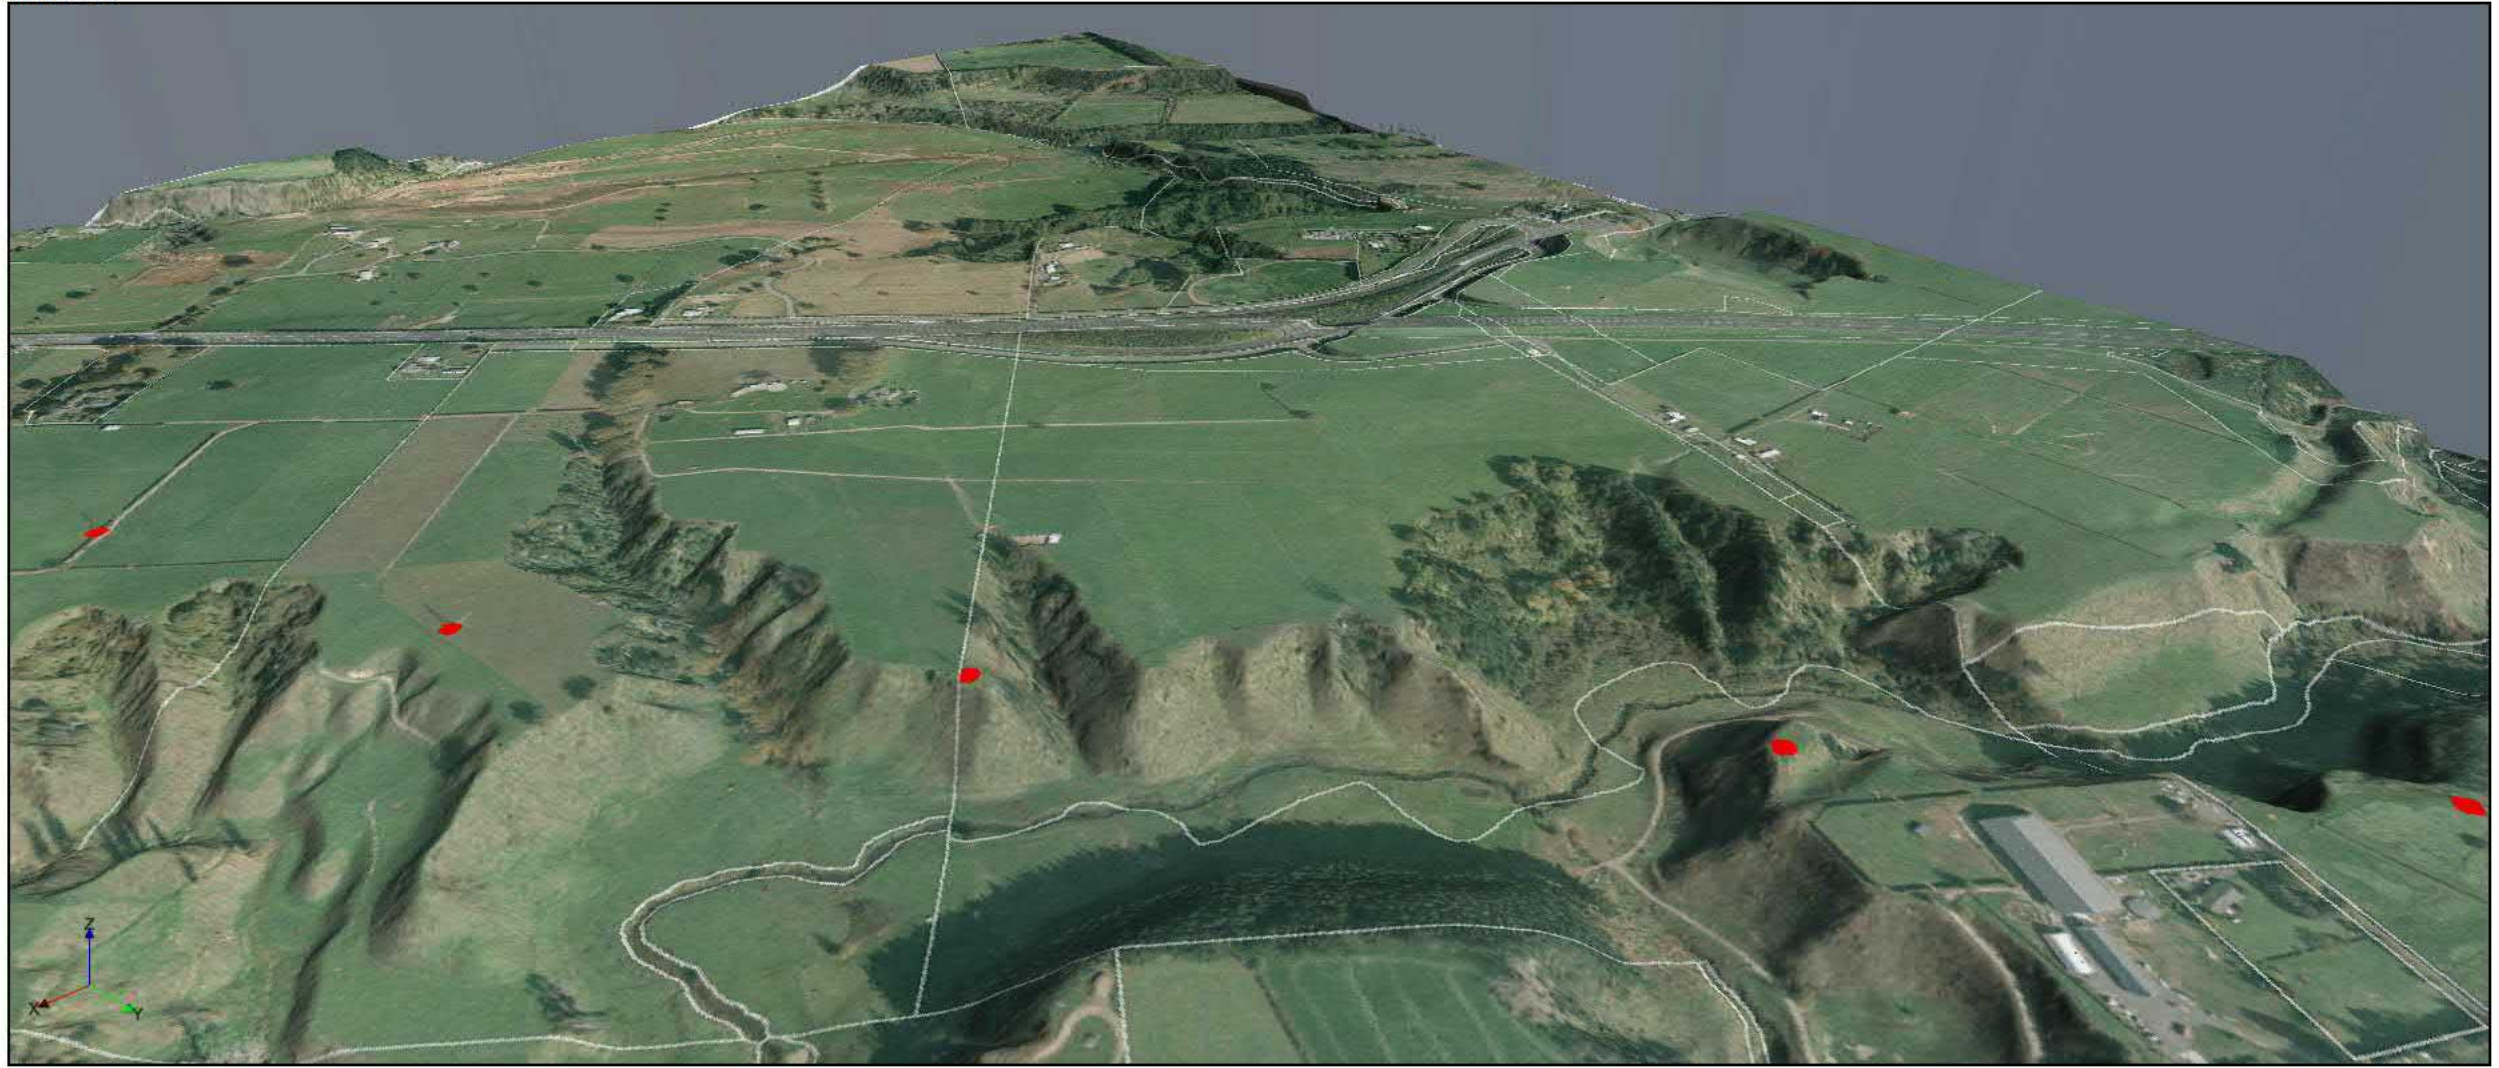
RS Sand – Quarry Planning

Processing area and bunds

RL 70
3.9 ha
RL 72

Volume to remove = 93,000m³

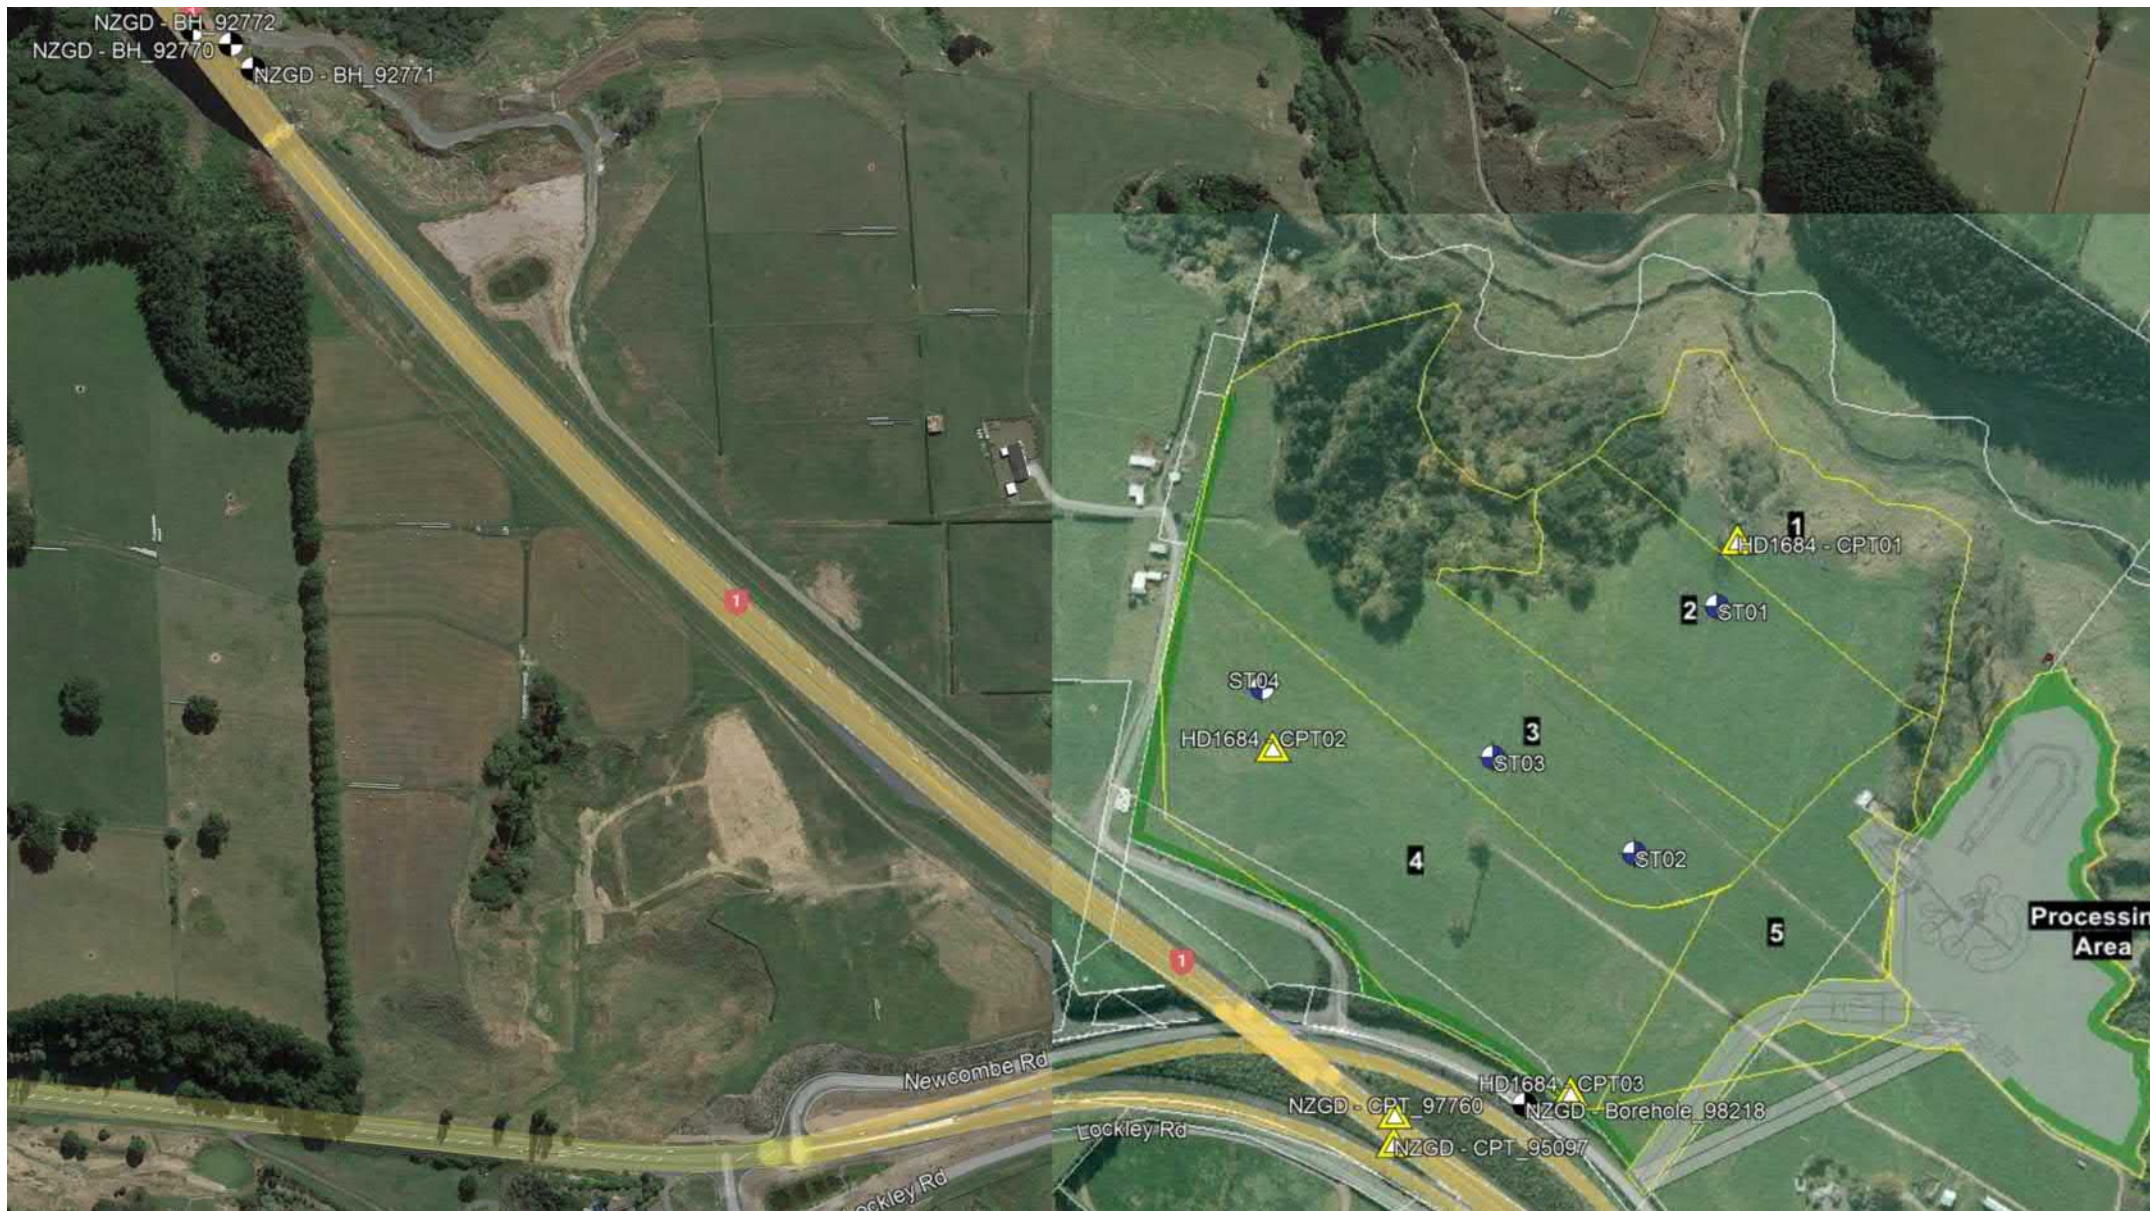
CPTs (NZGD)

Bore Holes (NZGD)

- Bore Hole (BH)
- Cone Penetrometer test (CPT)
- Soakage test

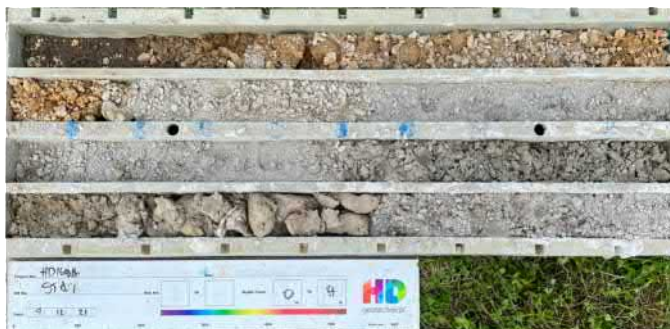
Photo

End of borehole at 4.0 meters_ target depth achieved

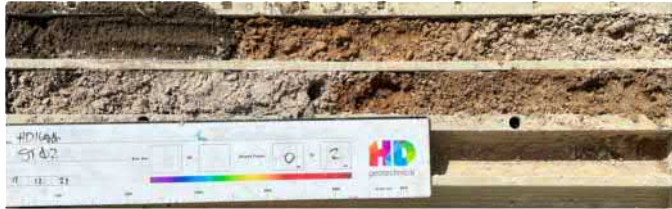
Photo	Remarks

End of borehole at 2.0 meters_ target depth not achieved_ repeated hole collapse_ collapsed to 1.8 meters <div style="display: flex; justify-content: space-between;"> <div style="width: 30%;"> <p>Shear Vanes</p> <ul style="list-style-type: none"> Peak Remoulded </div> <div style="width: 30%;"> <p>Water</p> <ul style="list-style-type: none"> Standing Water Level Out flow In flow </div> <div style="width: 30%;"> <p>Investigation Type</p> <ul style="list-style-type: none"> <input checked="" type="checkbox"/> Hand Auger <input type="checkbox"/> Investigation Pit <input type="checkbox"/> Machine Borehole </div> </div>

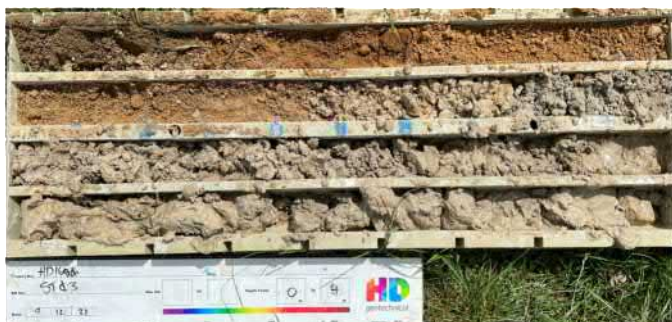
Photo

End of borehole at 4.0 meters_ target depth achieved_ due to hole collapse separate borehole drilled to 2.0 meters for soakage test

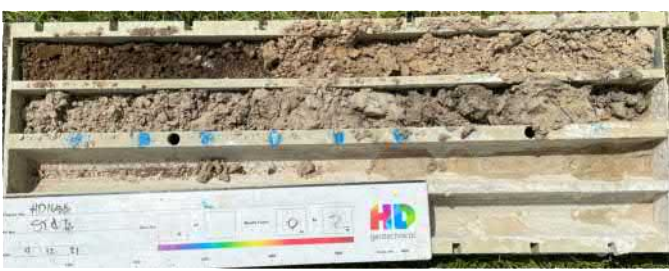
Photo	Remarks

End of borehole at 2.0 meters_ target depth not achieved_ saturation and ground water causing collapse <div style="display: flex; justify-content: space-between;"> <div style="width: 30%;"> <p>Shear Vanes</p> <ul style="list-style-type: none"> Peak Remoulded </div> <div style="width: 30%;"> <p>Water</p> <ul style="list-style-type: none"> Standing Water Level Out flow In flow </div> <div style="width: 30%;"> <p>Investigation Type</p> <ul style="list-style-type: none"> <input checked="" type="checkbox"/> Hand Auger <input type="checkbox"/> Investigation Pit <input type="checkbox"/> Machine Borehole </div> </div>

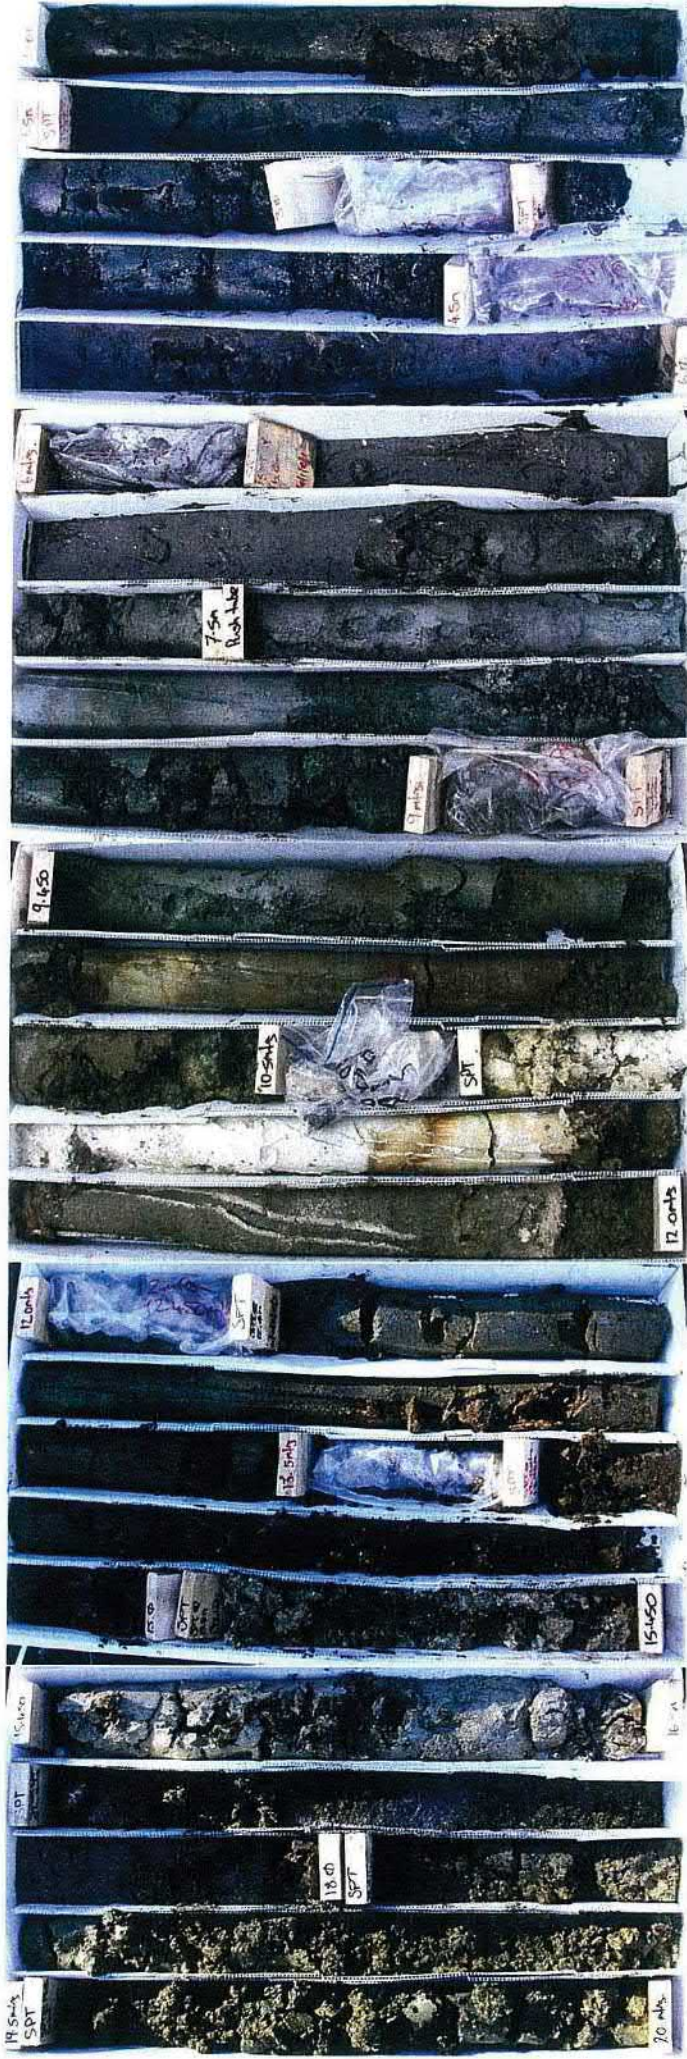
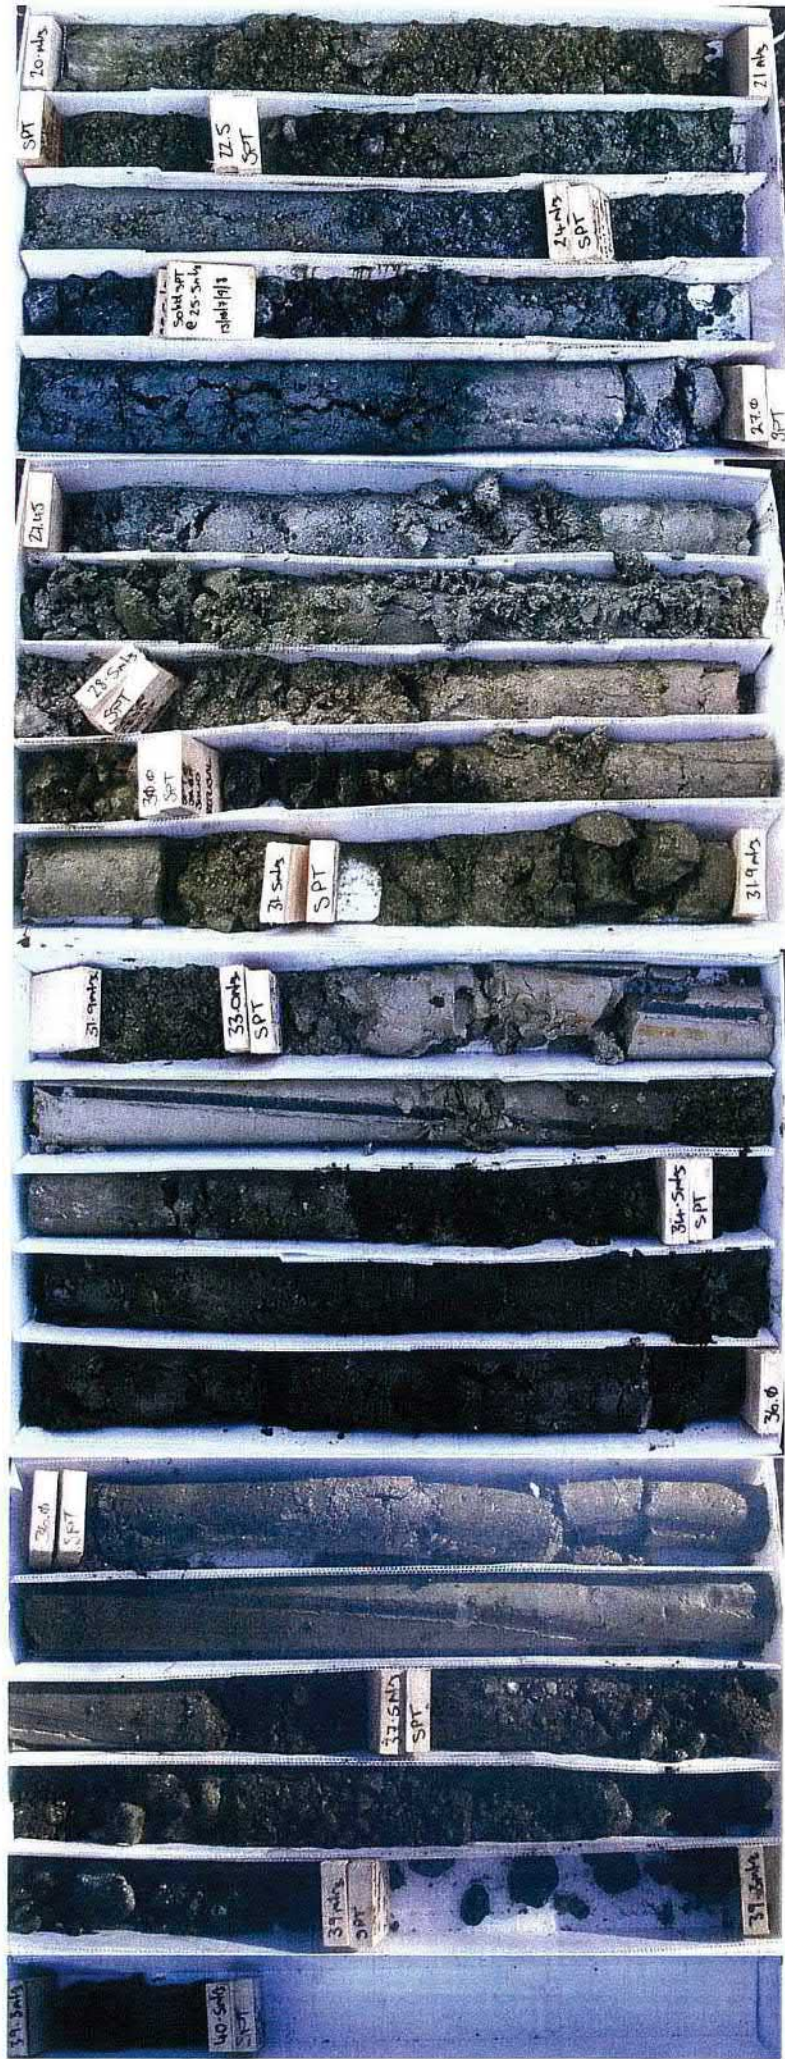
SH1 CAMBRIDGE BYPASS
 261647.00
 DATE: 27/05/08
 BOREHOLE: G9

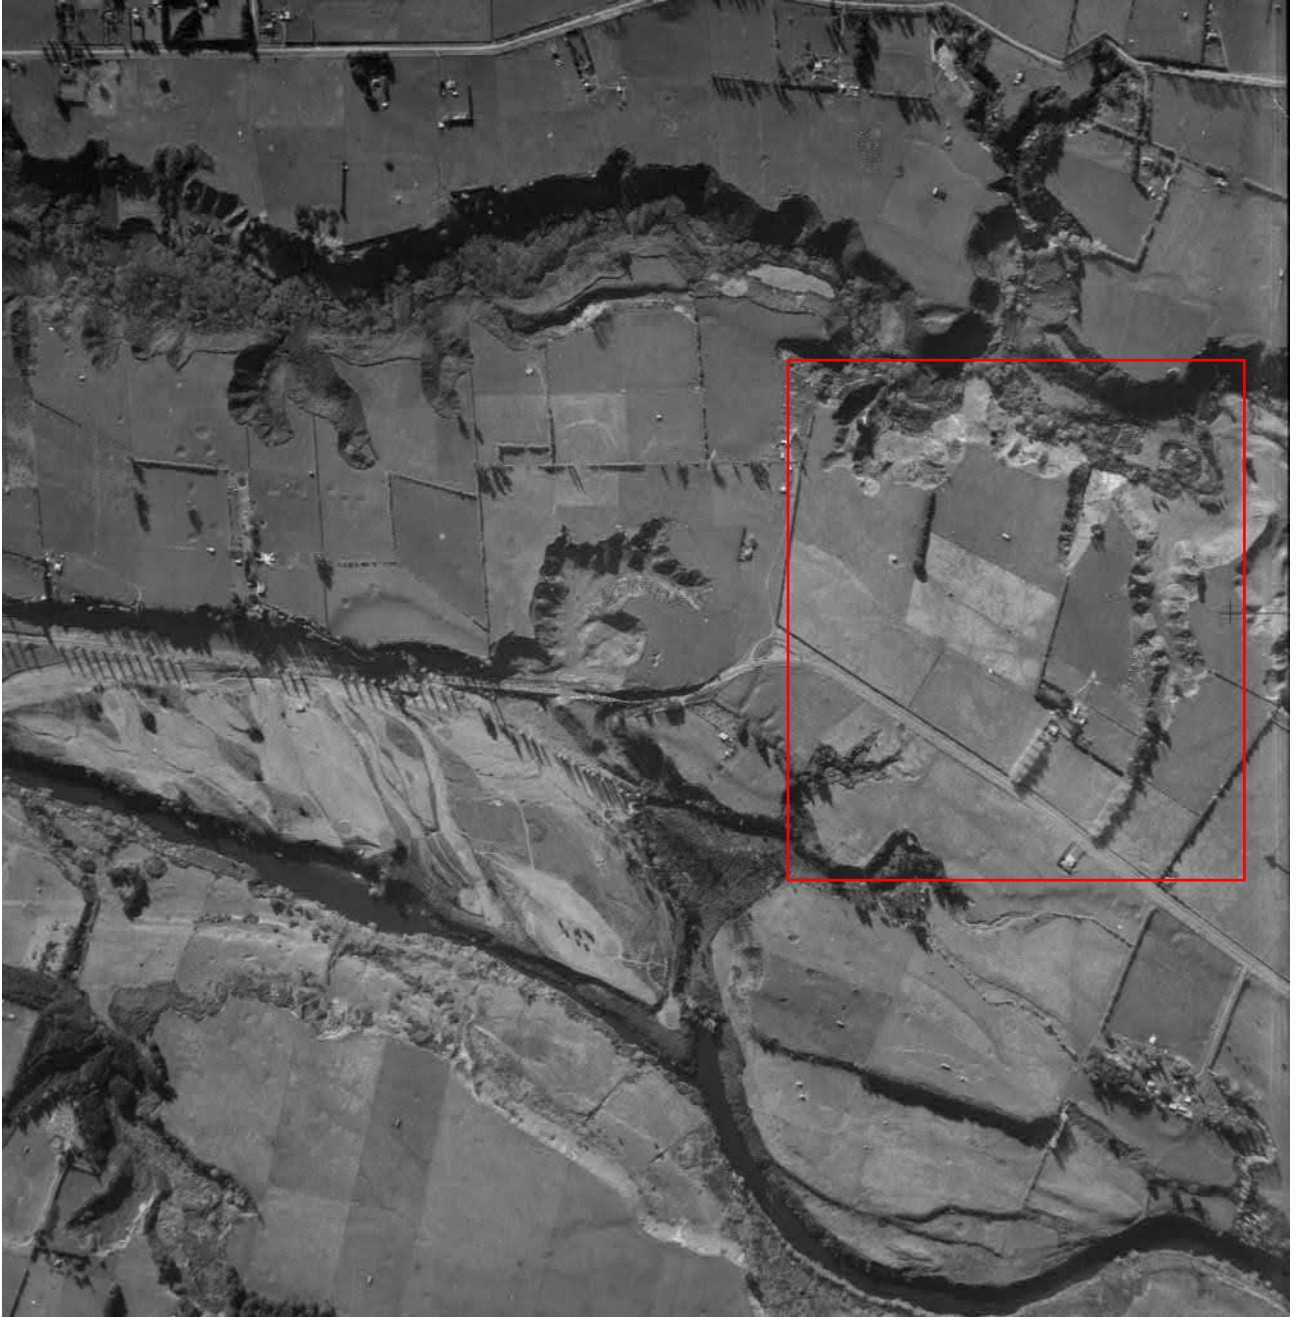
*Figure 1. Historical Imagery from 1943. Approximate site location marked by red square.
(Imagery from <http://retrolens.nz/>)*

Aerial images indicate that an area of historical instability is located to the west of CPT01. The surface expression (circular type scarp) and longer, shallower slope angles at the base of the slope indicated failures have occurred in the past (> 80 years, before the earliest aerial images available). The heavy vegetation that is now present may indicate this is where localised groundwater has been seeping and causing the slope to regress further compared to the surrounding slopes. This vegetation will now be providing additional stability to the shallow soils.

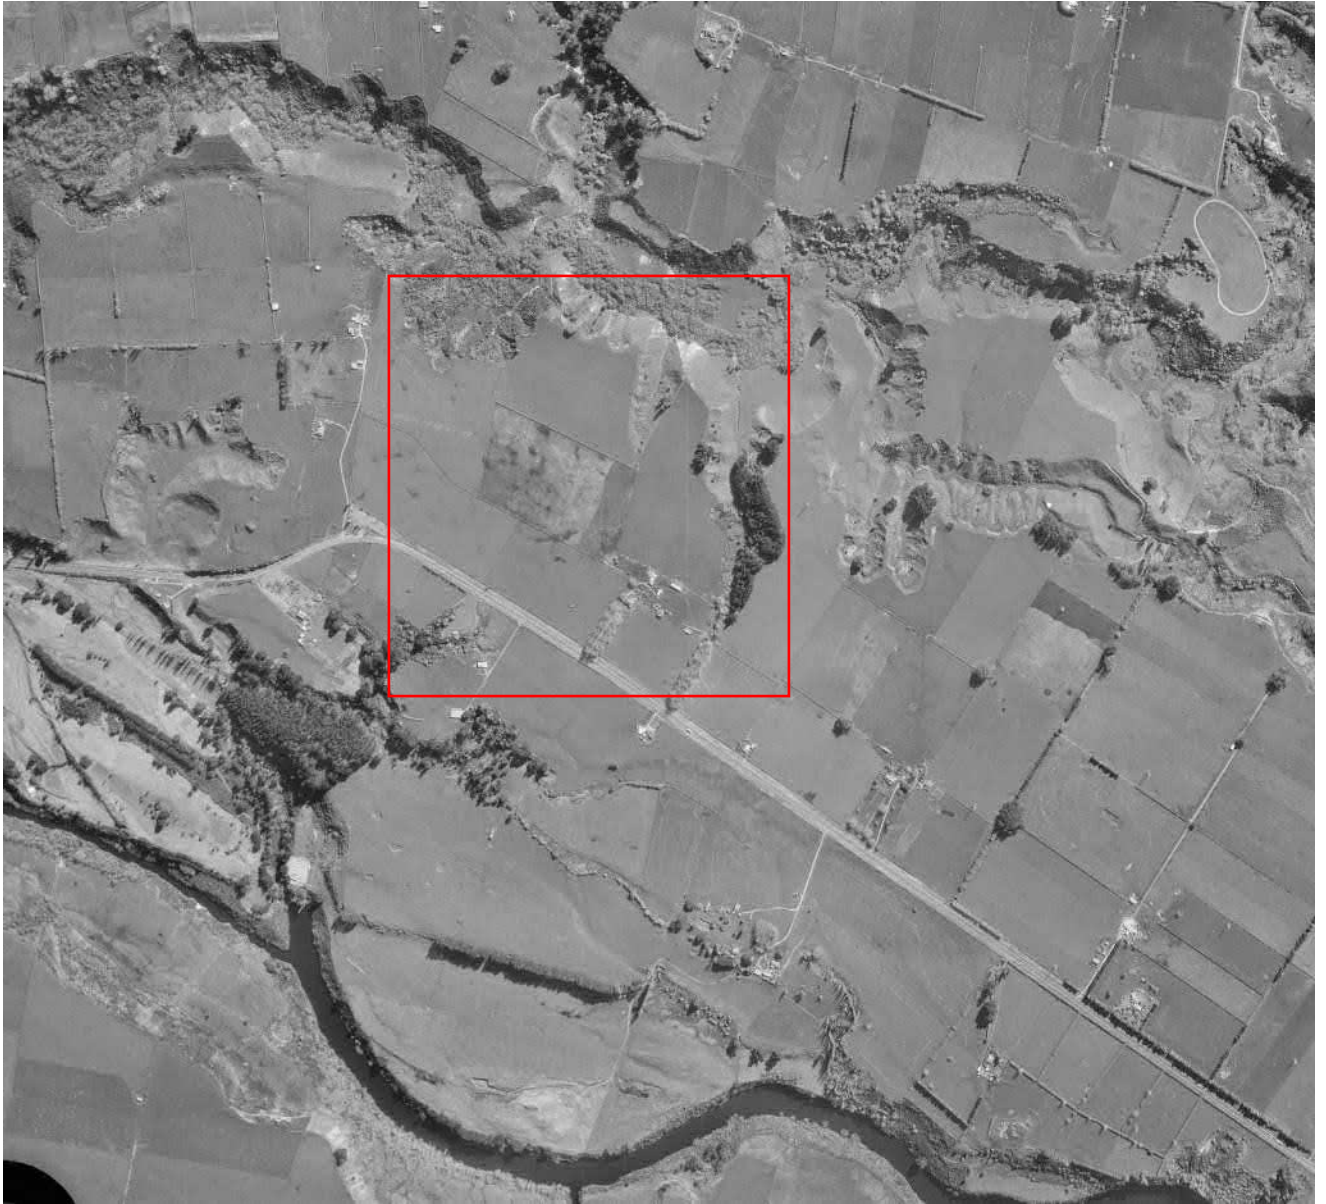
*Figure 2. Historical Imagery from 1966. Approximate site location marked by red square.
(Imagery from <http://retrolens.nz/>)*

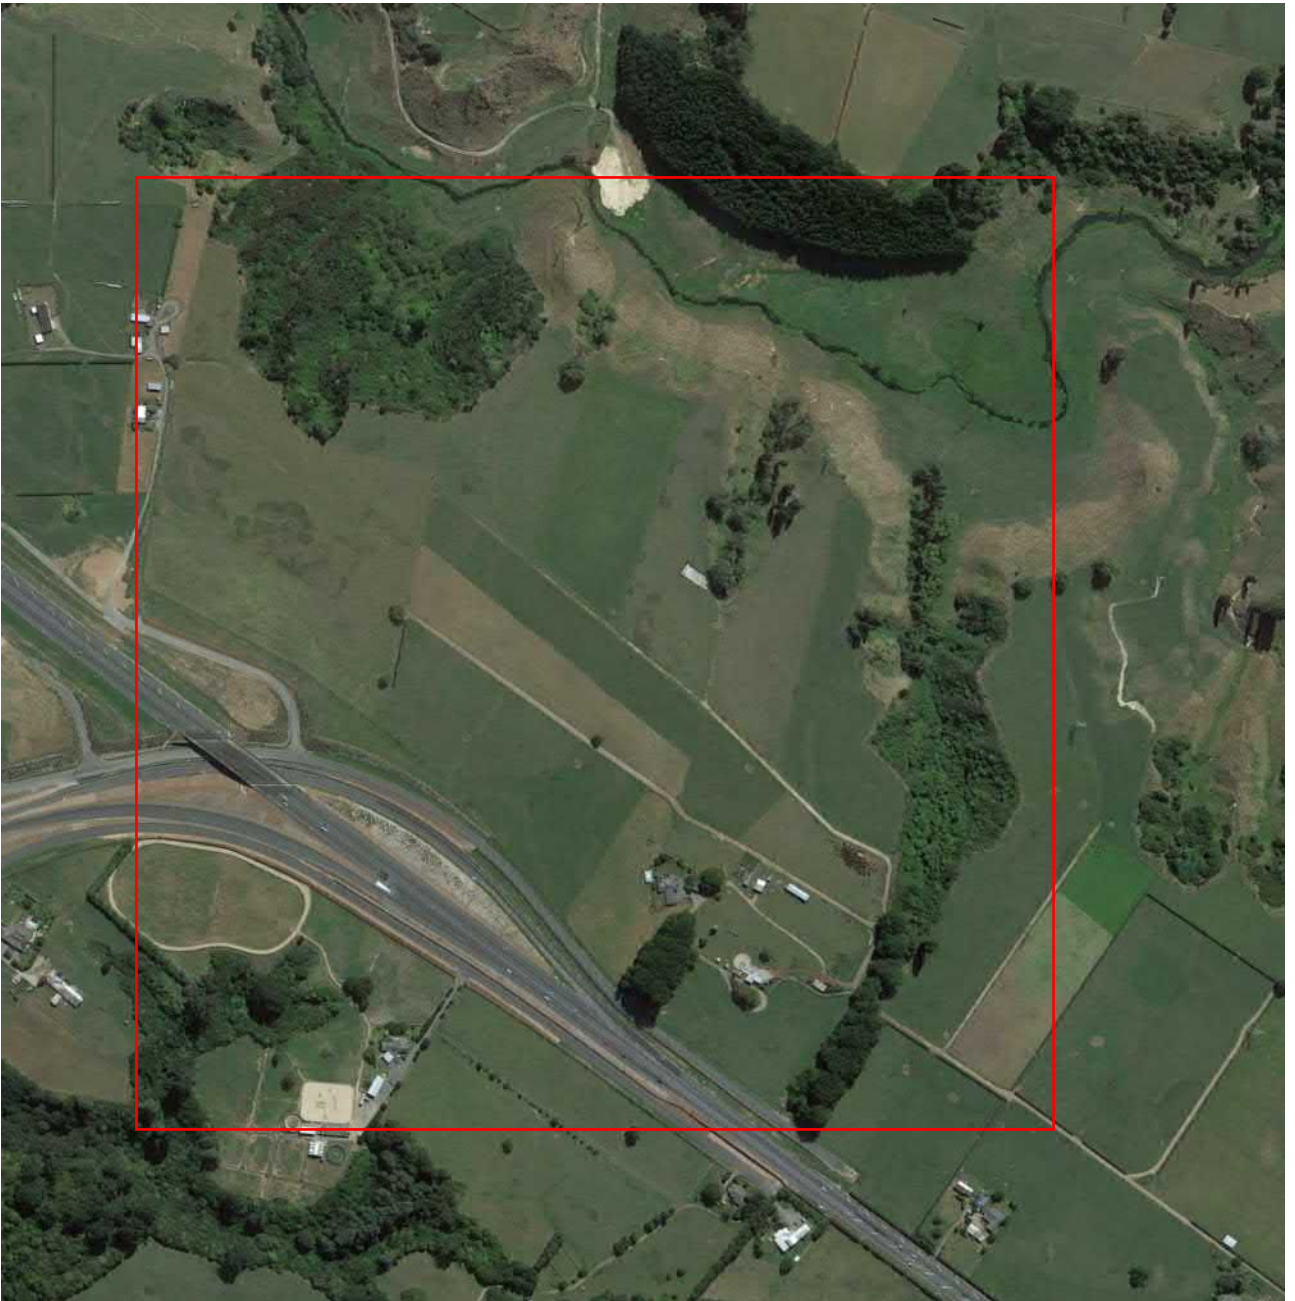
*Figure 3. Recent Imagery from 2020. Approximate site location marked by red square.
(Imagery from Google Earth pro).*
