**77 NEWCOMBE
ROAD,
CAMBRIDGE**

**PRELIMINARY
GEOTECHNICAL
REPORT**

PROJECT NO: HD1684
RS SAND
REFERENCE: PGR REV 2
08 AUGUST 2022

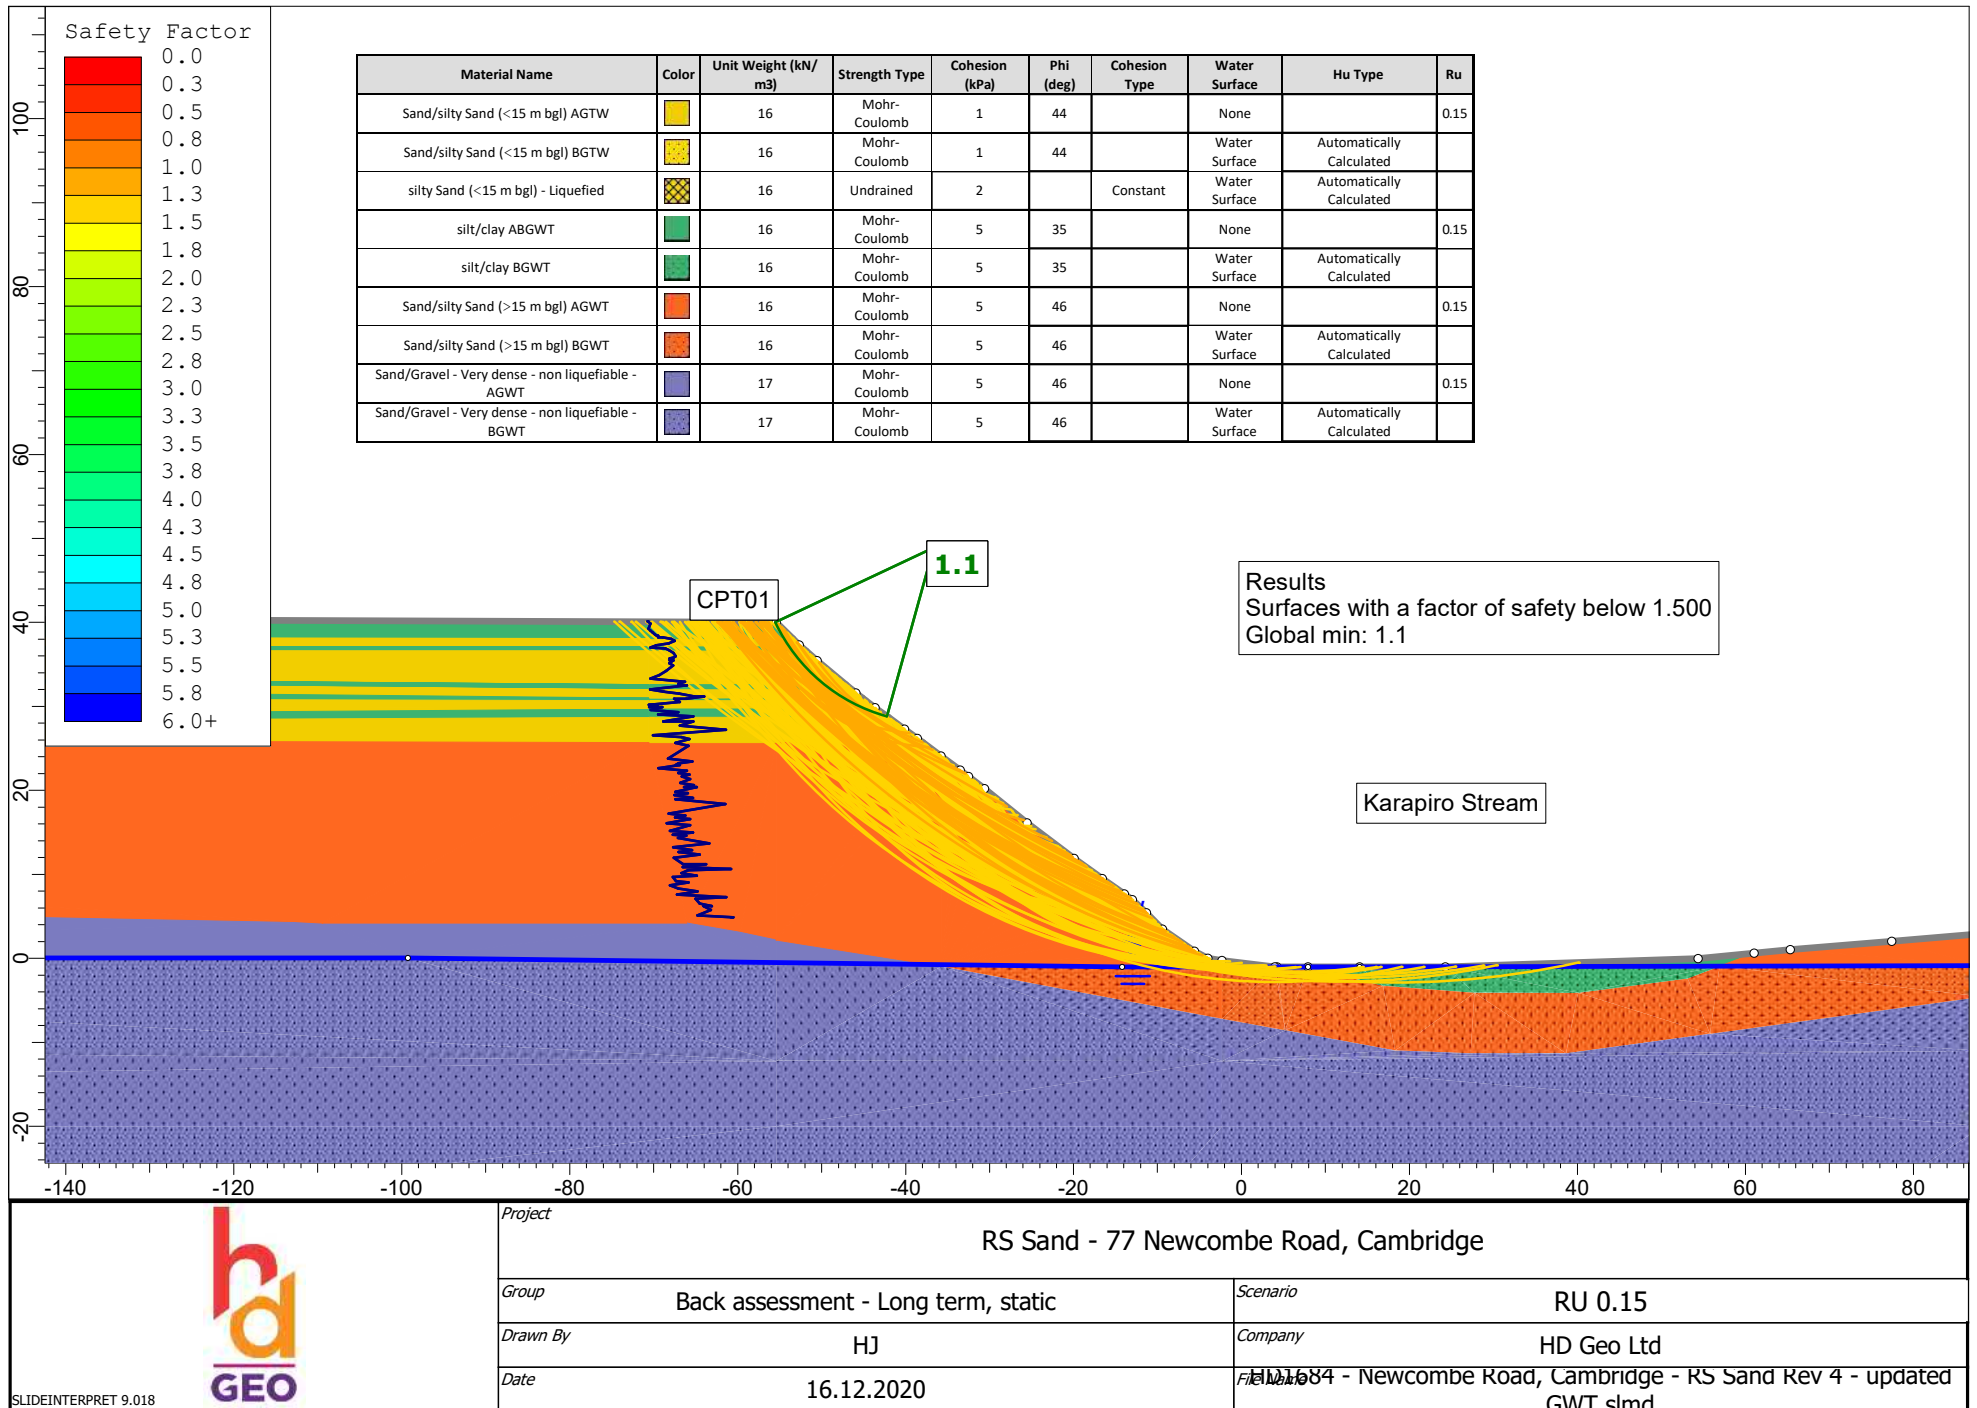
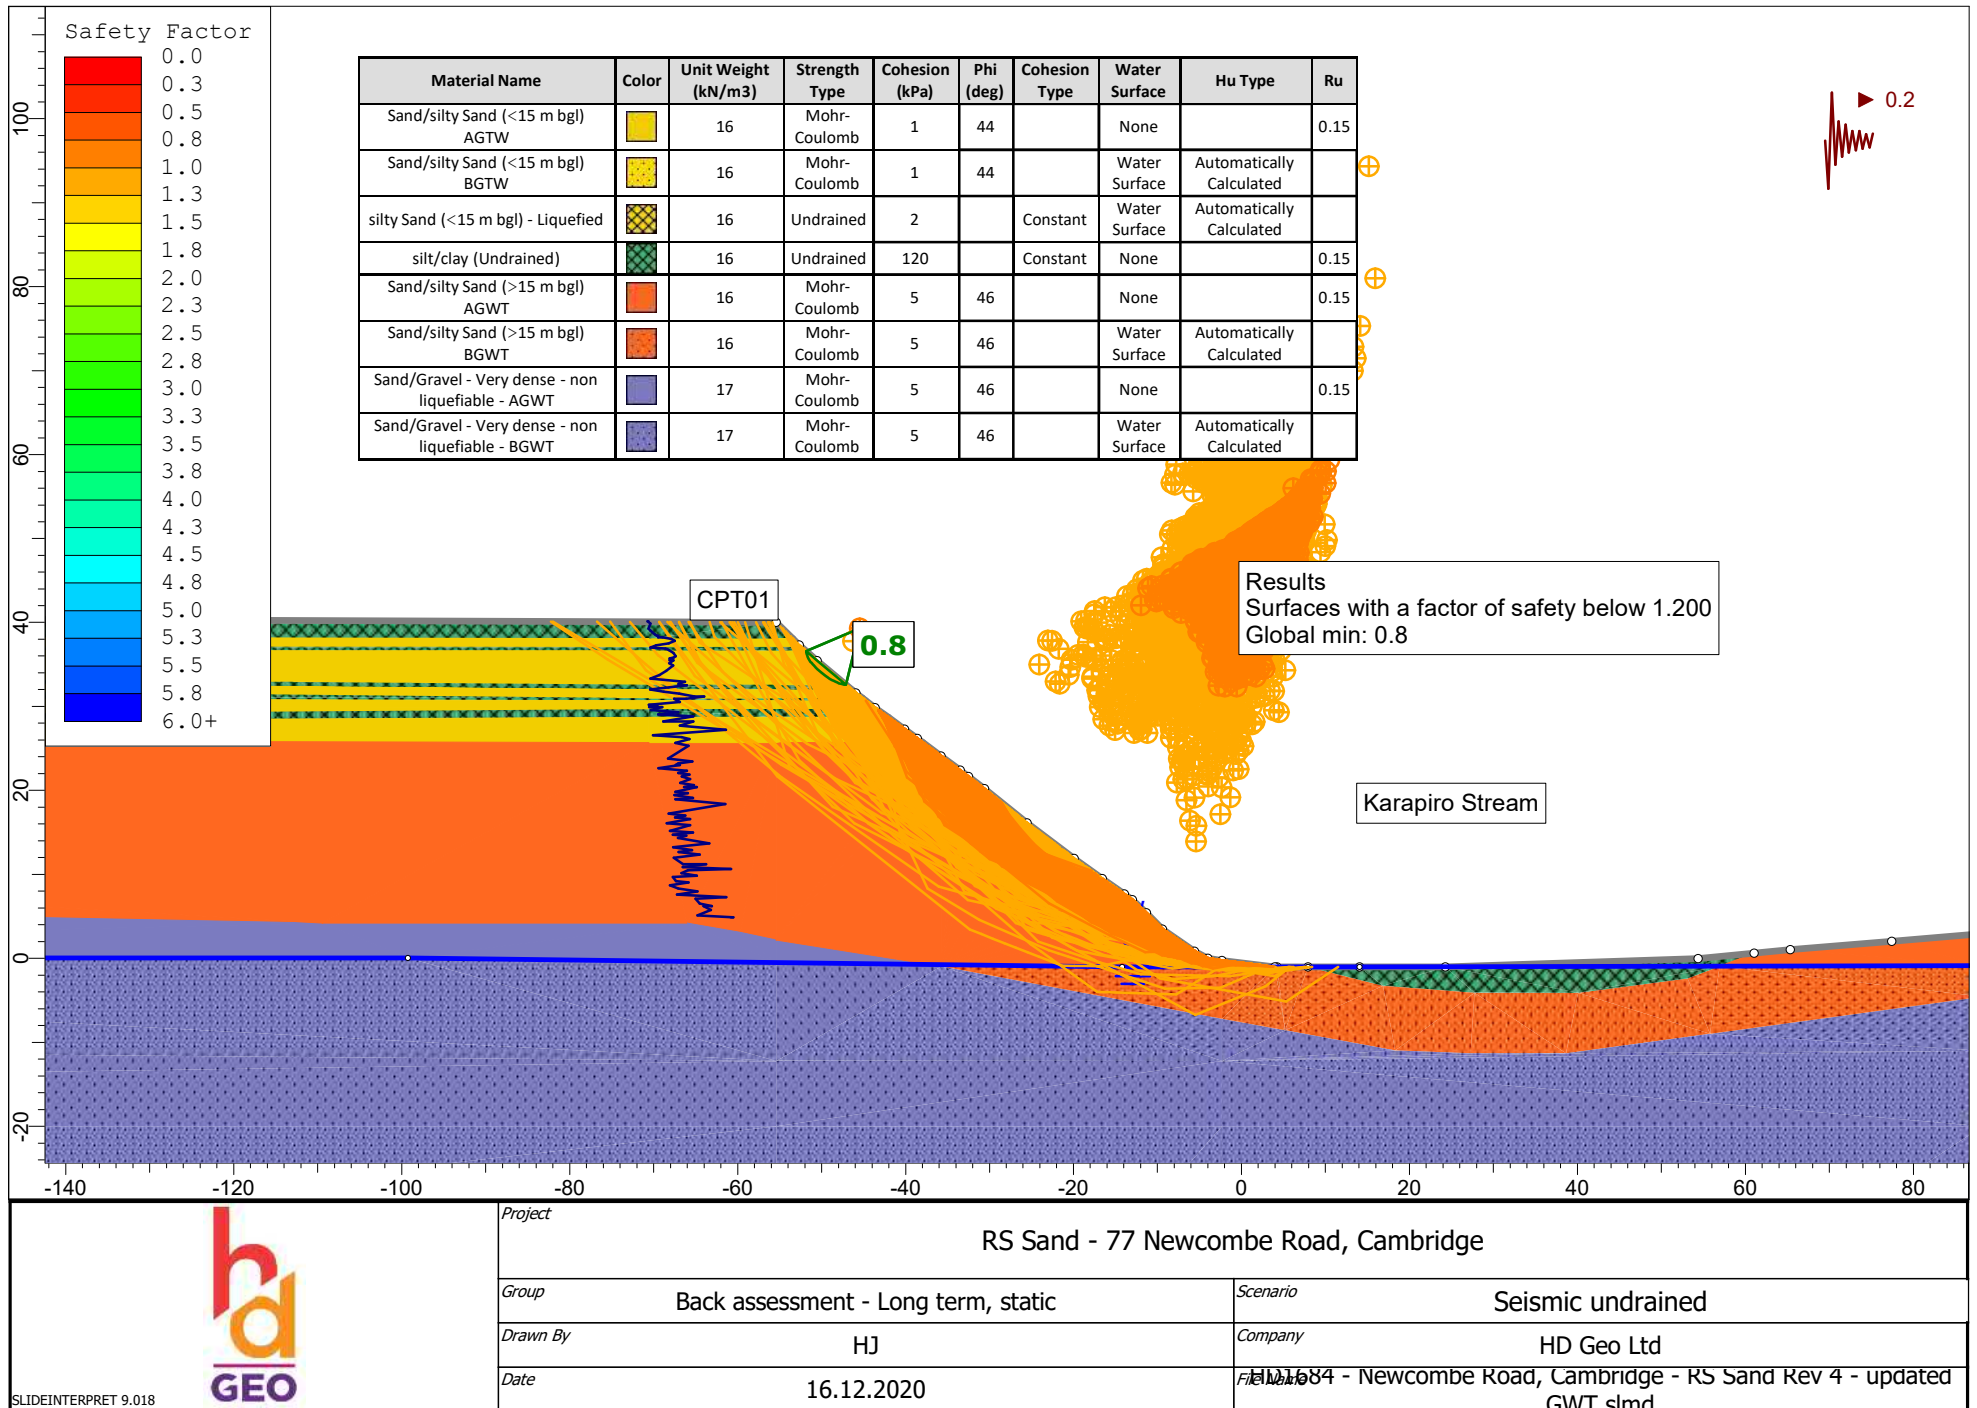
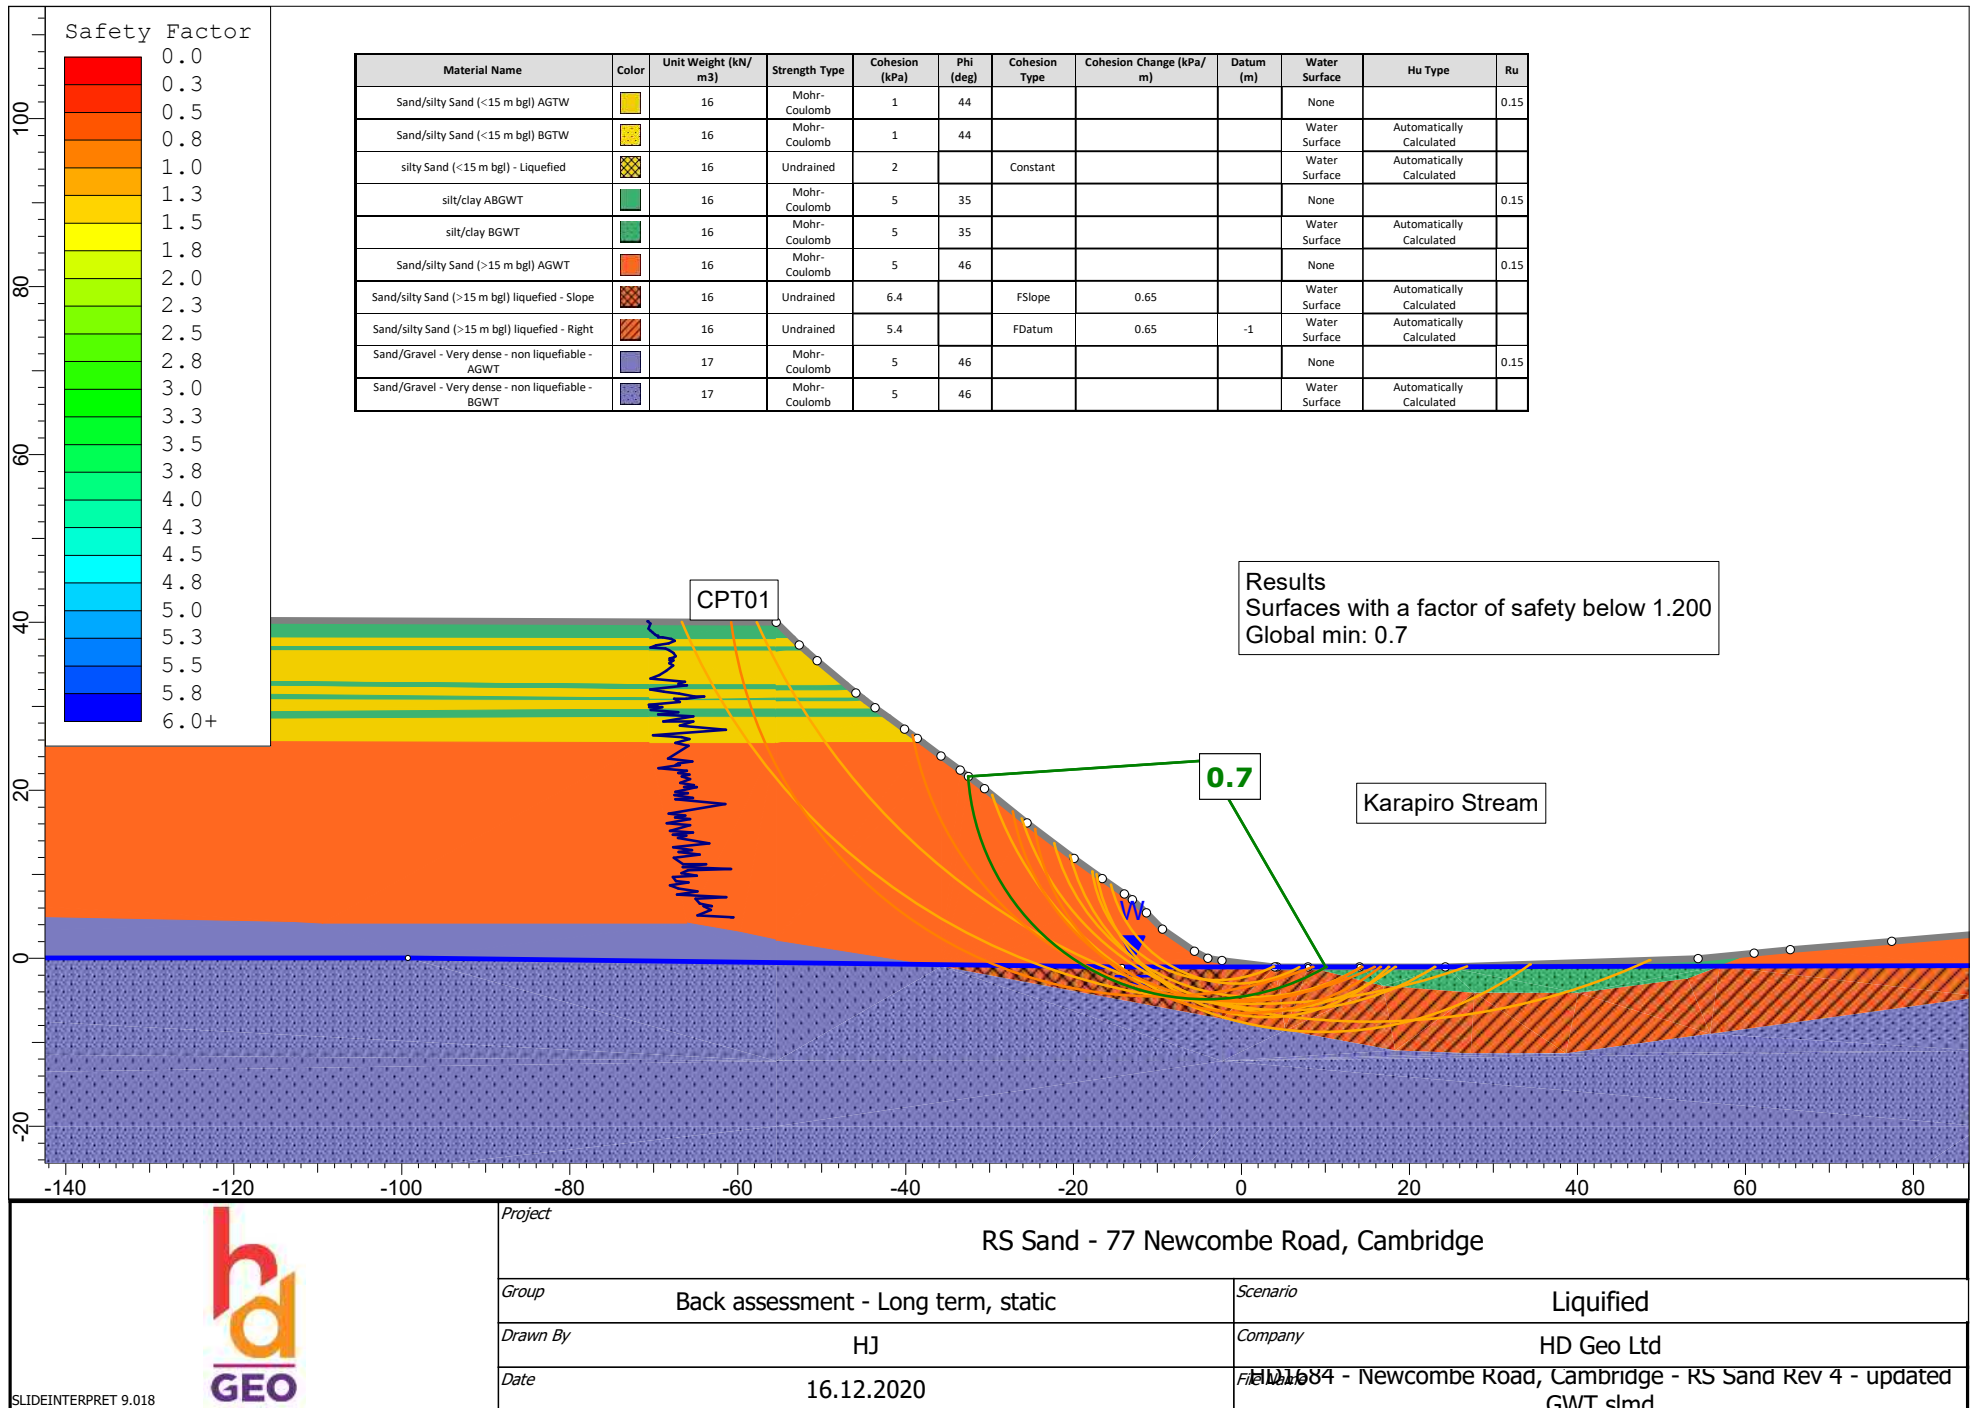
Project		RS Sand - 77 Newcombe Road, Cambridge	
Group	Back assessment - Long term, static	Scenario	Liquefied
Drawn By	HJ	Company	HD Geo Ltd
Date	16.12.2020	File No	111184 - Newcombe Road, Cambridge - RS Sand Rev 4 - updated GWT slmd

Aerial imagery, and the geomorphology (downcut stream gully in alluvial materials) indicates the slopes are marginally stable and may experience failures during higher ground water conditions or due to undermining of the slopes. By assessing the current slope geometry, we were able to iterate our model until representative FoS values were achieved. A FoS of just over 1.0 during long term,

normal ground water, conditions and slightly less than 1.0 in short term, high ground water, conditions was used as representative of the current slope conditions.

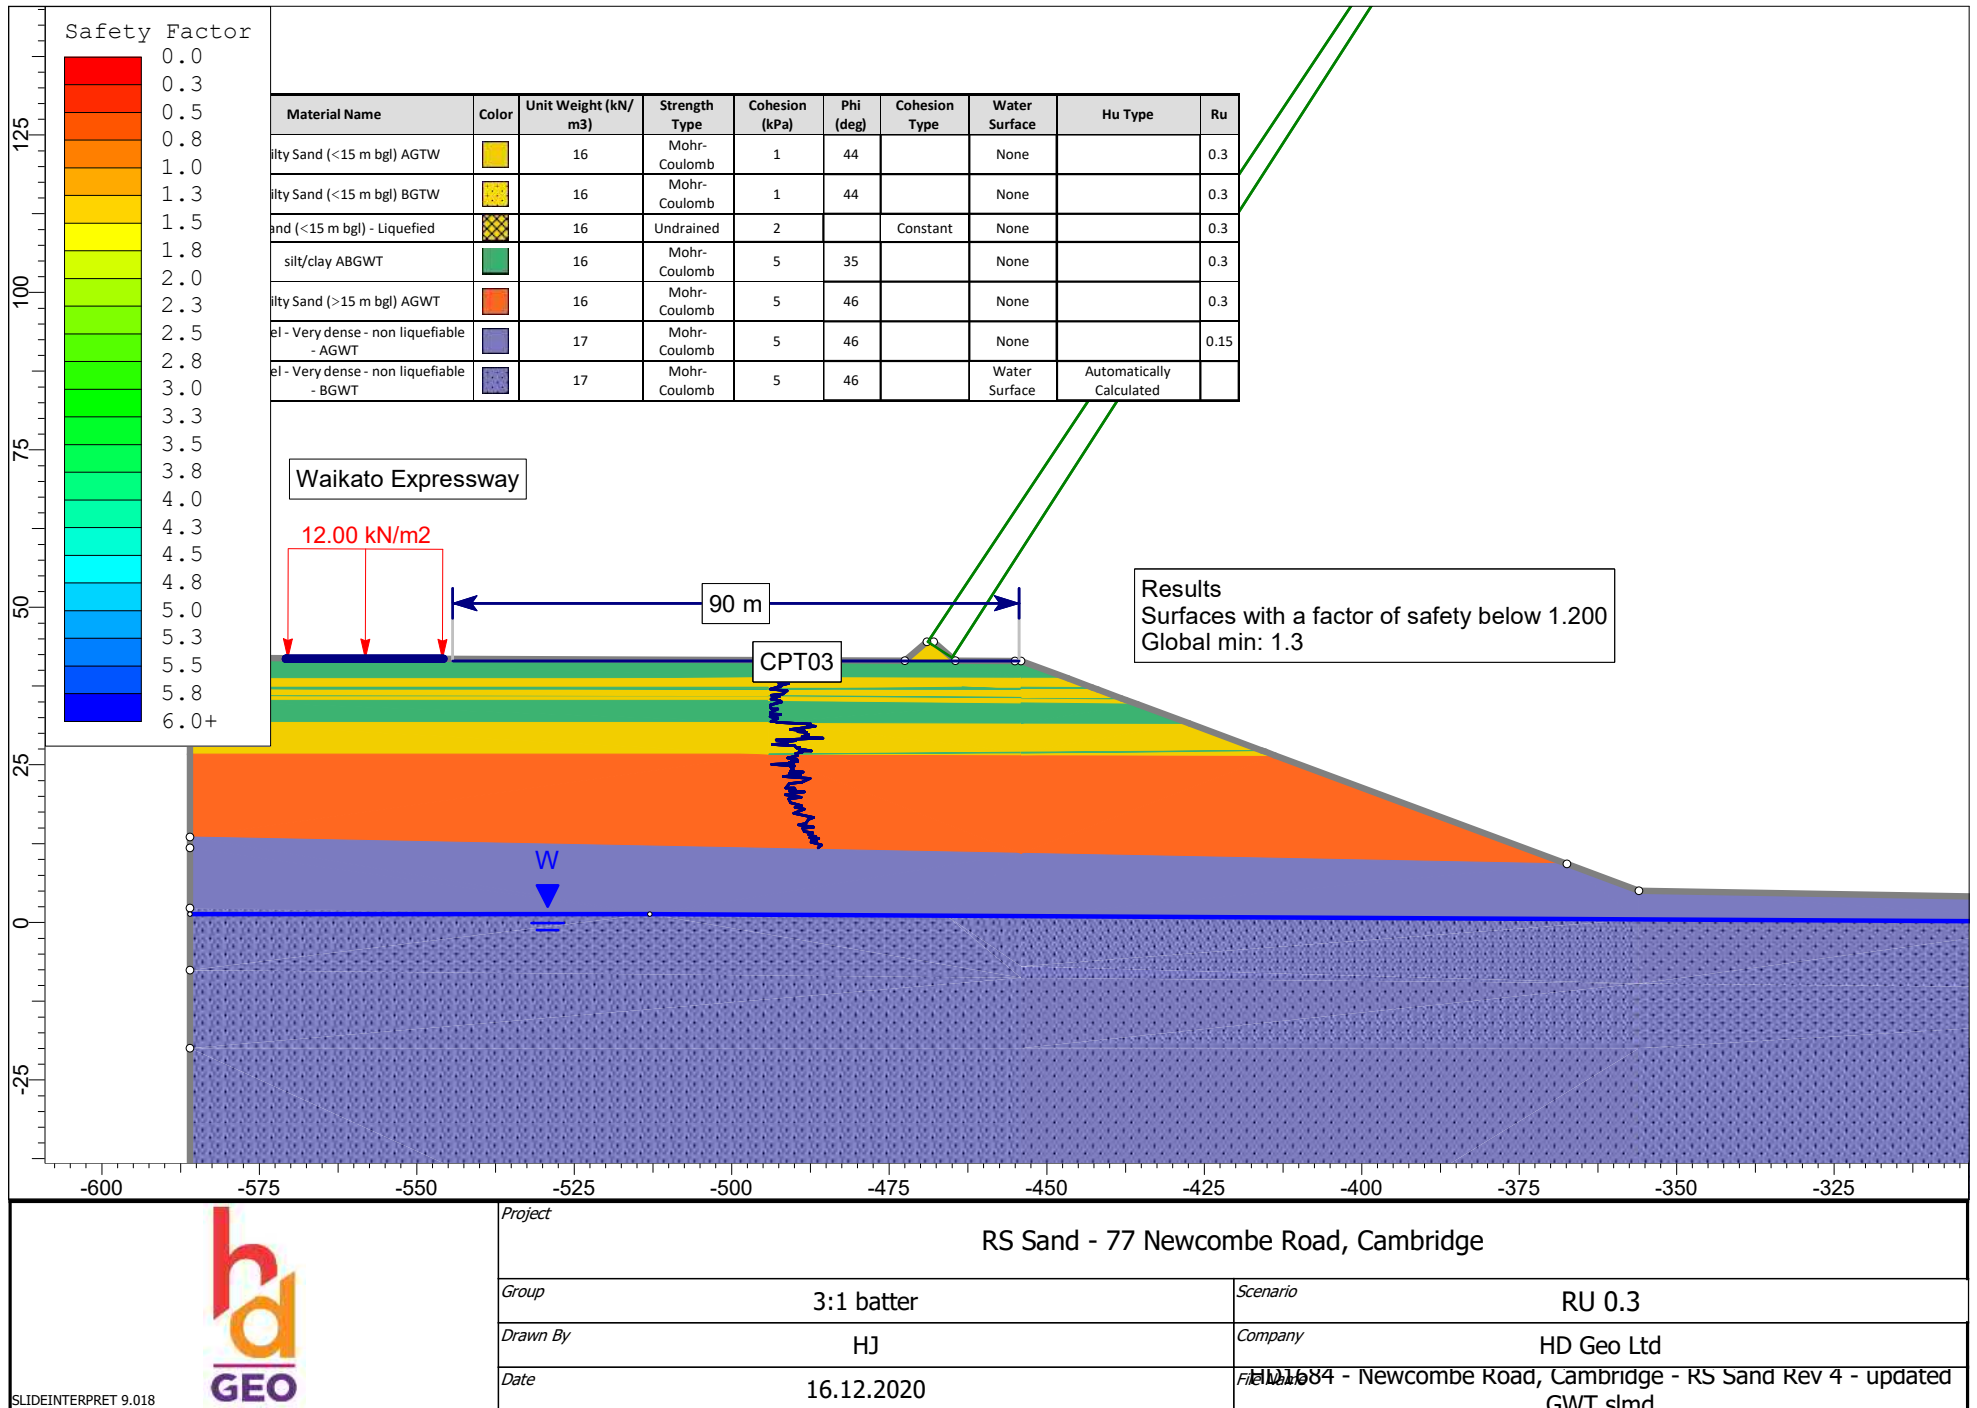
Project	RS Sand - 77 Newcombe Road, Cambridge		
Group	3:1 batter	Scenario	Liquified - worst case
Drawn By	HJ	Company	HD Geo Ltd
Date	16.12.2020	File No	111184 - Newcombe Road, Cambridge - RS Sand Rev 4 - updated GWT slmd

Scenario	FoS required (min)	FoS achieved (min)
Long term, normal GWT conditions	1.5	2.2
Short term, high GWT conditions	1.2	1.8
Short term, seismic, undrained	1.2	1.5
Short term, liquified (worst case)	1.0 (=no deformation)	1.0
