Te Awamutu Waste to Energy Plant Groundwater Assessment

GROUNDWATER ASSESSMENT

WGA222576-RP-HG-0001_A

August 2023

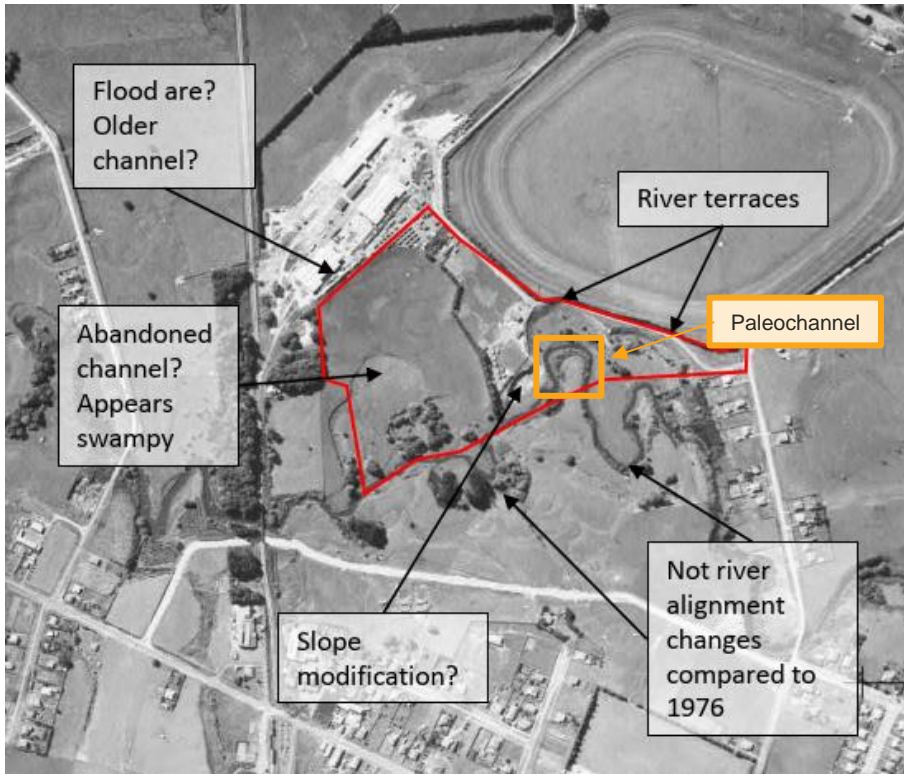
Figure 2: Historical Aerial imagery from 1944 Adapted from HGGeo 2021.

HDGeo's review of historical aerial imagery shows paleo channels on the lower terrace, including one partially infilled channel that is currently draining the eastern side of the lower terrace.

WGA notes that this ‘drainage ditch’ is a paleochannel as identified in HDGeo 2021 (Figure 2). The lower terrace ditch receives both groundwater and runoff water. Therefore, WGA considers that there are currently groundwater discharges at the site.

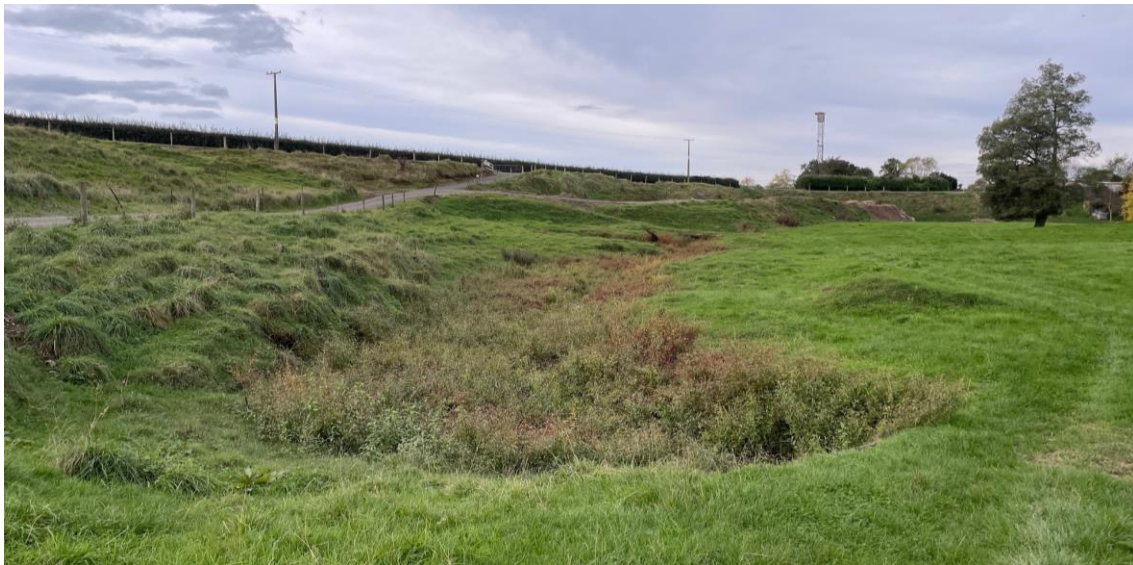
Figure 3: Present Day Paleochannel in Eastern Area of Lower Terrace 18 May 2023.

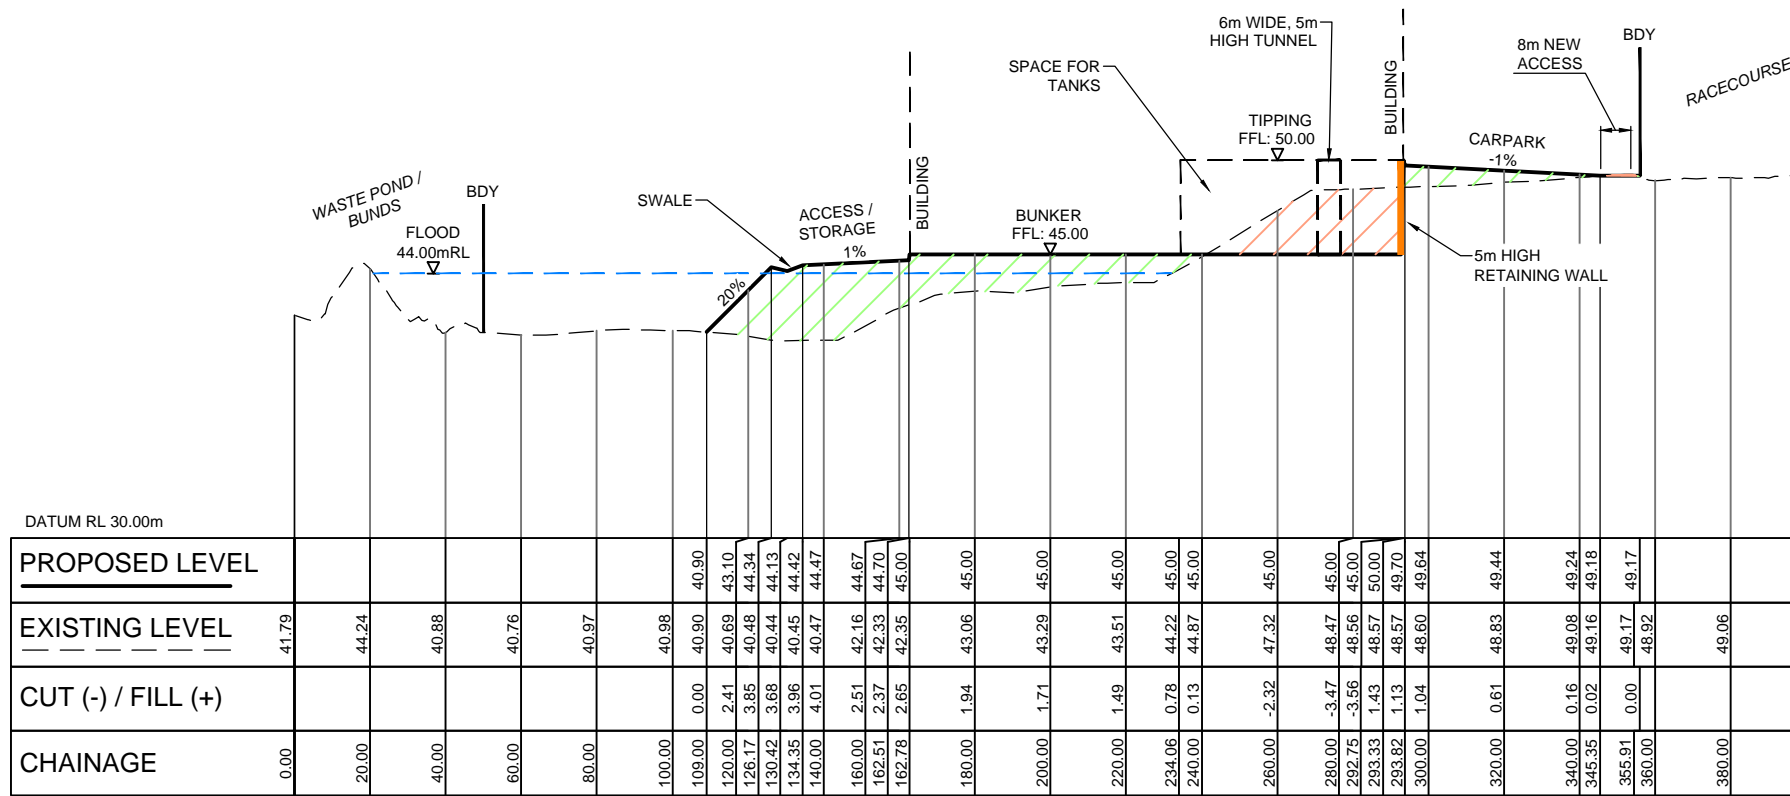
SECTION B (5x VERTICAL EXAGGERATION)
1:1000H 1:200V @ A1 (DOUBLE FOR A3)

- a. Section B acknowledges the shallow water table at around 0.5 m bgl in this area showing the water table above the invert 1 level. Planting in this area is also planned as a wetland.*

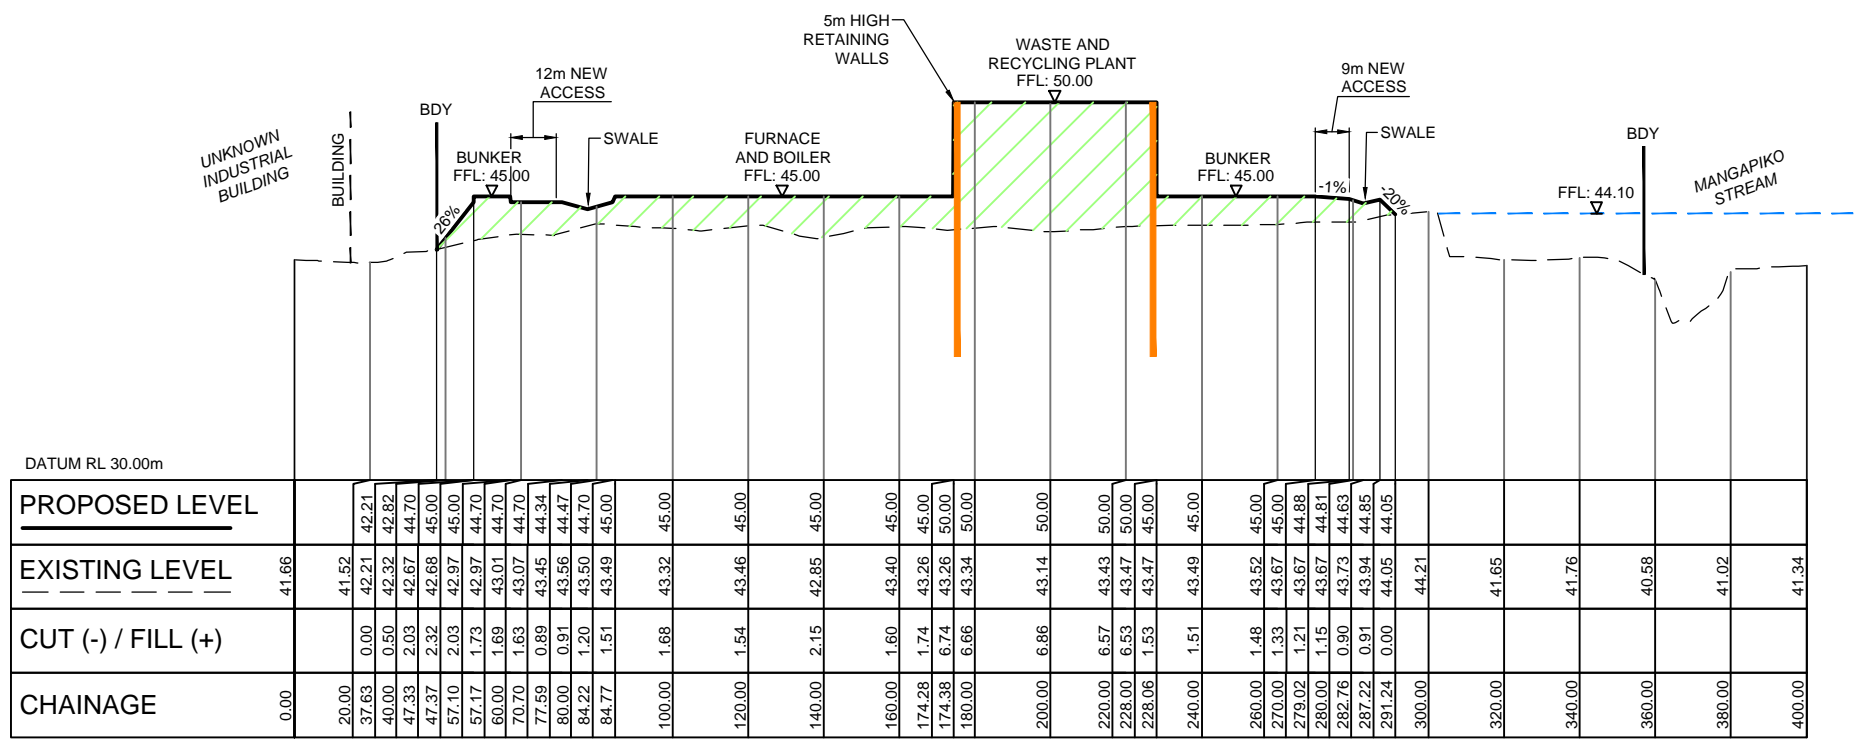
SECTION D (5x VERTICAL EXAGGERATION)
1:1000H 1:200V @ A1 (DOUBLE FOR A3)

- c. Extrapolation of the 41 m water level contour indicates that the water table would be approximately 1 m or less below the flood plain in the vicinity of Section D and above the invert level of the flood mitigation basin.*

“In DWG No RC-012, 013 and 14 (Rev C) indicative groundwater levels are shown in some of the cross sections. In Sections C and D, the invert level of the flood displacement mitigation is at a similar level to the indicative groundwater level. The groundwater level is likely to fluctuate seasonally, therefore there is a likelihood that the flood displacement mitigation areas could experience ponding and the flood displacement mitigation will not be fully effective. Sections F and G do not show indicative groundwater levels as the groundwater contours in plan DWG RC-045 do not cover this area, however the invert of the flood displacement mitigation is at similar levels to the stream invert so there is also a risk that groundwater levels will cause ponding that will reduce the amount of flood displacement mitigation available in a flood.”

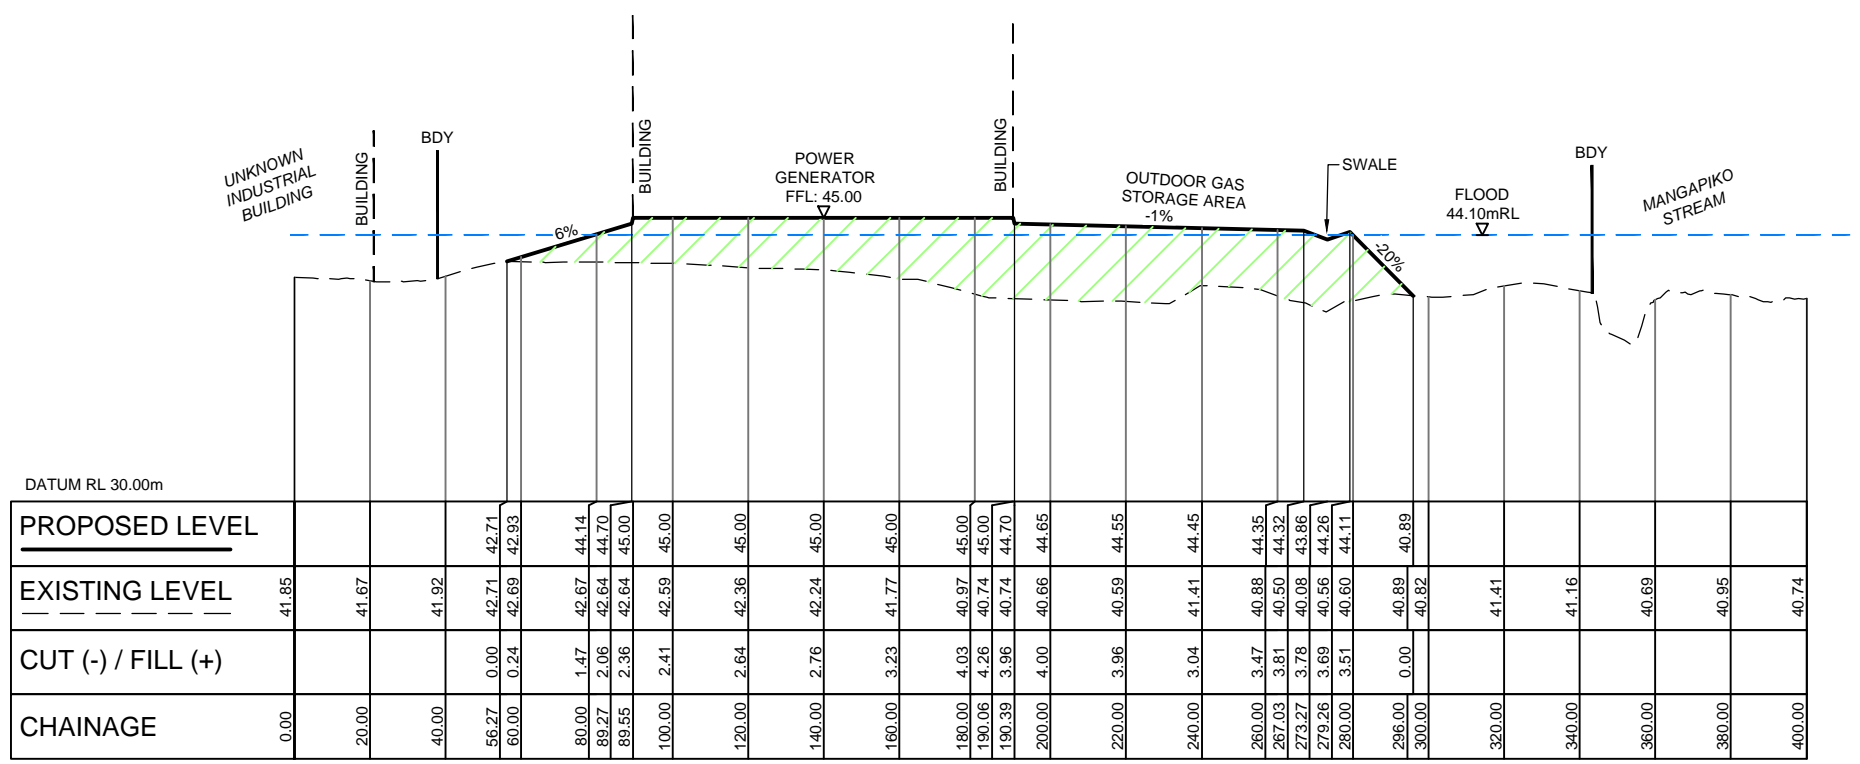
SECTION C (5x VERTICAL EXAGGERATION)
1:1000H 1:200V @ A1 (DOUBLE FOR A3)

- b. Extrapolation of the 40 m water level contour at Section C indicates that the water table is likely around 1 m below the flood plain which would put the water table above the invert level of the flood mitigation basin.*

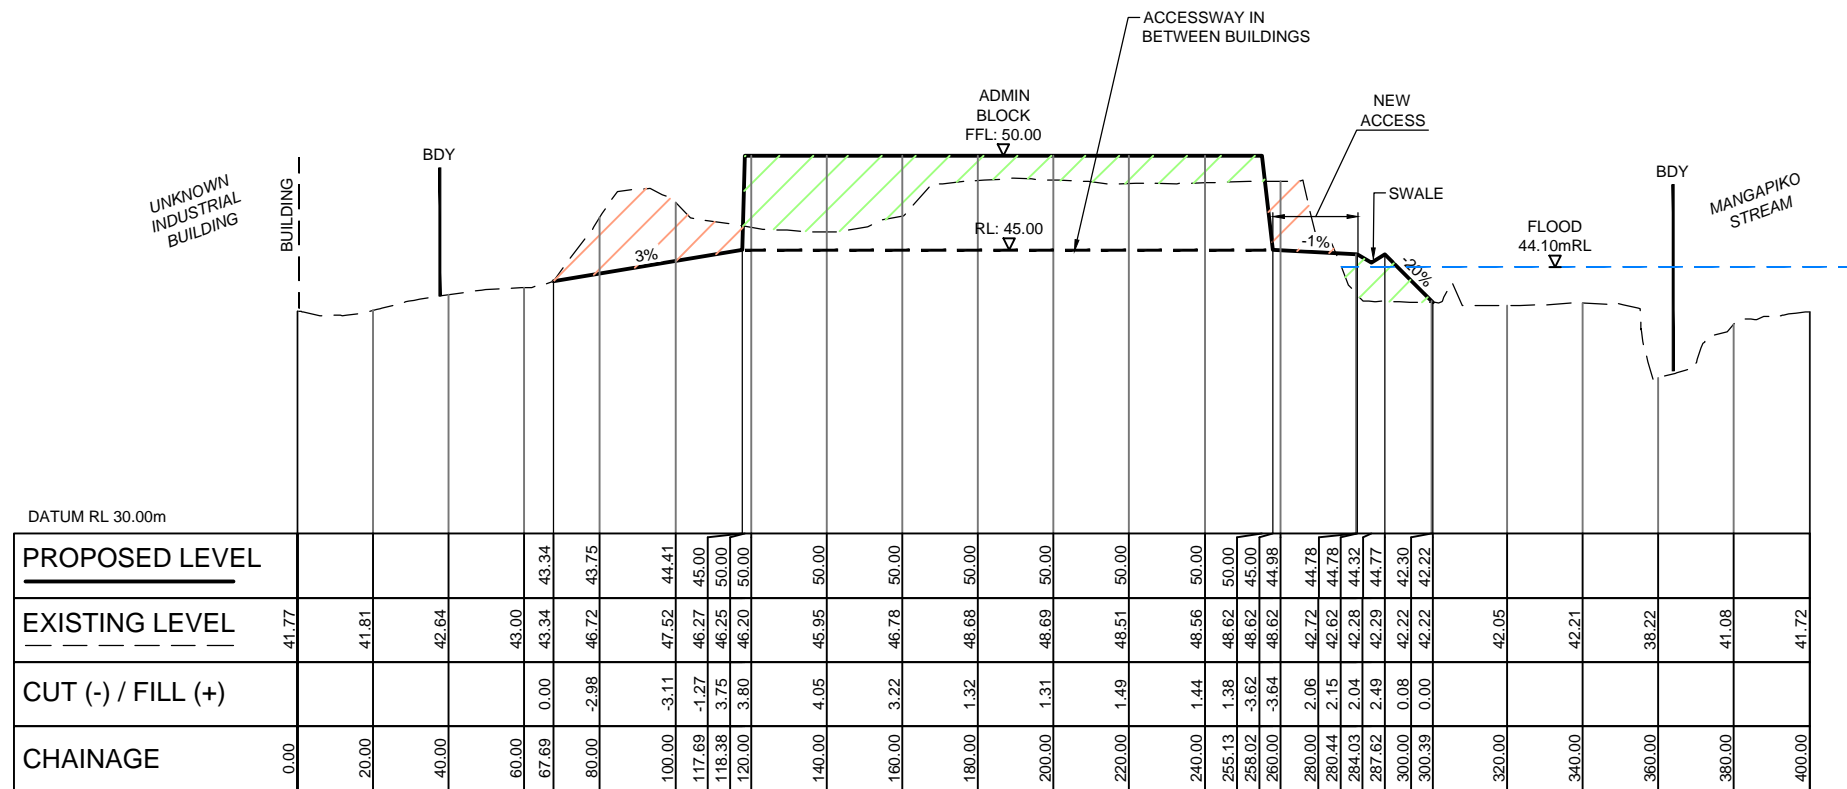
SECTION E (5x VERTICAL EXAGGERATION)
1:1000H 1:200V @ A1 (DOUBLE FOR A3)

- e. At Section E the water table contours are likely to be at approximately 42 m which is above the base of the invert.*
- f. At Section G, where the ditch is currently controlling seepage at the base of the scarp, the ditch would be replaced by the flood mitigation basin which would then receive the seepage.”*

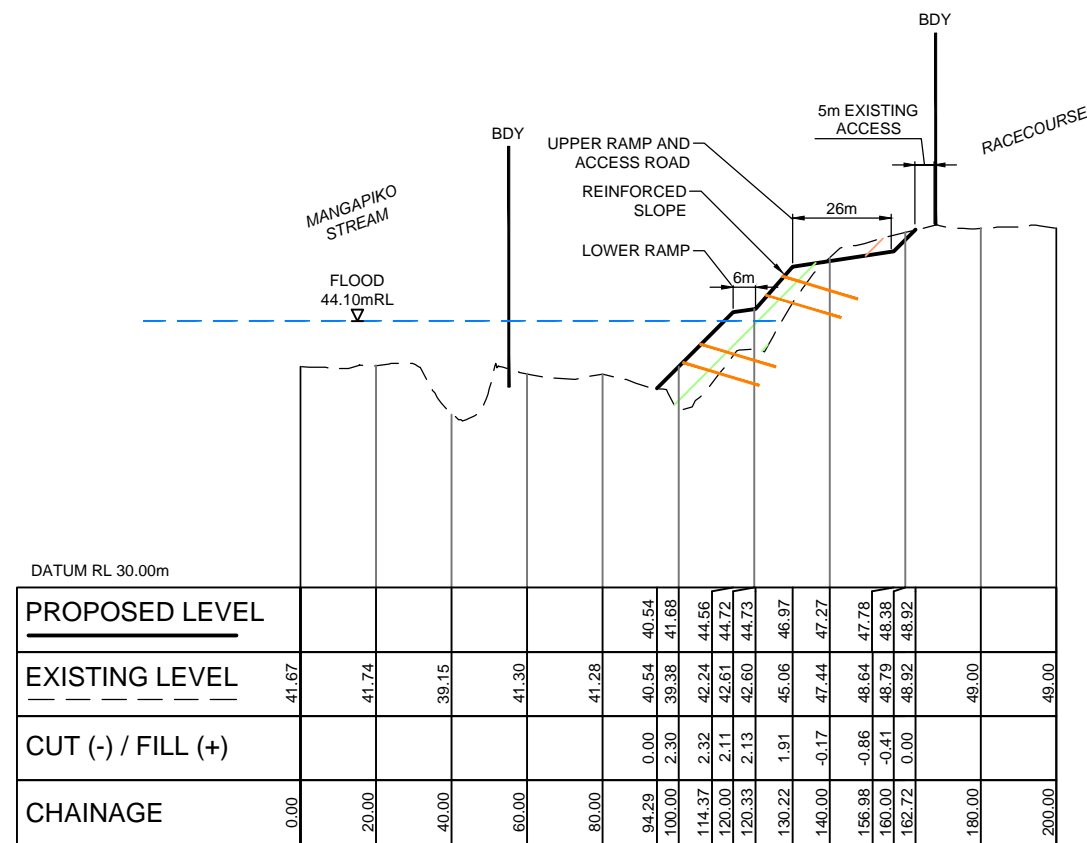
SECTION G (5x VERTICAL EXAGGERATION)
1:1000H 1:200V @ A1 (DOUBLE FOR A3)

- d. Extrapolation of the 42 m and 43 m water level contours indicate that the contours are likely to “daylight” along the terrace scarp resulting in a seepage face, particularly at times of high water levels. The presence of a drainage ditch at the base of the scarp in the vicinity of Section G suggests that this seepage is occurring.*

“At Section G, where the ditch is currently controlling seepage at the base of the scarp, the ditch would be replaced by the flood mitigation basin which would then receive the seepage.”

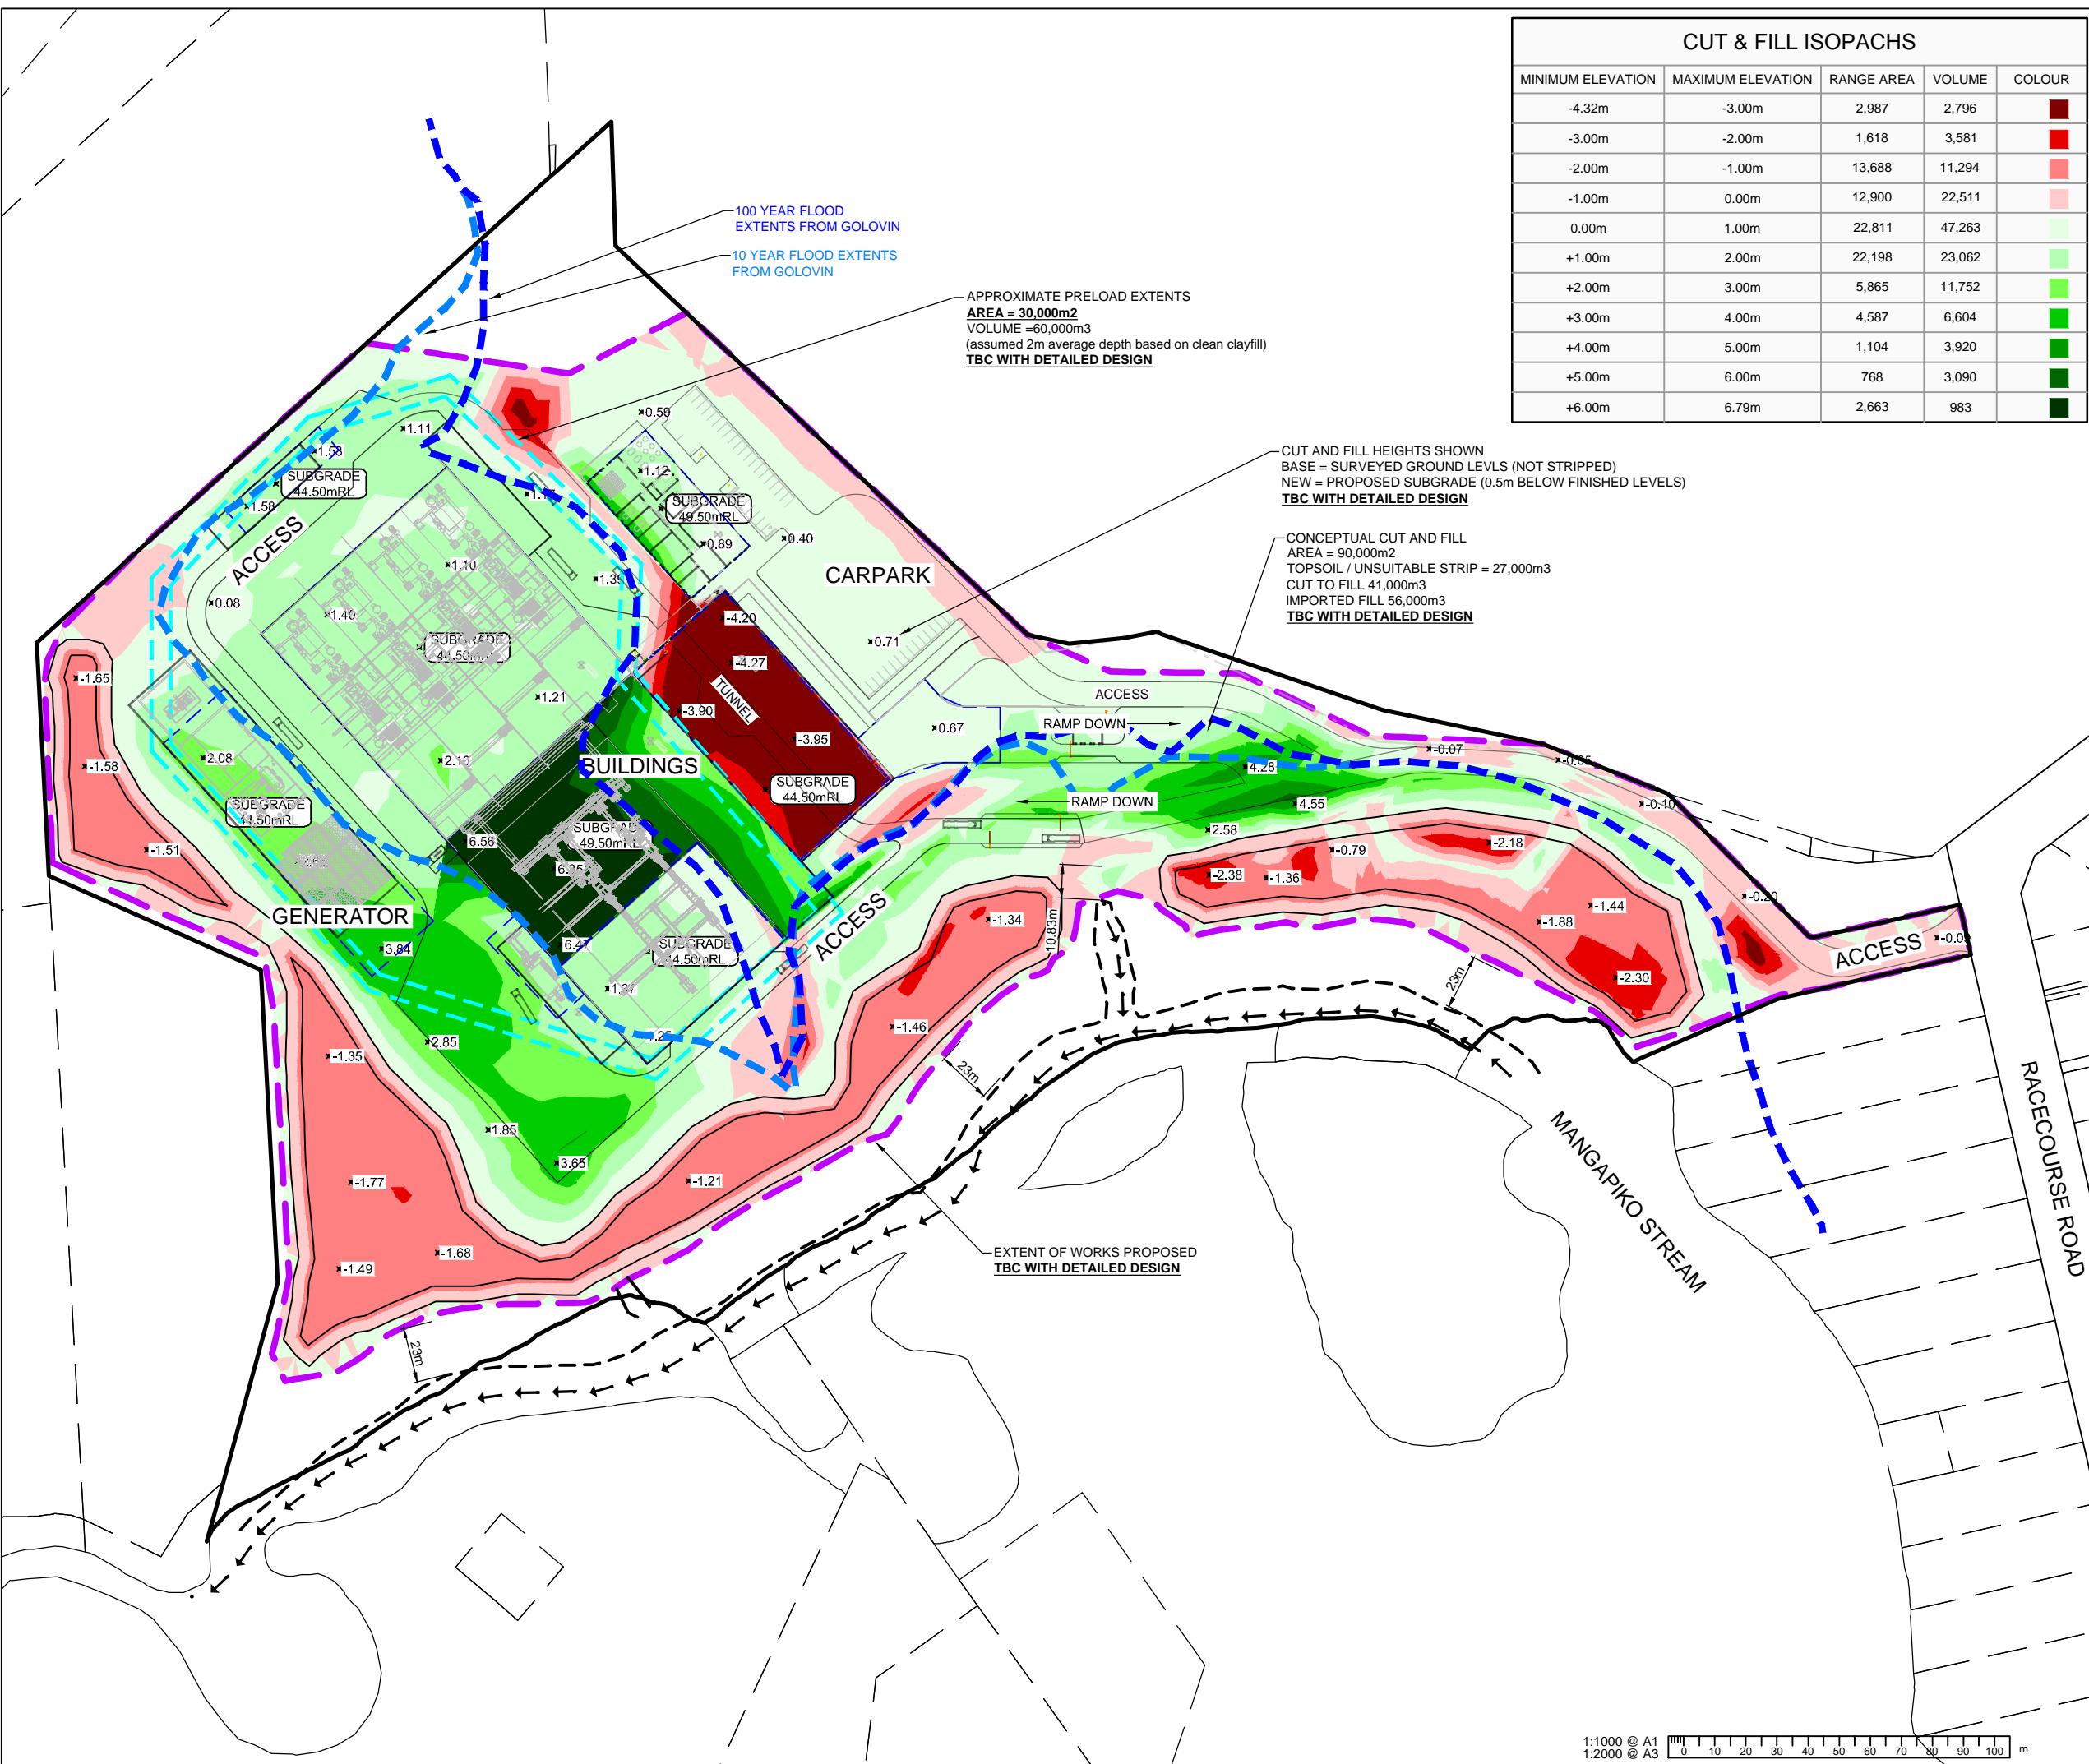
CUT & FILL ISOPACHS				
MINIMUM ELEVATION	MAXIMUM ELEVATION	RANGE AREA	VOLUME	COLOUR
-4.32m	-3.00m	2,987	2,796	Dark Red
-3.00m	-2.00m	1,618	3,581	Red
-2.00m	-1.00m	13,688	11,294	Light Red
-1.00m	0.00m	12,900	22,511	Pink
0.00m	1.00m	22,811	47,263	Light Green
+2.00m	3.00m	5,865	11,752	Green
+3.00m	4.00m	4,587	6,604	Dark Green
+4.00m	5.00m	1,104	3,920	Very Dark Green
+5.00m	6.00m	768	3,090	Black
+6.00m	6.79m	2,663	983	Black

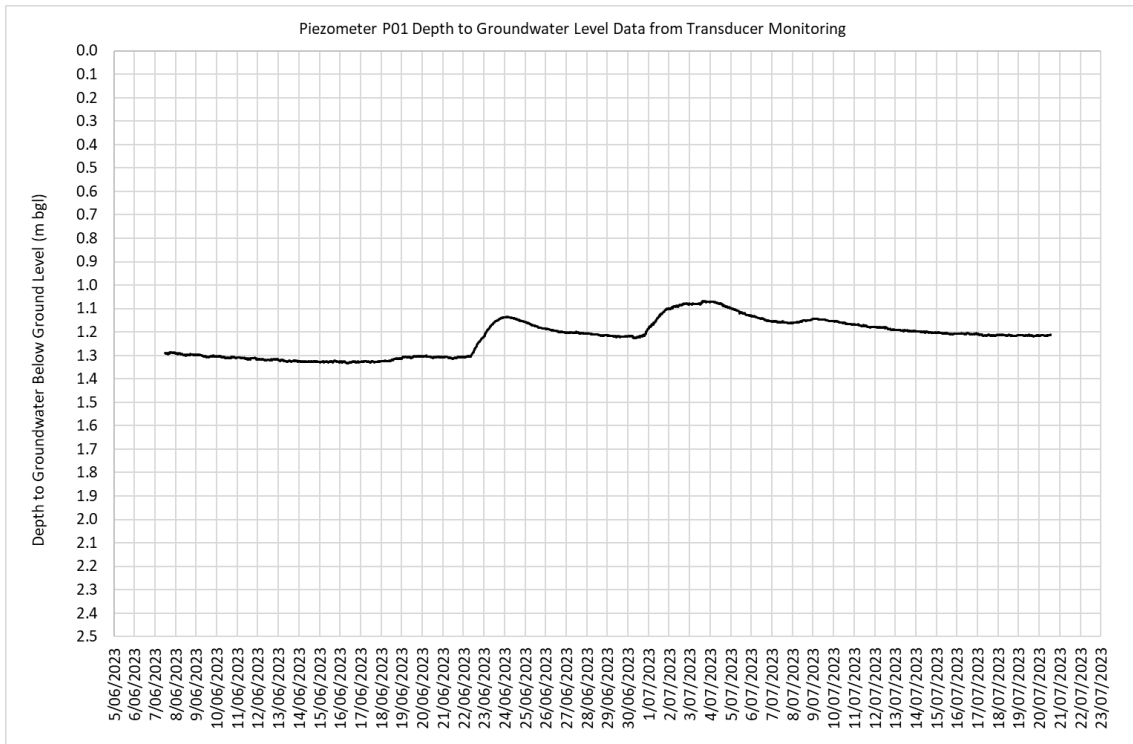
Figure B5: Groundwater Level Monitored Levels Piezometer P1

Groundwater levels measured during drilling for installation of the new piezometers was similar to the subsequent groundwater levels monitored over a period of 43 days (Appendix B). The shallowest groundwater level (approximately 0.5 m bgl) has been observed in Piezometer P02, which is located in a relatively low-lying topographical position on the terrace.

In terms of seasonal “highs”, the recent groundwater level monitoring indicated groundwater levels during a particularly high rainfall period were still 0.5 m to 2.0 m below ground level on the lower terrace (Appendix B). Small fluctuations were observed in response to rainfall events over 43 days of monitoring. However, since the site is located near the stream discharge location this will maintain relatively stable groundwater levels. Therefore, WGA disagrees that seasonal groundwater highs have potential to exacerbate any effects.

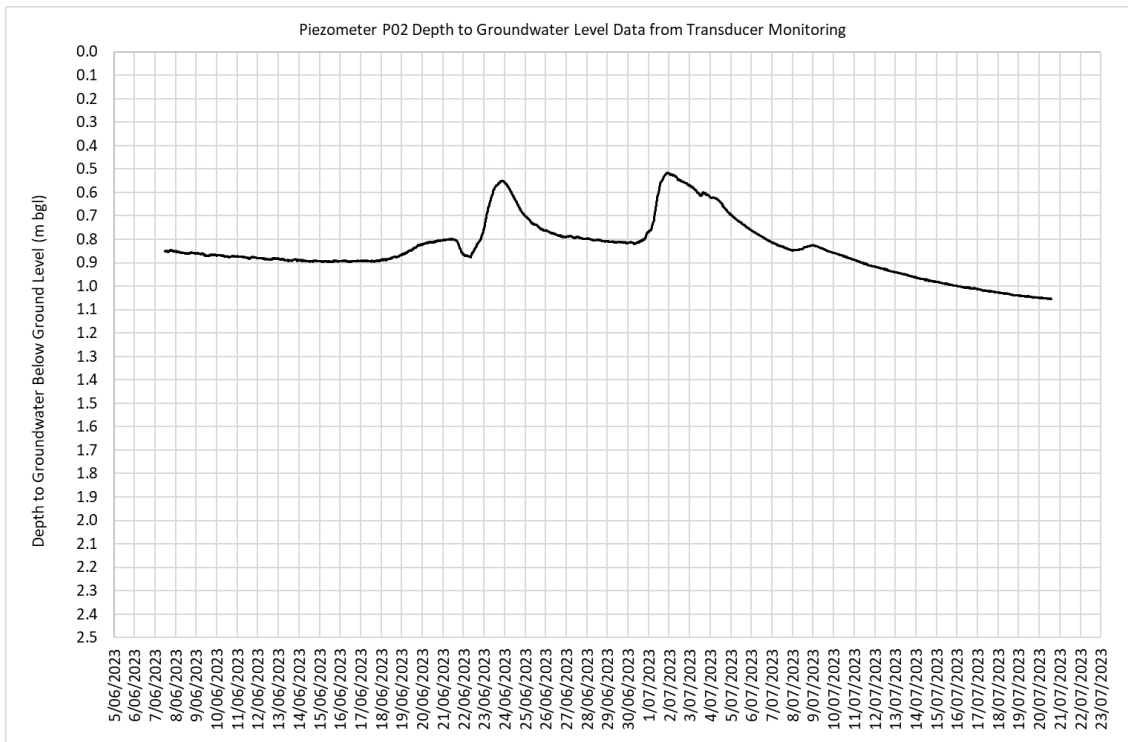
Figure B6: Groundwater Level Monitored Levels Piezometer P2
