16A WICKHAM STREET, HAMILTON - PRELIMINARY AND DETAILED SITE INVESTIGATION

1.0 Introduction

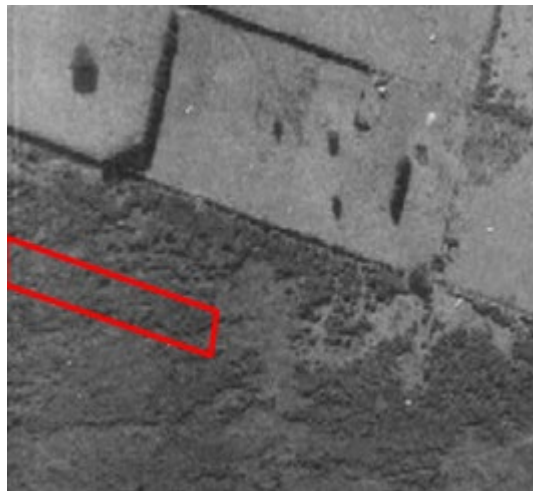
1943 Aerial

The 1943 aerial is the oldest photograph obtained for the site. The site (approximately outlined in red) is towards the northern edge of a large area of bush/scrub. There is no evidence of buildings on the site. The site is bordered by pastureland (beyond the bush/scrub) to the north / northeast and by bush/scrub to the south.

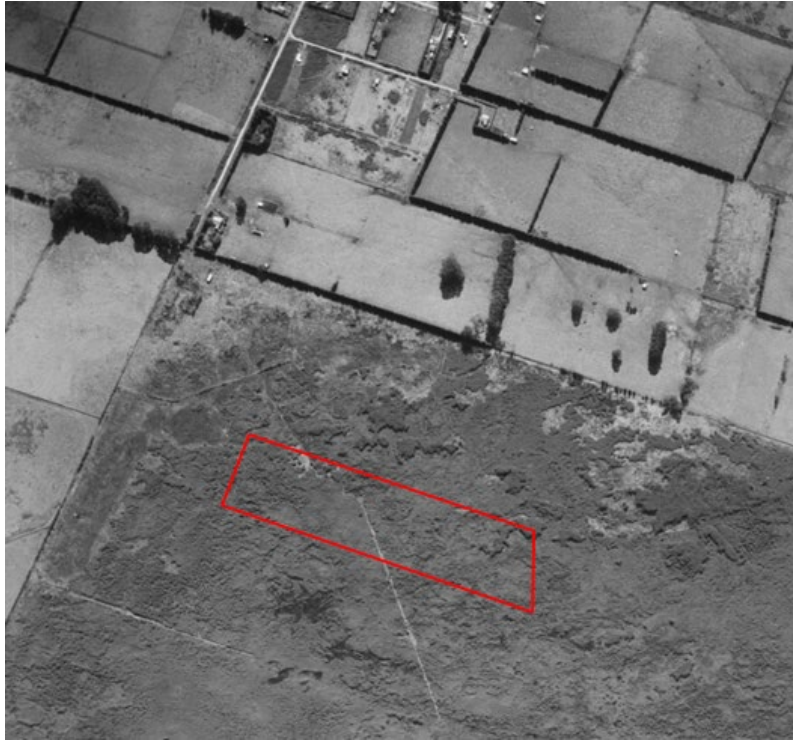
1953 Aerial

The site is as described previously. There appears to be development occurring to the north of the site with dwellings and associated roadways now present.

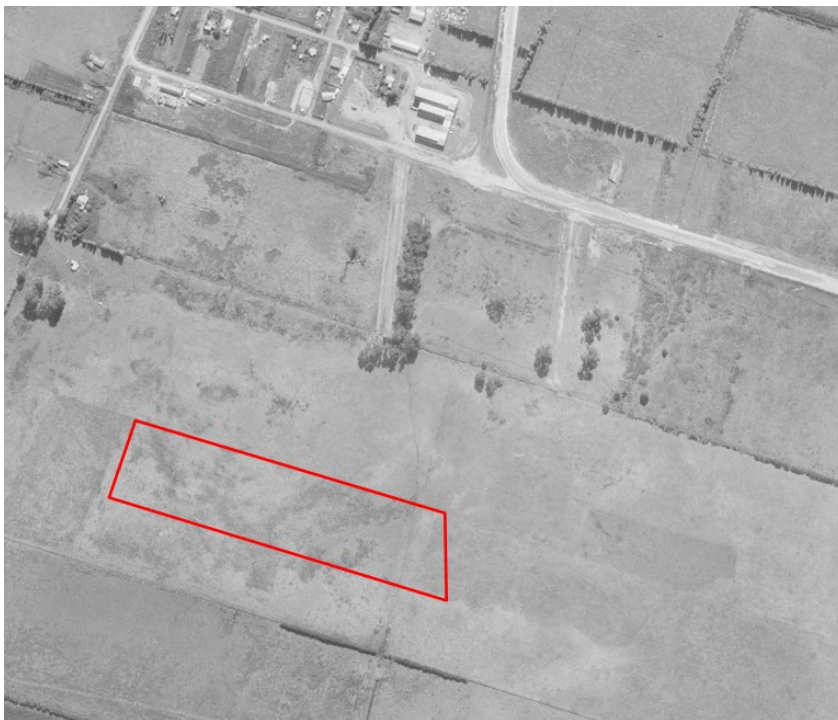
1971 Aerial

The site has been cleared of bush/scrub and now appears to be pastureland. The development to the north has grown with further buildings and roadways evident. The immediate surrounding area appears to be pastureland.

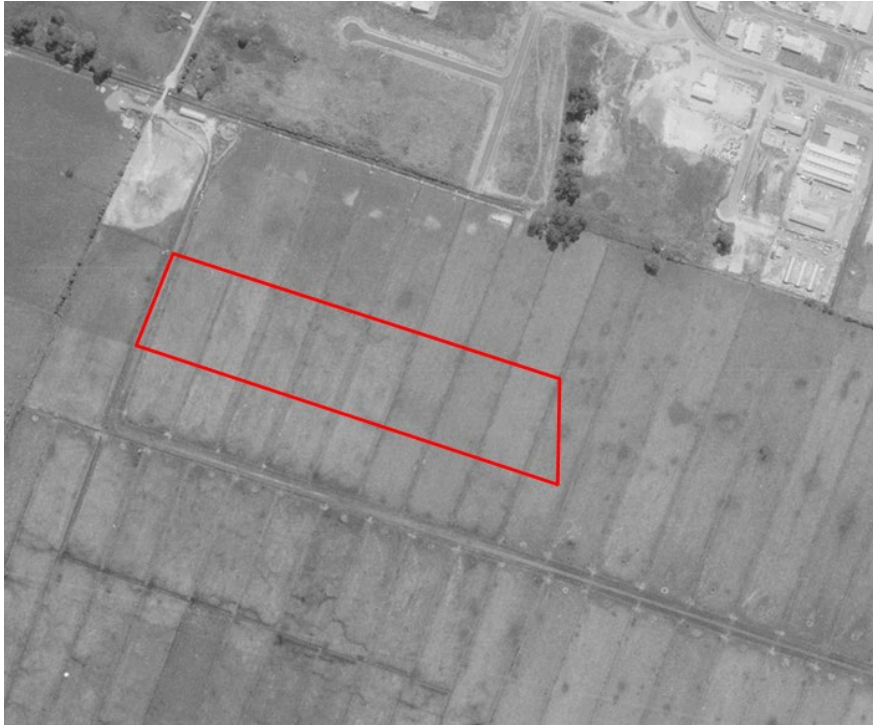
1979 Aerial

The site appears to have been divided up into sections for pastoral purposes. Development to the north has progressed further with more buildings and roadways now present.

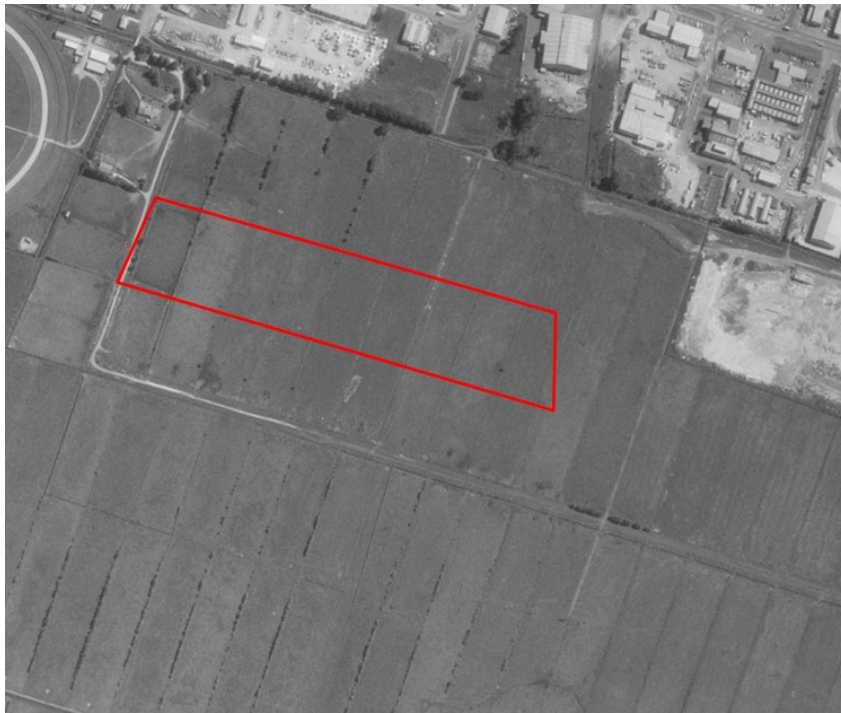
1990 Aerial

The site appears to still be pastureland. Development to the north has progressed further and appears to be largely commercial/industrial. A racecourse appears to have been developed to the west of the site. A new roadway / farm track is present to the west and south of the site. An area of disturbed land is present to the east of the site.

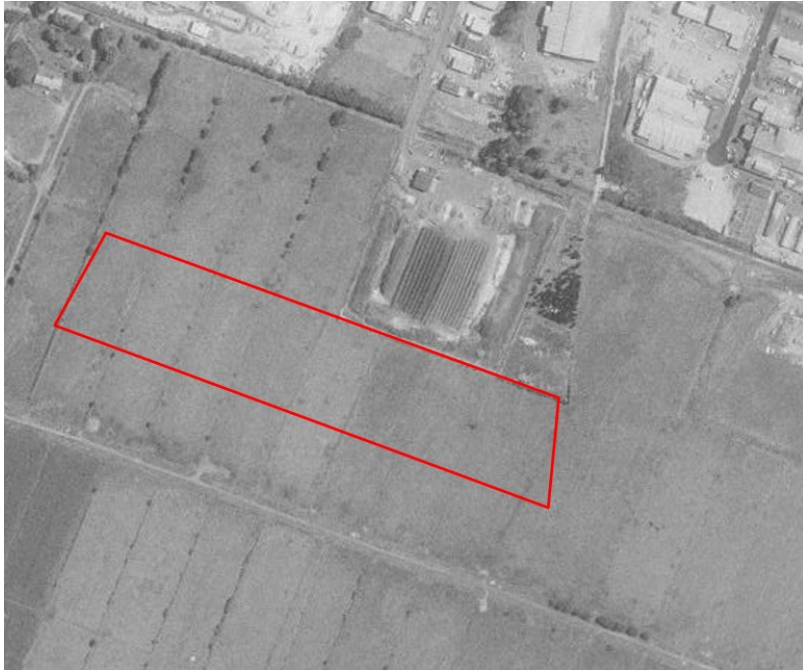
1995 Aerial

The site and surrounds are largely as described previously. To the north of the eastern half of the site (current location of Hamilton Organic Green Waste Recycling Centre), some disturbed land and new buildings are present.

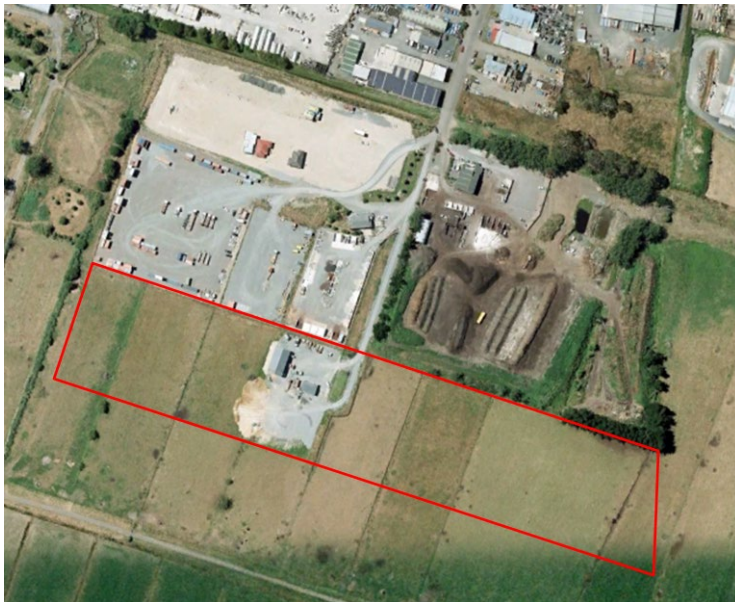
2008 Aerial

The central part of the site has started being developed with two buildings now present. The remainder of the site remains pastureland.

The yard at 16 Wickham Street to the north of the site has now been developed and appears to be used for storage and industrial purposes. The disturbed ground adjacent to the northeast border of the site noted in the 1995 aerial is still present and the property it is located on has been developed further. Pastureland is still present to the west, east and south of the site.

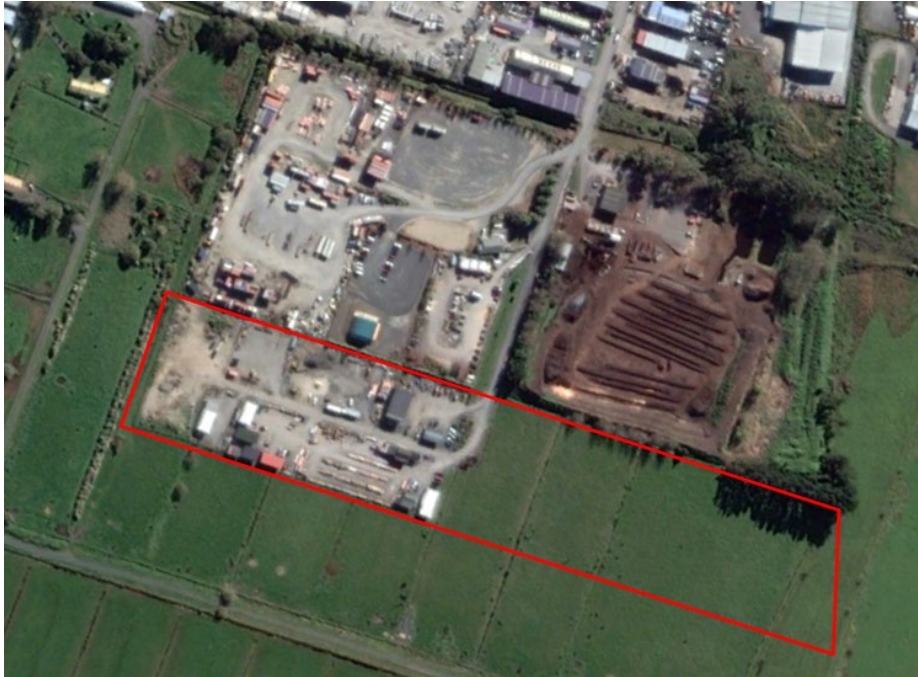
2012 Aerial

The western half of the site has been developed and appears to consist of numerous yards largely used for storage. A number of small buildings are present. The eastern half of the site remains pastureland. The surrounding land use is as described previously.

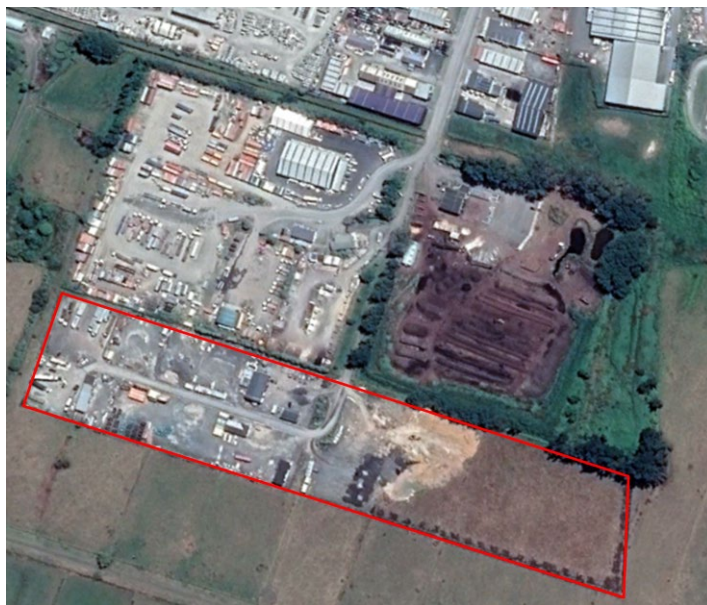
2017 Aerial

A small portion of the eastern half of the site has started to be developed with what appears to be disturbed ground from earthworks present. The remainder of the site and surrounds are as described previously.

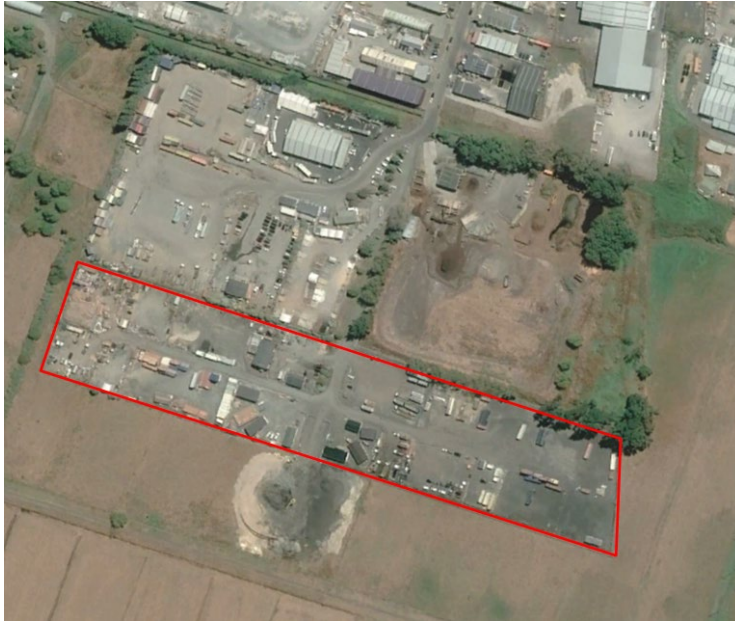
2020 Aerial

The remainder of the site has been developed. It appears to be separated into numerous smaller yards which are largely being used for storage of containers and vehicles. A number of small buildings are present.

It appears that further development has begun adjacent to the central southern boundary of the site. The remainder of the surrounding land use is as described previously.

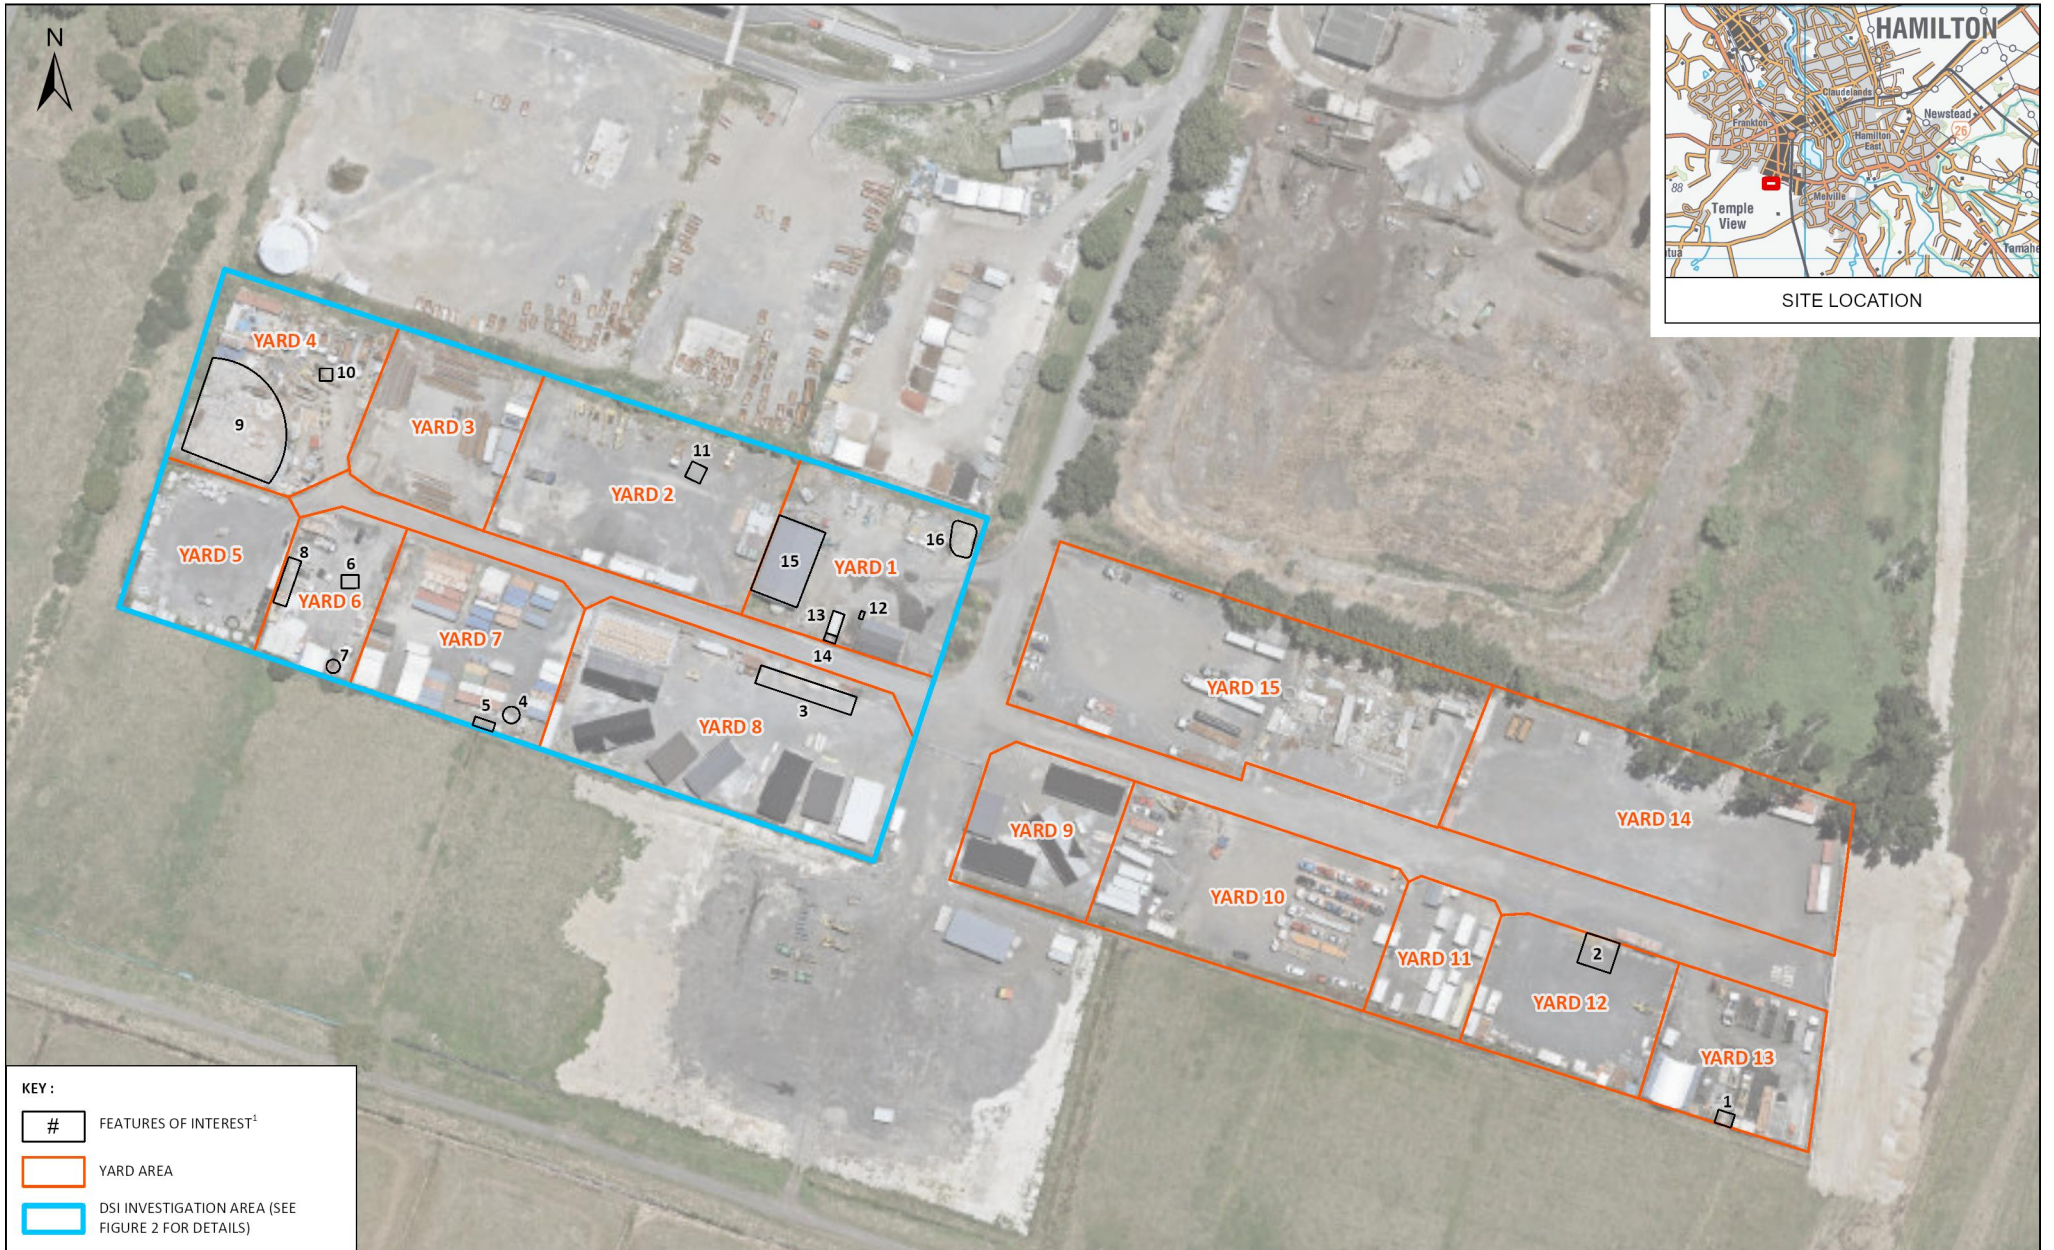
- # FEATURES OF INTEREST¹
- YARD AREA
- DSI INVESTIGATION AREA (SEE FIGURE 2 FOR DETAILS)

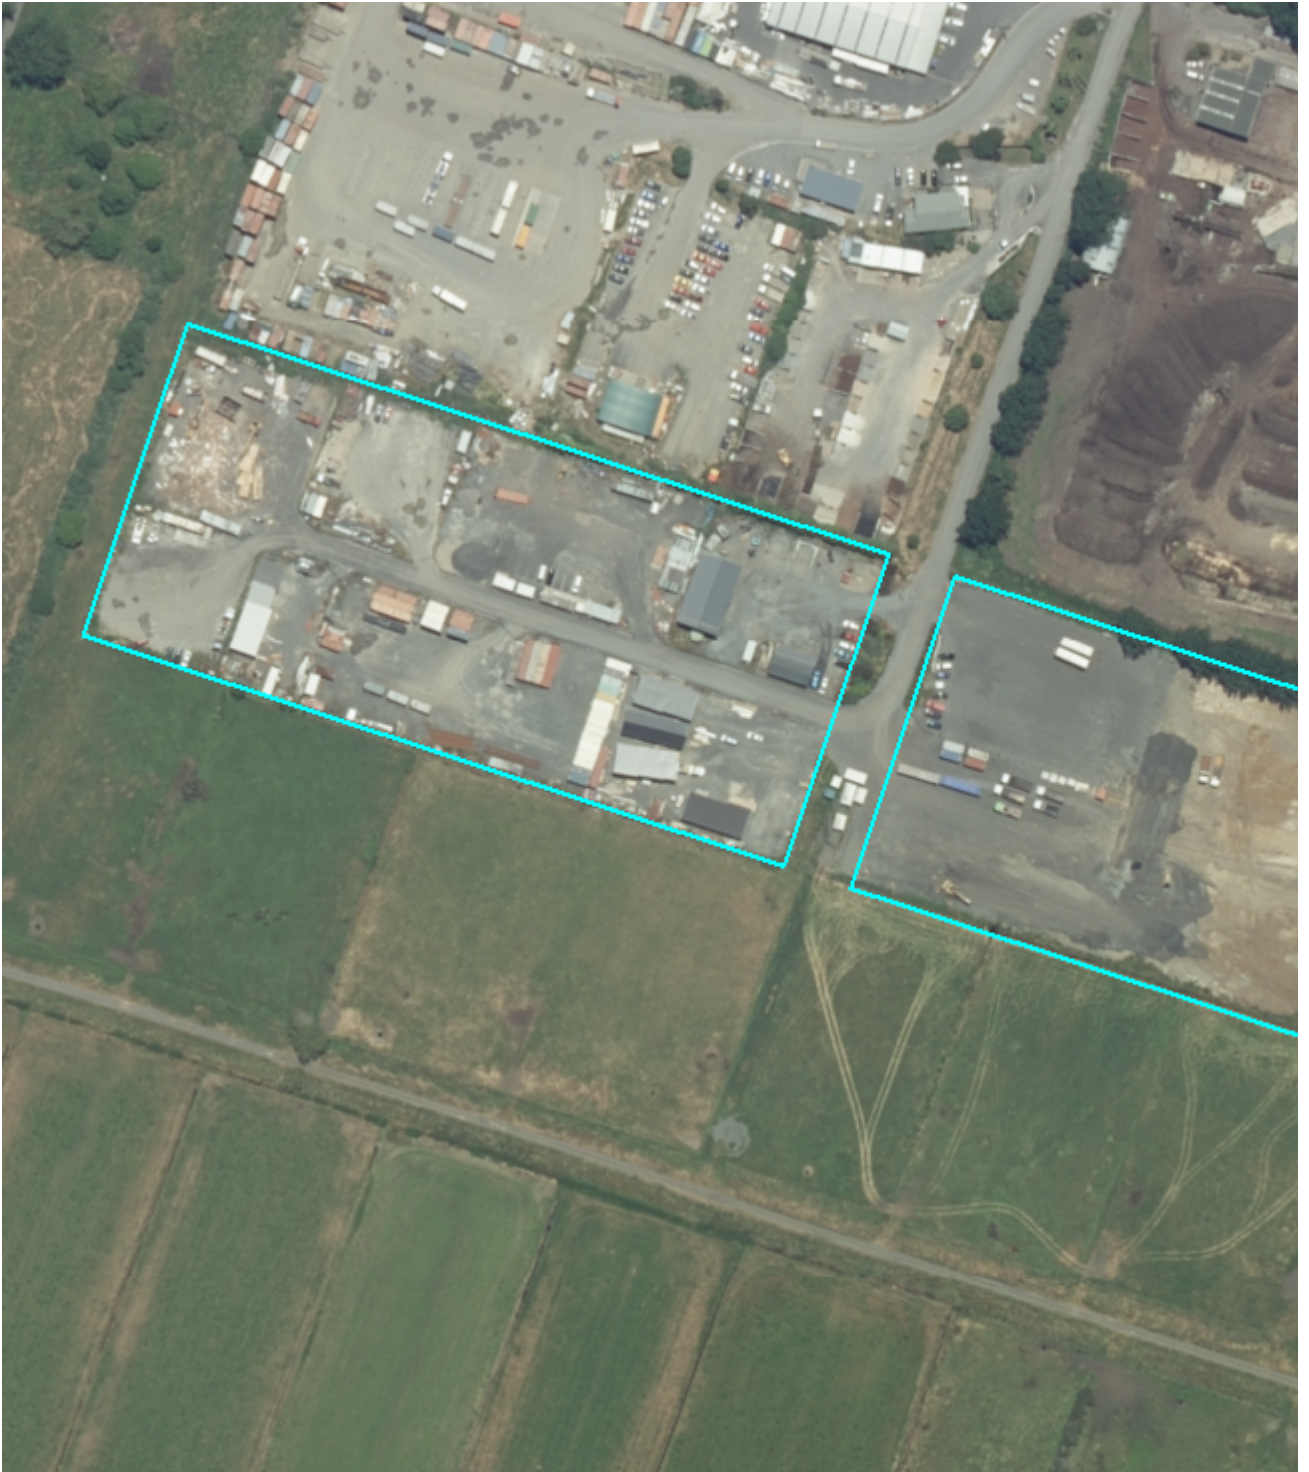
This property: I can confirm that this property **does** appear on the Land Use Information Register, as indicated by the area shaded blue on the maps below.

The area shaded blue above appears on the Land Use Information Register as **LUI11099** with a classification of 'Verified HAIL – No Sampling' due to (past OR past and current) land use for HAIL activity 'A18. Wood treatment or preservation or bulk storage of treated timber' (approximate dates 2010 – 2015) associated with Kiwi Timbers Supplies. This site is included on the register for land use information only; we do not hold soil investigation reports regarding the presence or otherwise of hazardous substances in the soil.

The area shaded blue above appears on the Land Use Information Register as **LUI12419** with a classification of 'Verified HAIL – No Sampling' due to current land use for HAIL activity 'F8. Transport depot and yards' associated with Auto Logistics/PTS Logistics Hamilton Depot. This site is included on the register for land use information only; we do not hold soil investigation reports regarding the presence or otherwise of hazardous substances in the soil.

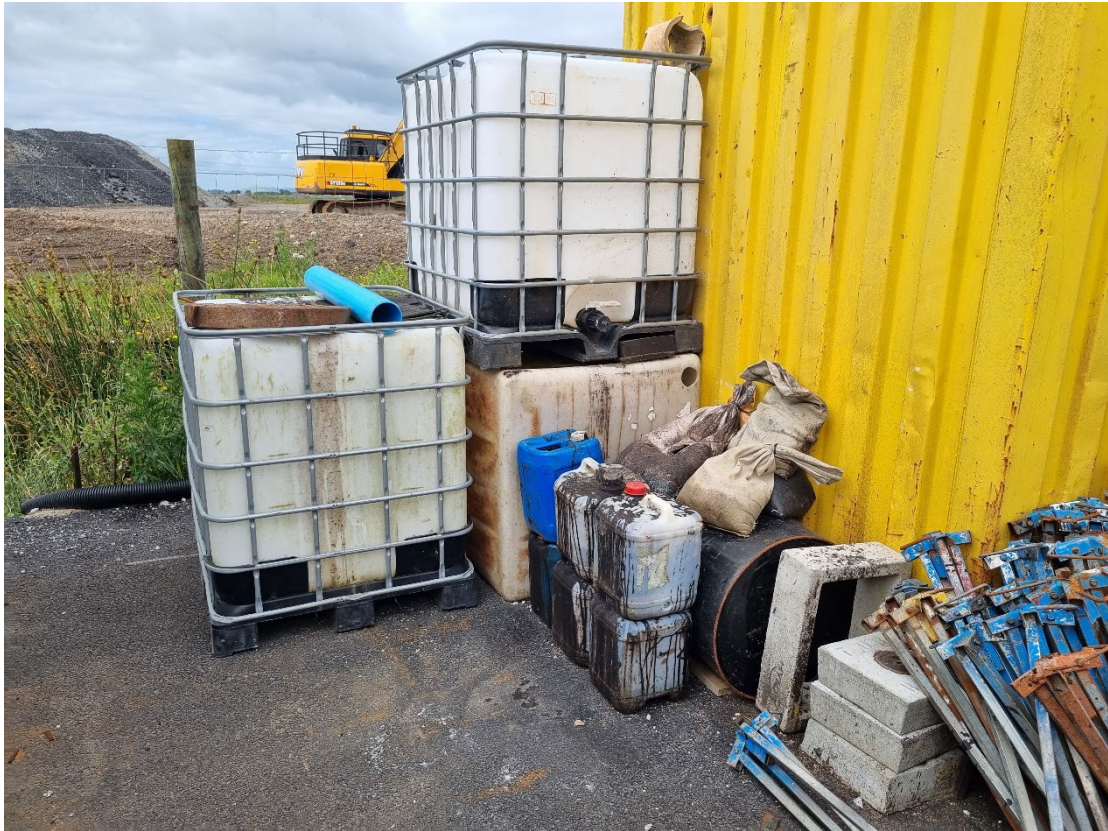
Feature of Interest	Location and Photograph Log Reference	Description	Correspondence with Site Tenant
1	Yard 13 (Yrear Contracting Limited) <i>Photographs 1 and 2</i>	Empty IBC's, 20 L plastic containers (part filled with unknown black liquid (possible bitumen emulsion)) and empty 200 L steel drum stored on asphalt. Staining on asphalt next to locked container immediately adjacent to above mentioned container/drum storage.	No yard employee available for interview.
2	Yard 12 (Livingstone Builders) <i>Photographs 3 and 4</i>	Minor fuel, oil and chemical storage and general staining of ground.	Correspondence with an employee on site stated that Yard 13 is a storage yard for Livingstone Builders. The yard is used to store general construction material which is largely recycled quickly between jobs. The employee was not aware of any additional storage of fuels/chemicals or any other potentially contaminating activities within the yard.

Photograph 1: Empty IBCs, 20L plastic containers (part filled with unknown black liquid (possibly bitumen emulsion)) and empty 200 L steel drum in far southeast yard of the site (Feature of interest 1).

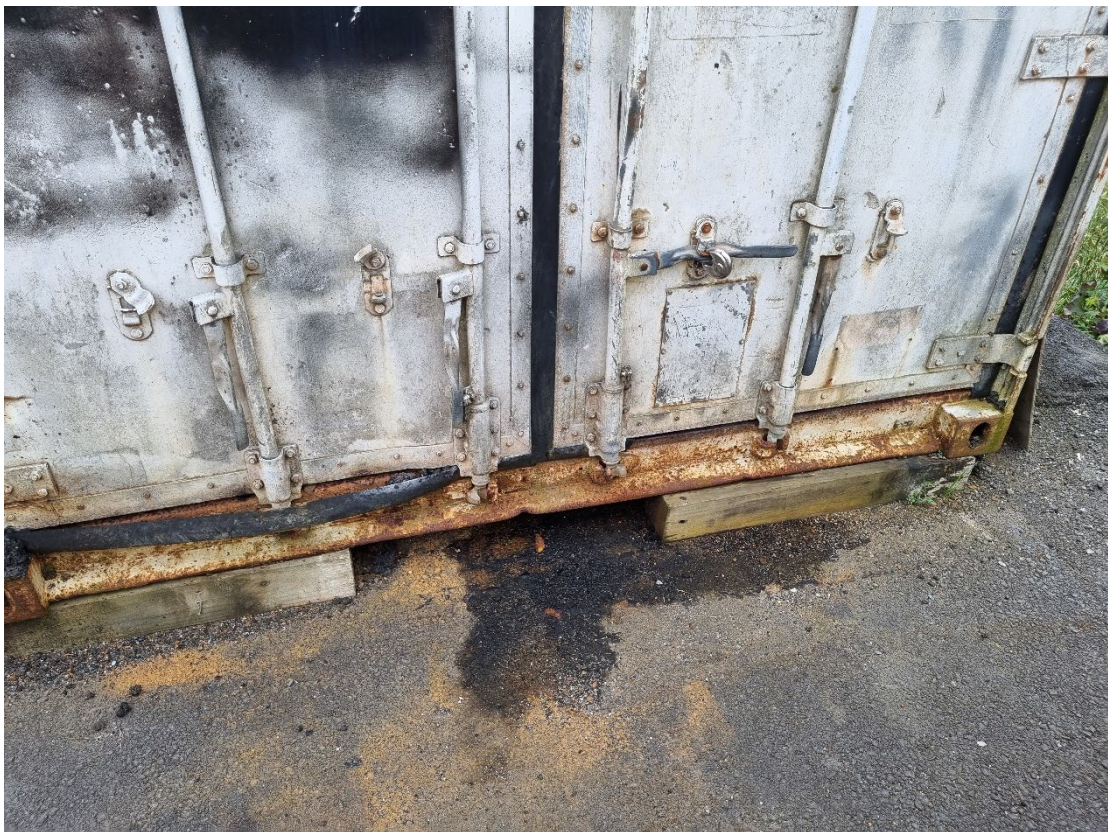
Photograph 2: Staining on asphalt next to locked container in far southeast yard of the site (Feature of interest 1).

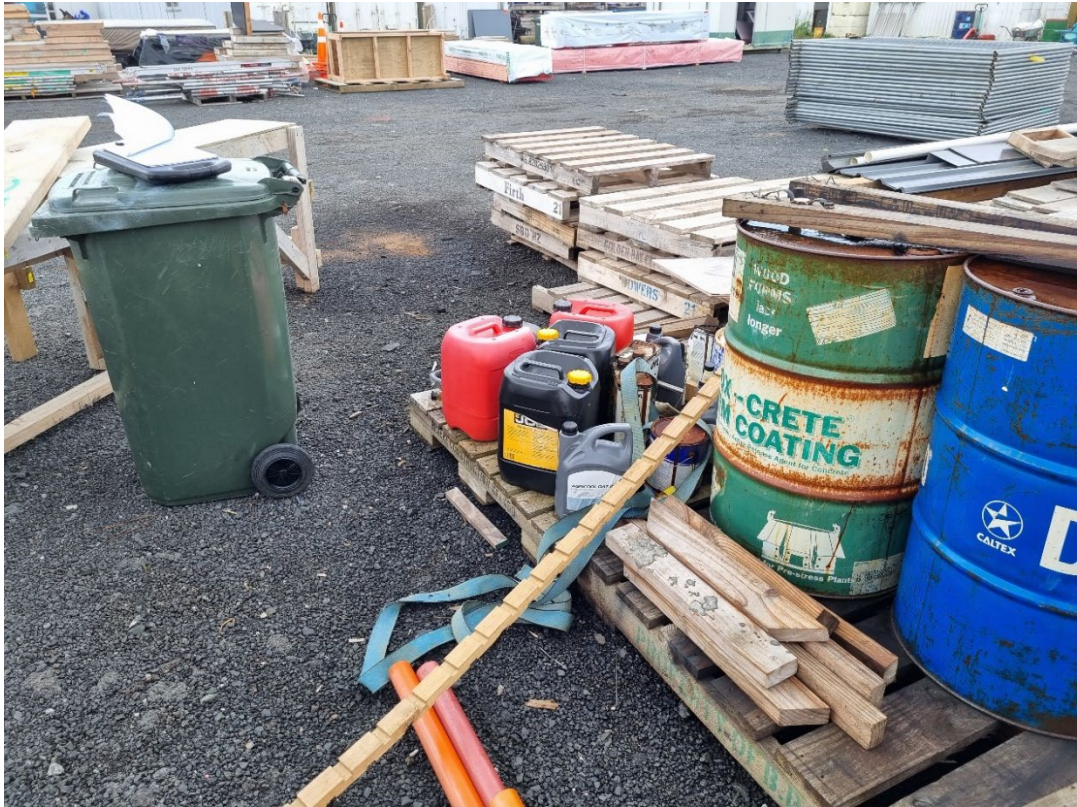
Photograph 3: Minor fuel, oil and chemical storage and general staining of ground in Livingstons Construction yard (southeast of the site) (Feature of interest 2).

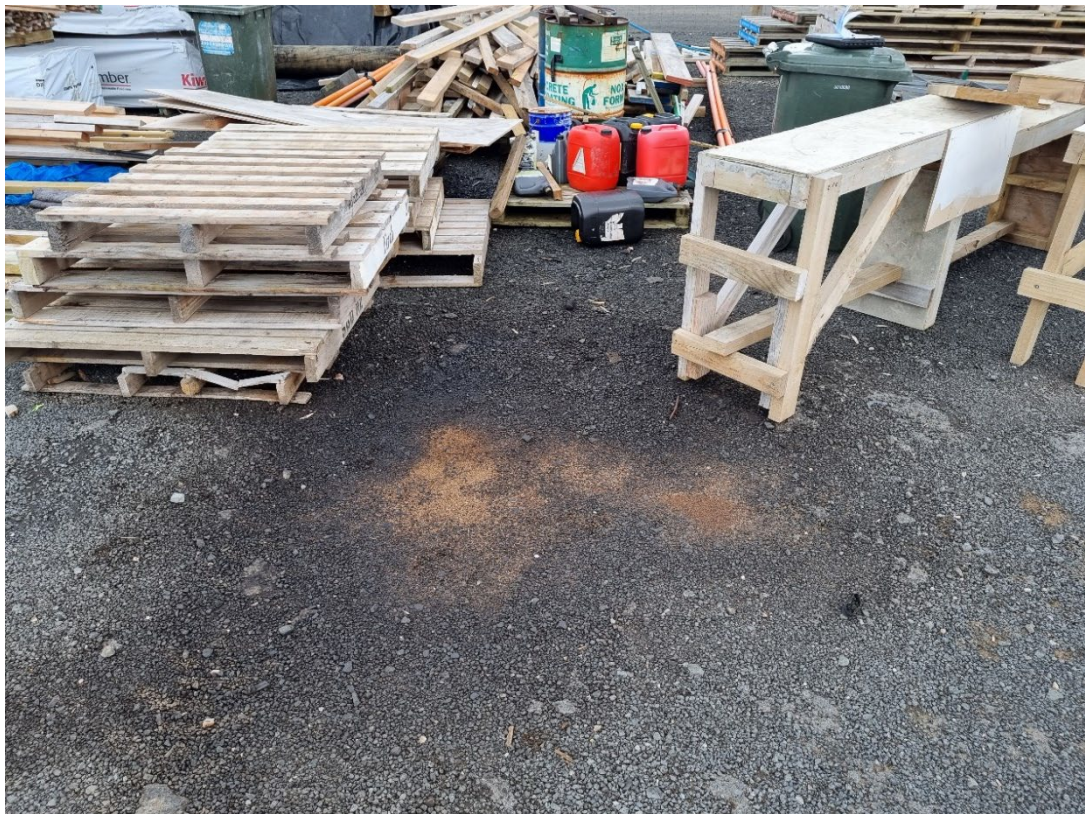
Photograph 4: Staining on ground next to minor fuel, oil and chemical storage in Livingstons Construction yard (southeast of the site) (Feature of interest 2).

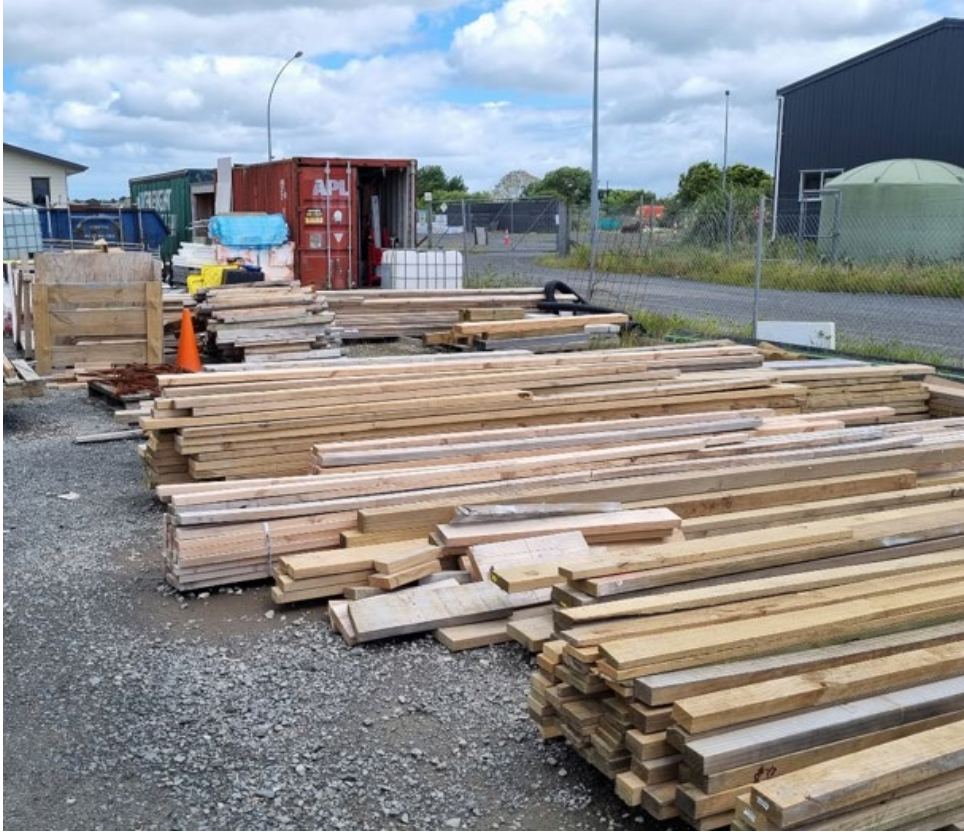
Photograph 5: Storage of potentially treated timber along northern boundary of the Kiwi Transportable Home's yard (Feature of interest 3).

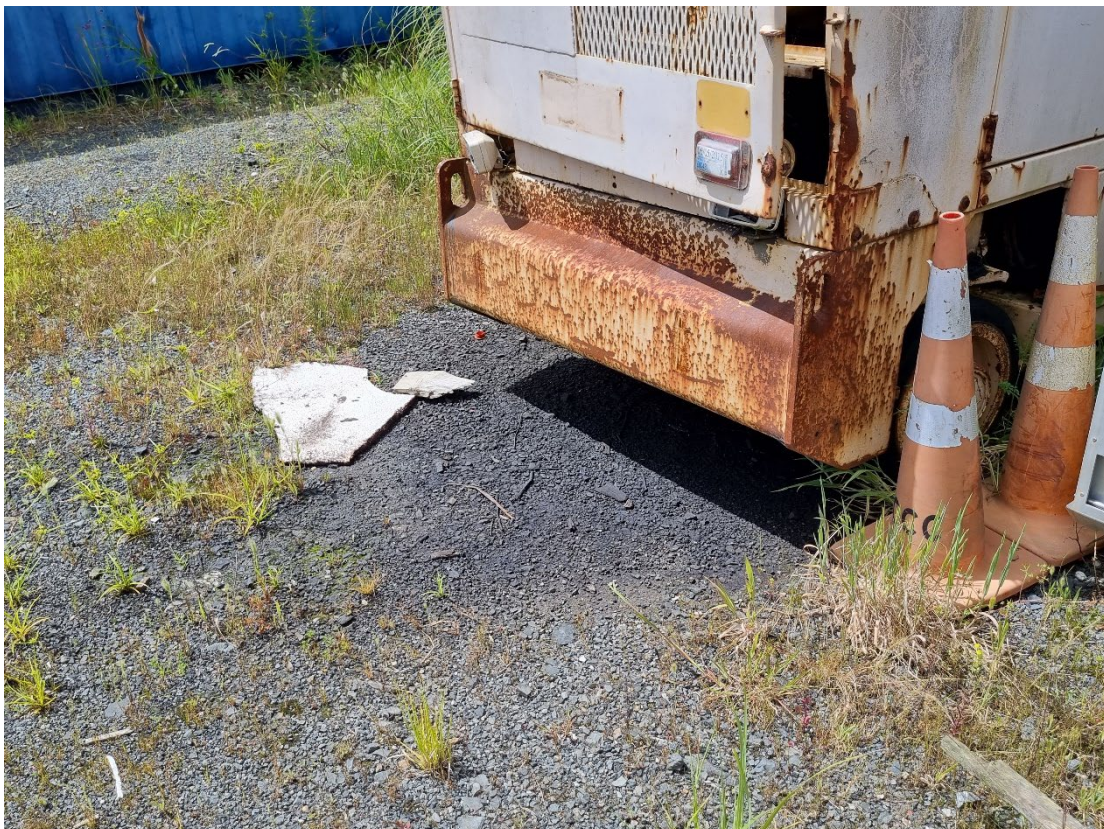
Photograph 6: Staining on ground in front of old Bitelli asphalt paver. Within an unknown yard largely containing shipping containers in the southwest of the site (Feature of interest 4).

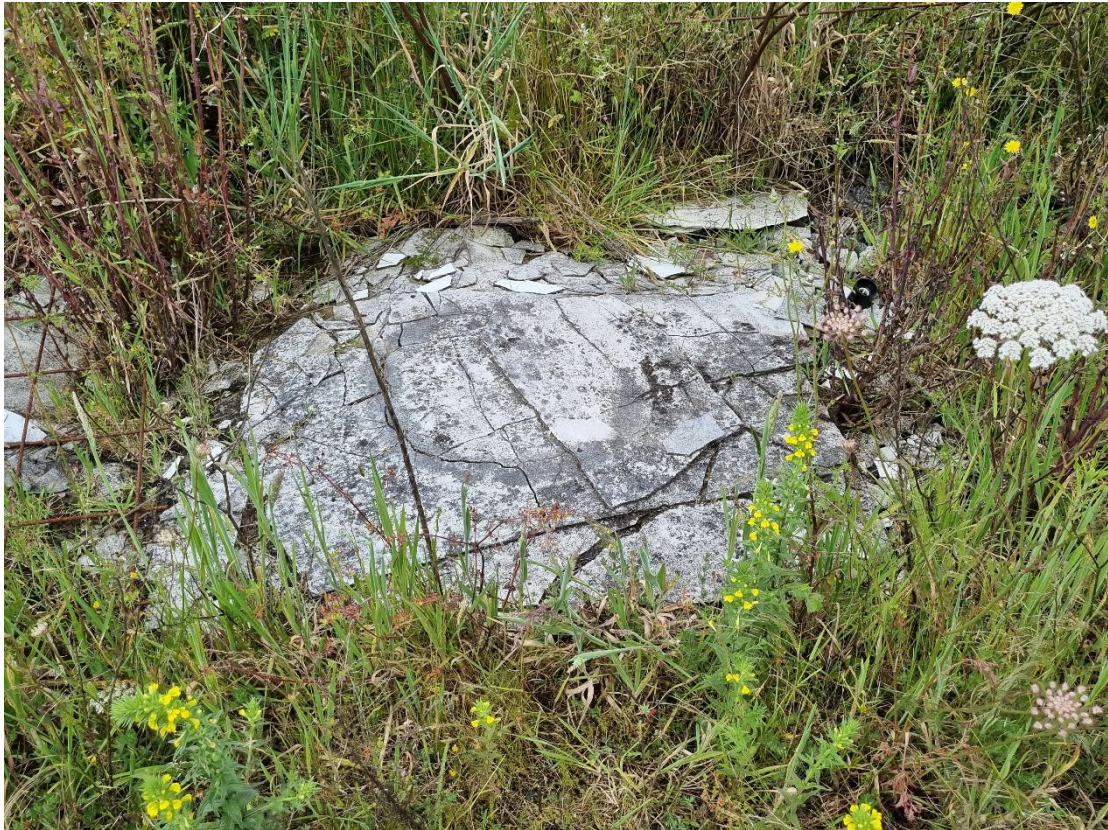
Photograph 7: Broken fibre cement sheets on ground within the unknown yard largely containing shipping containers in the southwest of the site (Feature of interest 5).

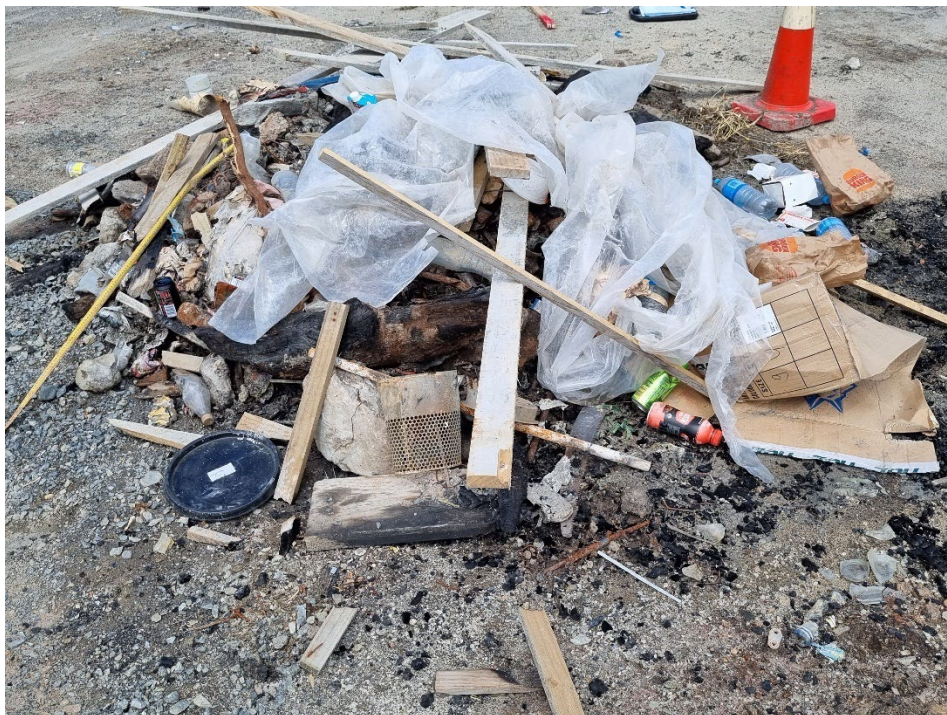
Feature of Interest	Location and Photograph Log Reference	Description	Correspondence with Site Tenant
6	Yard 6 (JK Concrete) <i>Photograph 8</i>	Rubbish / burn pile (approximately 9 m ²) containing timber, concrete, metal cans, bottles, spade head, pipes, cardboard and plastic sheets.	NA
7	Yard 6 (JK Concrete) <i>Photograph 9</i>	Stockpile (approximately 5 m ³) containing soil, gravel, concrete, timber (some burnt), plastic, cardboard, paint tin lid, food cans and glass bottles.	NA
8	Yard 6 (JK Concrete) <i>Photographs 10 to 12</i>	One sealed near empty IBC containing unknown black residue (possibly bitumen emulsion). Various sealed small plastic containers (mostly empty) containing mostly unknown contents (one container contained multi-purpose biodegradable cleaning gel). One sealed, near empty 200 L steel drum of hydraulic oil.	NA
9	Yard 4 (Pro Demolition) <i>Photograph 13</i>	Very large pile of timber covering approximately 1/3 of the yard.	Correspondence with a site employee stated that the yard was used as storage for Pro Demolition. The pile of timber is untreated and from when they used to mulch timber for biofuel production (this activity has now ceased – date was not known by the employee). Staining on the ground surface is likely from water blasting the excavators that they store on-site. The employee stated there was no bulk storage of any fuels/chemicals and was not aware of any other potentially contaminating activities within their yards.

Photograph 8: Rubbish / burn pile in centre of JK Concrete storage yard in the southwest of the site. Timber, concrete, metal cans, bottles, spade head, pipes, cardboard and plastic sheets observed (Feature of interest 6).

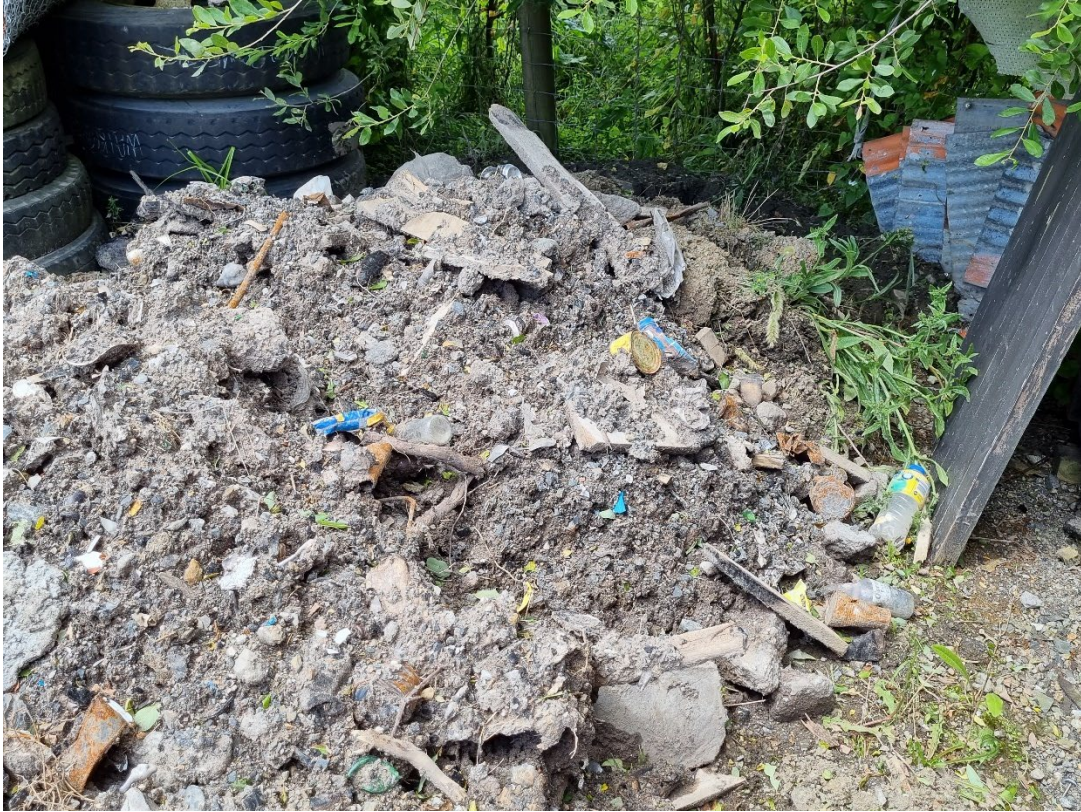
Photograph 9: Small stockpile of soil and refuse in southeast corner of JK Concrete storage yard in southwest of the site. Soil, gravel, concrete, timber (some burnt), plastic, cardboard, paint tin lid, food cans, glass bottles observed (Feature of interest 7).

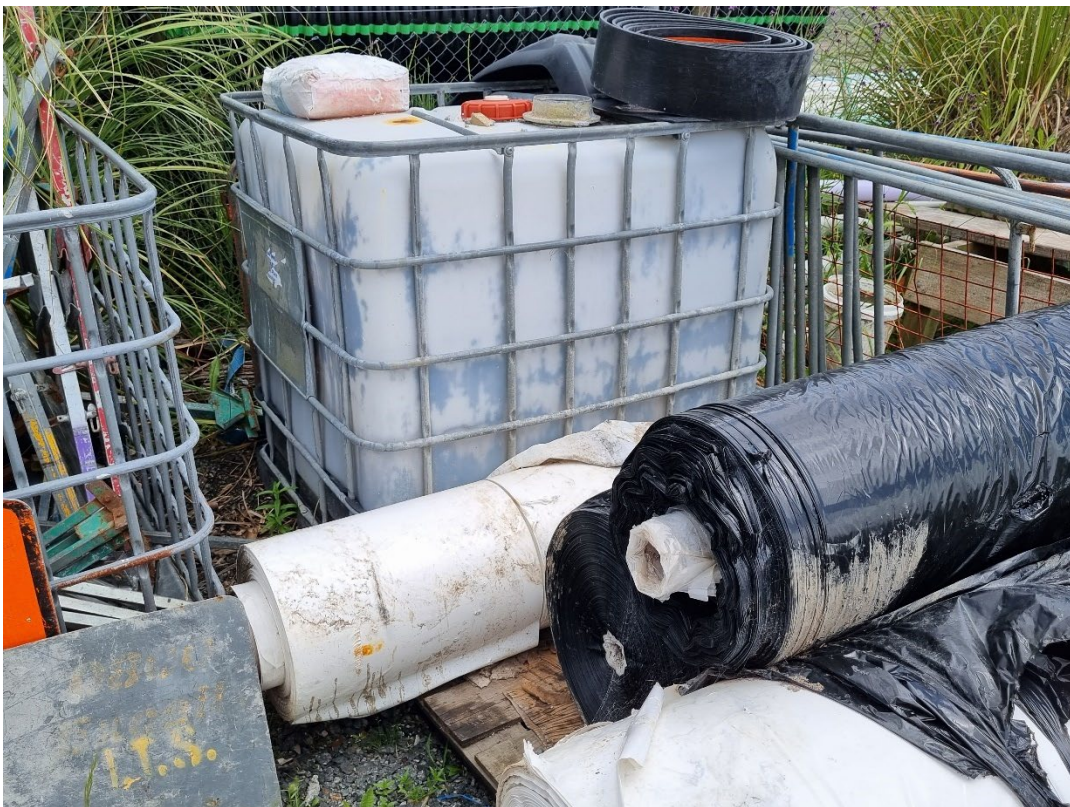
Photograph 10: Near empty IBC with unknown black residue inside on the western boundary of JK Concrete storage yard (Feature of interest 8).

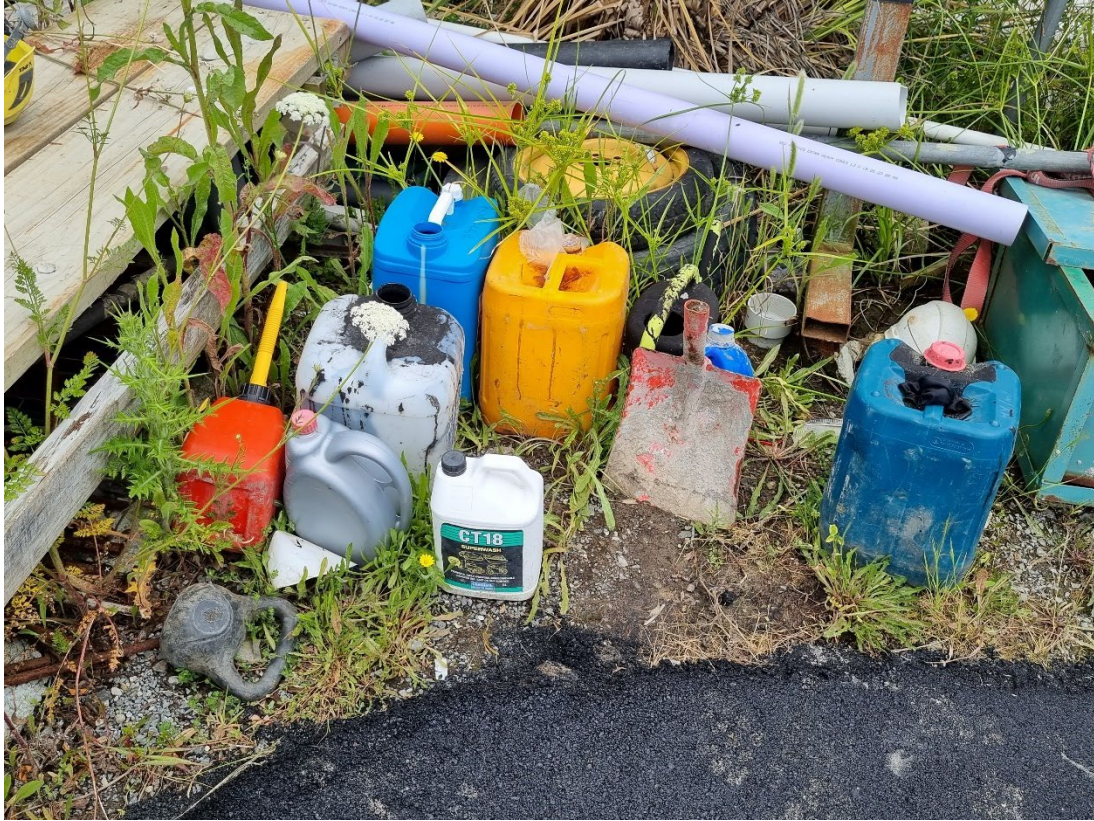
Photograph 11: Various small plastic containers (mostly empty) with mostly unknown contents (one container contained multipurpose biodegradable cleaning gel) in JK Concrete storage yard (Feature of interest 8).

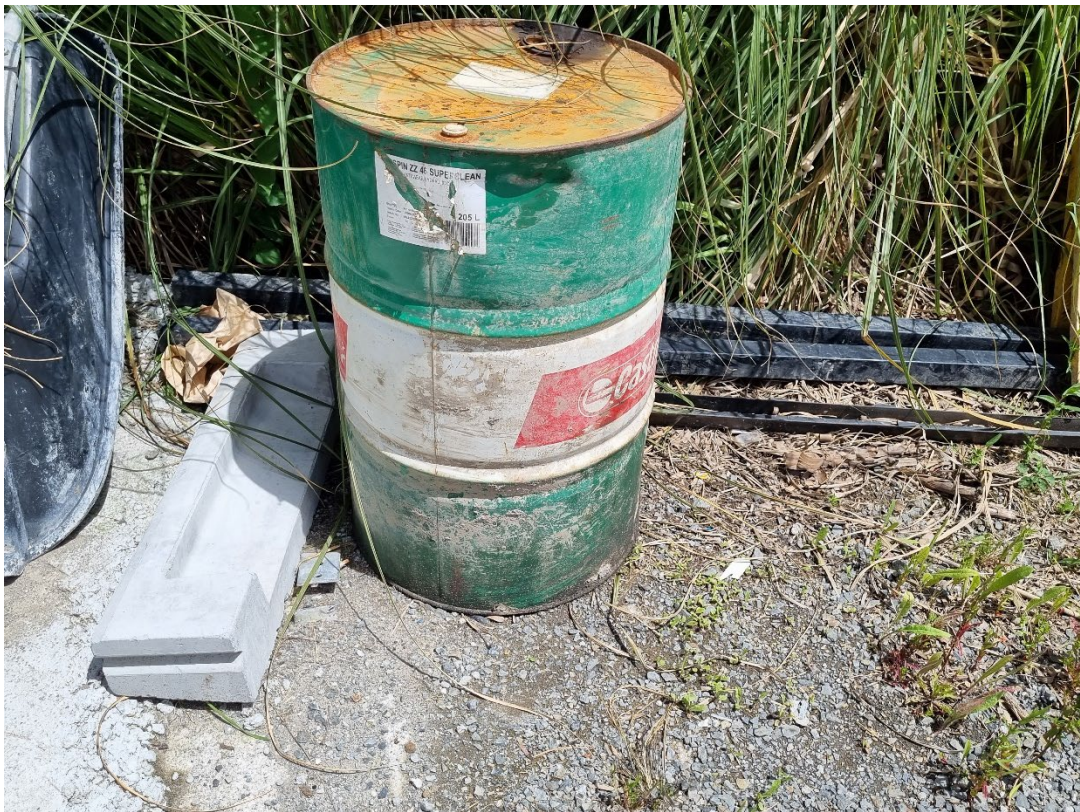
Photograph 12: Near empty 200 L steel drum of hydraulic oil on the western boundary of JK Concrete storage yard (Feature of interest 8).
