16A WICKHAM STREET, HAMILTON - PRELIMINARY AND DETAILED SITE INVESTIGATION

1.0 Introduction

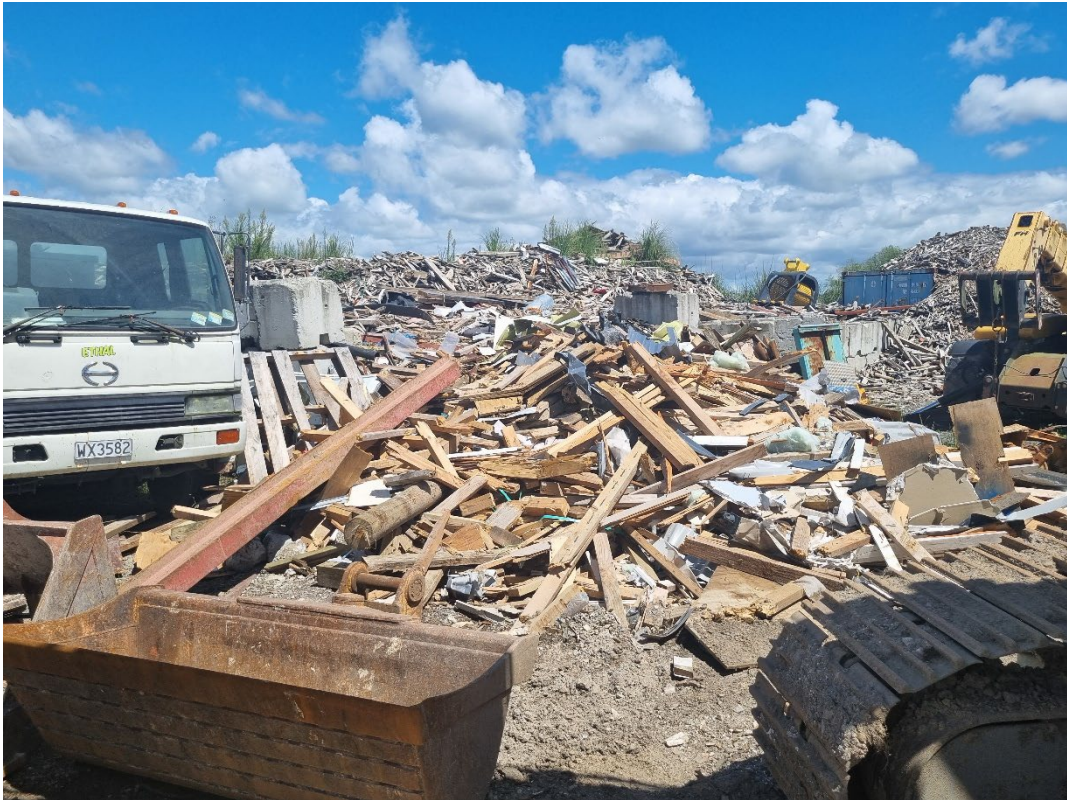
Photograph 13: Very large pile of timber (reportedly untreated) covering approximately 1/3 of the Pro Demolition yard (Feature of interest 9).

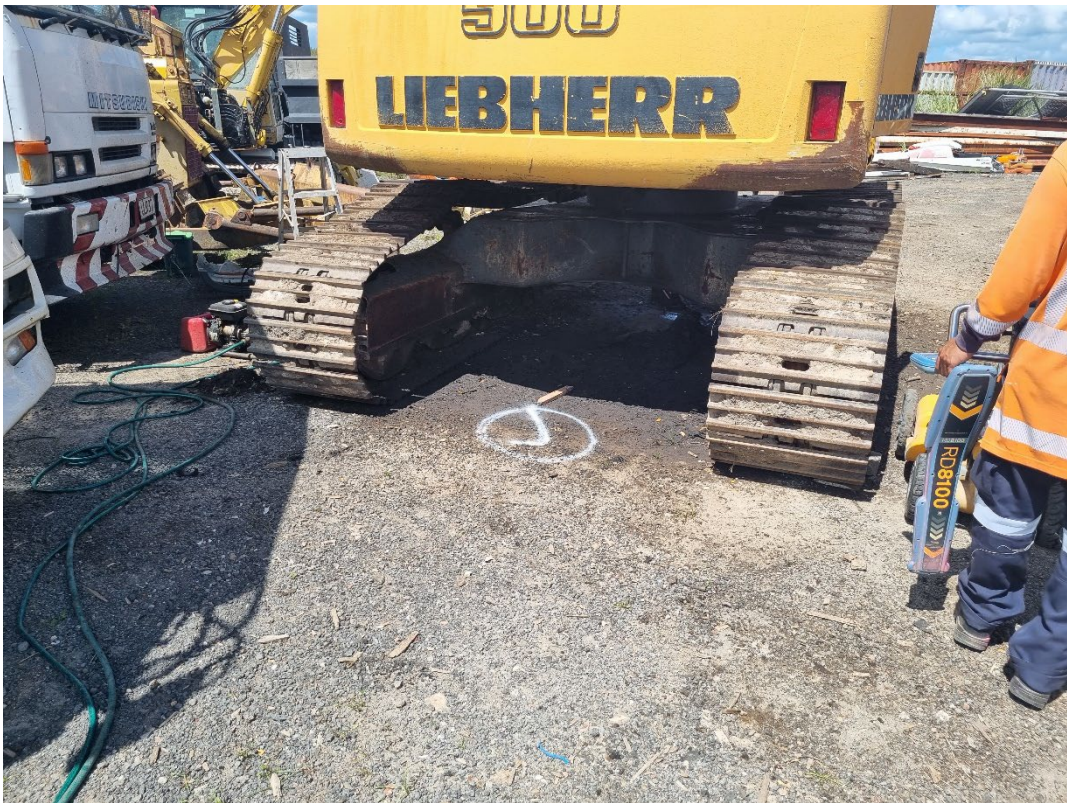
10	Yard 4 (Pro Demolition) <i>Photograph 14</i>	Staining of ground surface (approximately 4 m ²) beneath excavator.

Photograph 14: Staining of ground surface beneath excavator in Pro Demolition yard (Feature of interest 10).

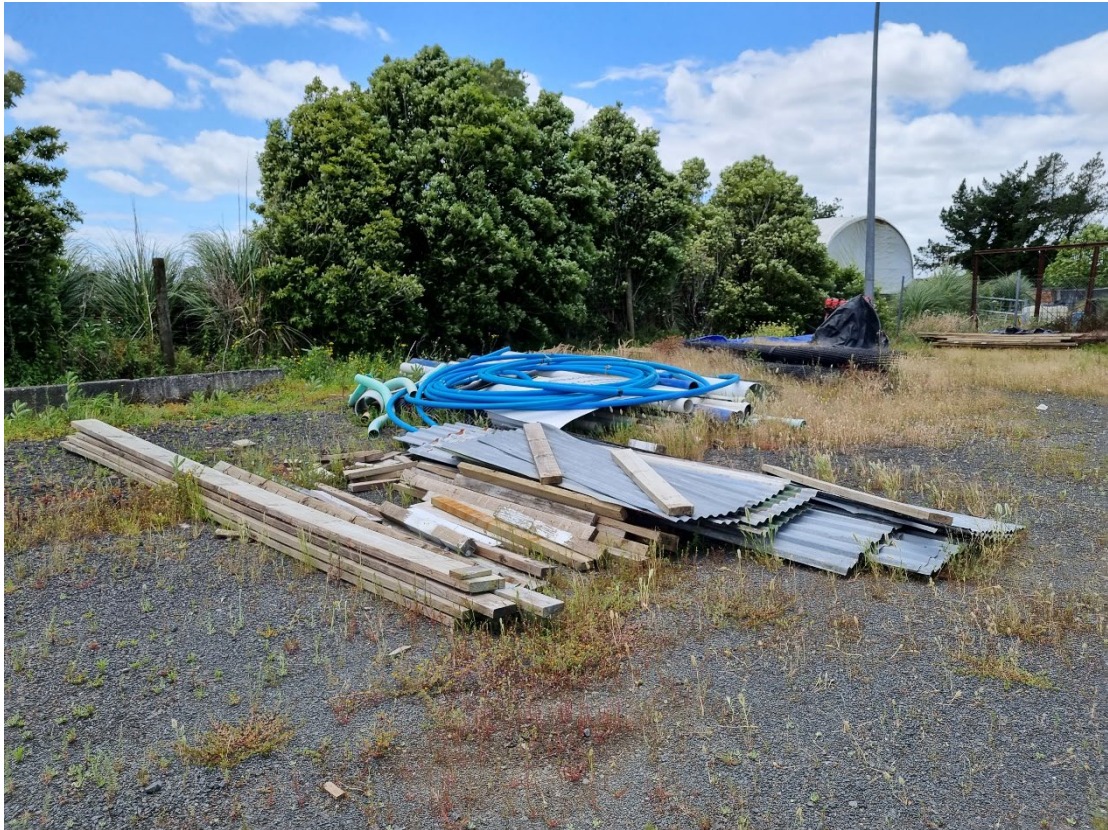
Photograph 15: Small pile of uncovered timber in the Cambridge Construction yard (Feature of interest 11).

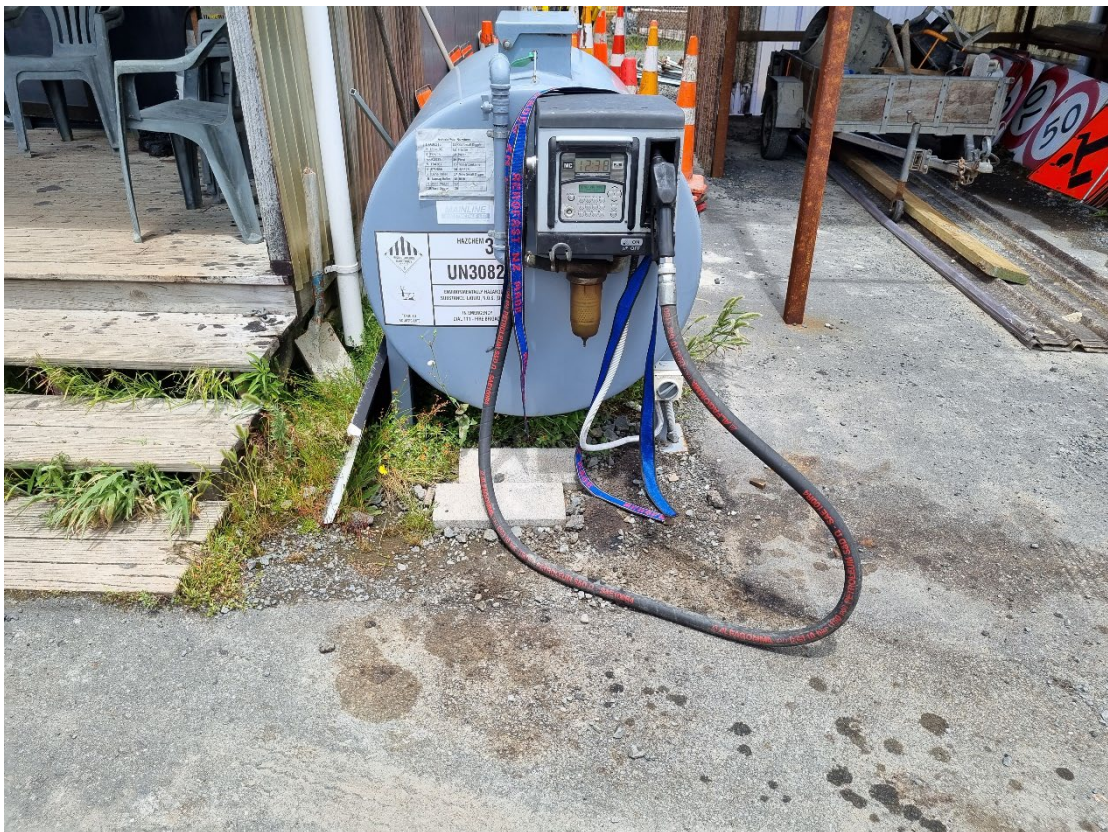
Photograph 16: Un-bunded diesel AST in Shaw Asphalters yard (central north of the site) (Feature of interest 12).

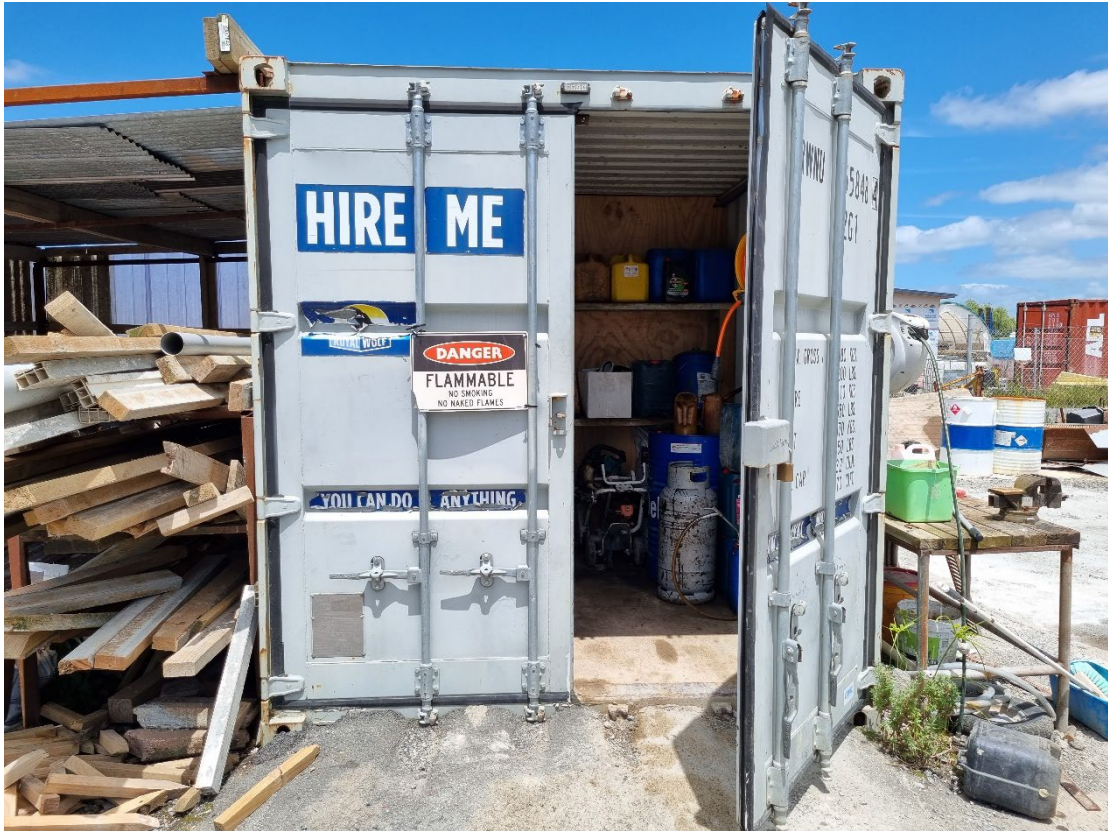
Photograph 17: Dangerous goods storage container in central south part of Shaw Asphalters yard (Feature of Interest 13).

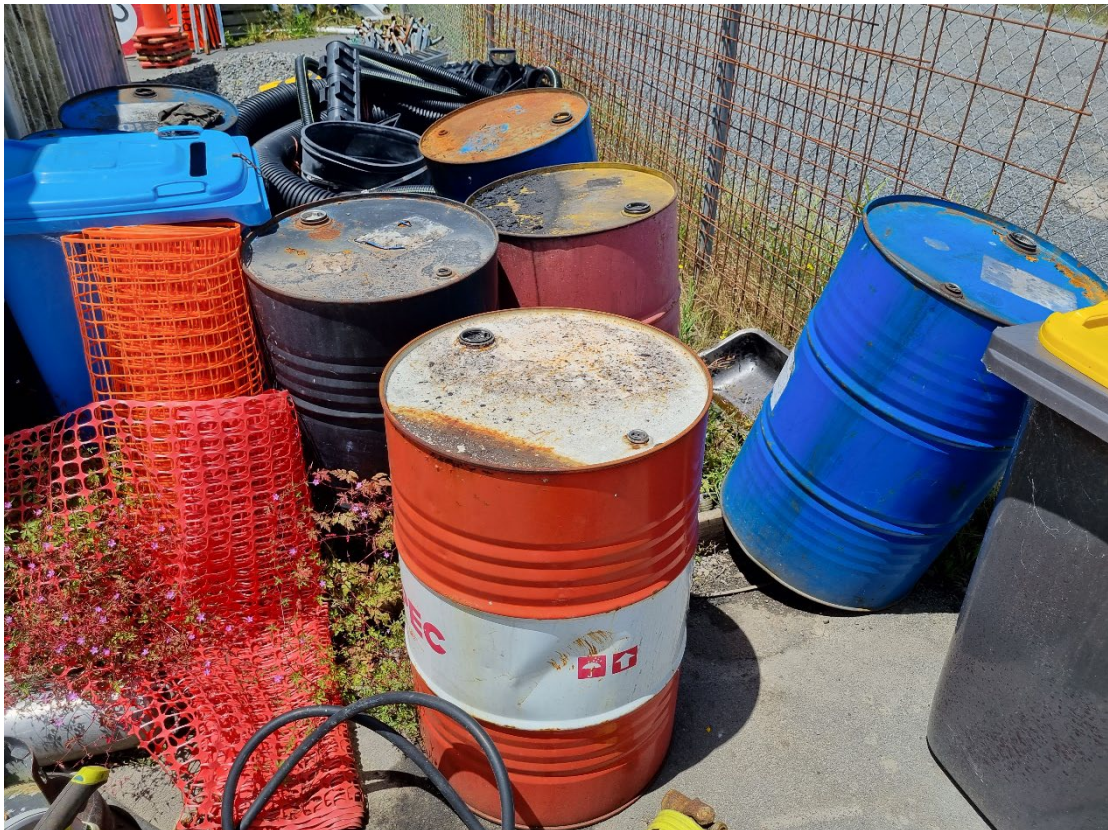
14	Yard 1 (Shaw's Asphalt) <i>Photographs 18 and 19</i>	Storage of seven sealed 200 L steel drums (half full to empty) containing kerosene and engine oil. Staining of the ground (approximately 3 m ²) observed in this area.	
15	Yard 1 (Shaw's Asphalt) <i>Photographs 20 to 23</i>	Open fronted building with two separate compartments used for vehicle, machinery and other (i.e., sealed, empty 20 L containers of engine/lube oil, tyres, carpet etc.) storage and as a 'workshop'. Some storage of 200 L steel drums containing kerosene and hydraulic fluid noted a long with numerous, minor (approximately 1 m ²) stains on ground surface.	
16	Yard 1 (Shaw's Asphalt) <i>Photograph 24</i>	Stockpile (approximately 25 m ³) of gravel, sand, concrete and bitumen.

Photograph 18: 200L Steel drums (empty to half full - containing kerosene and engine oil) behind dangerous goods storage container. 5 within a wooden 'bund' and 2 outside of bund on asphalt (Feature of interest 14).

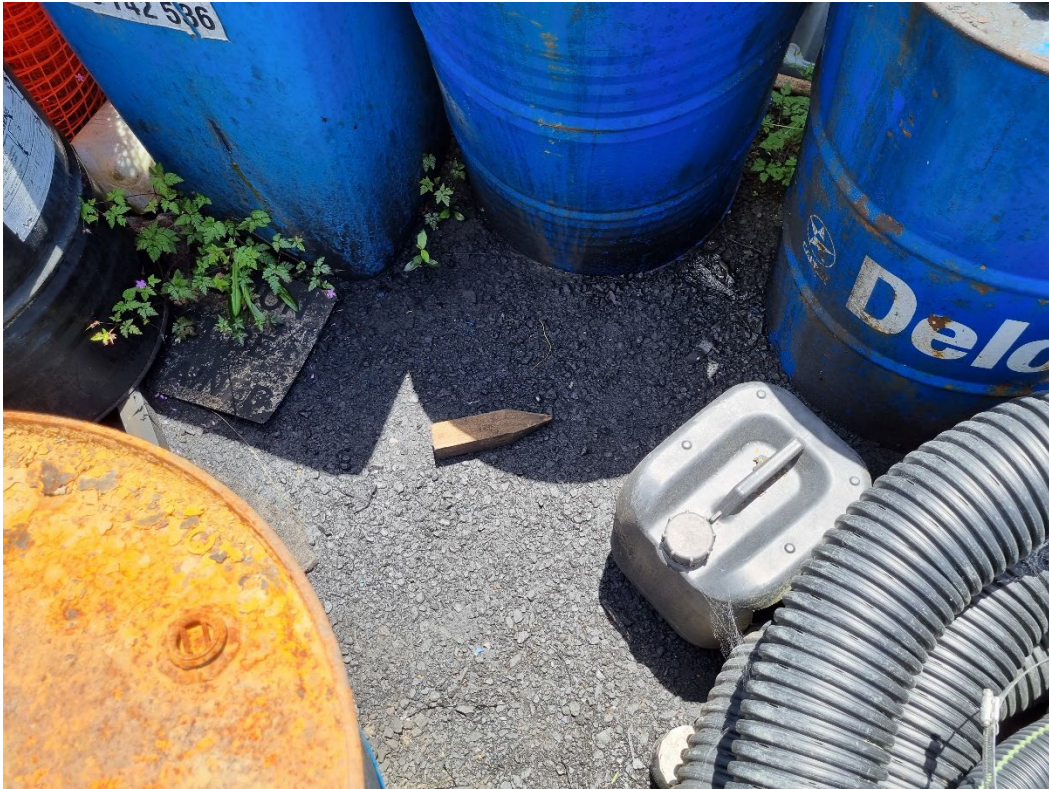
Photograph 19: Stained ground within the 'bund' containing 200L steel drums of kerosene and engine oil behind dangerous goods storage container (Feature of interest 14).

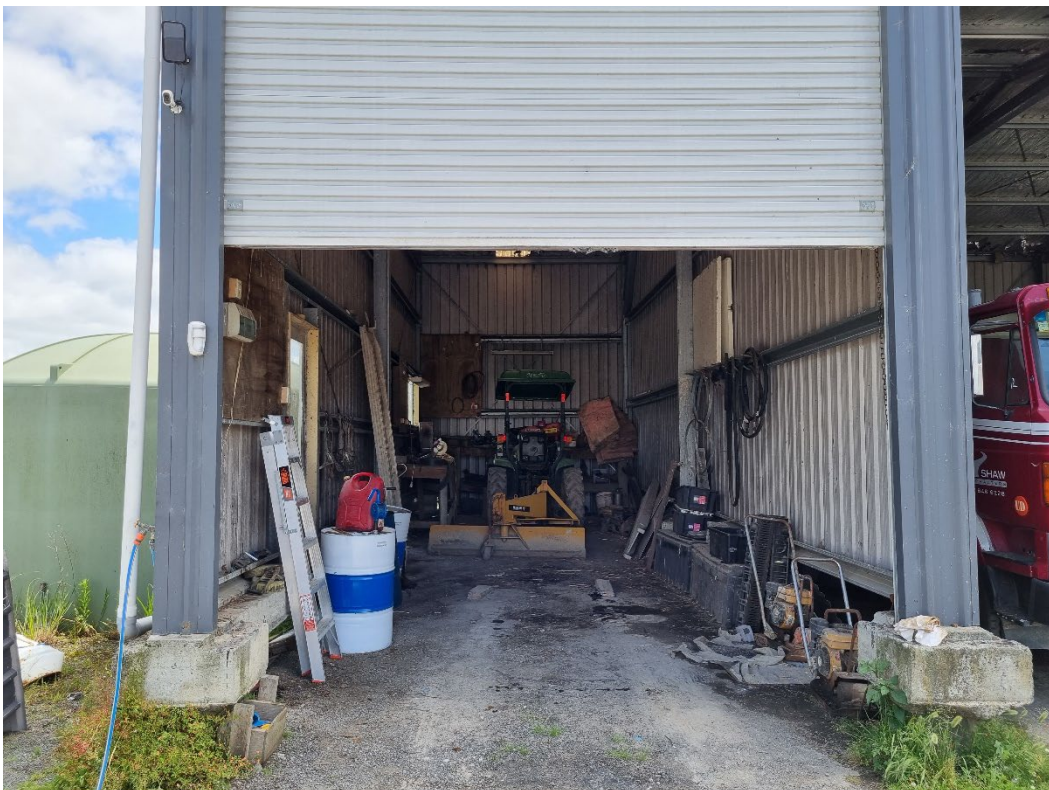
Photograph 20: 'Workshop' / storage shed on western boundary of Shaw Asphalters yard. Numerous black stains on ground. 2 x 200 L steel drums of kerosene and 1 x 200 L steel drum of hydraulic fluid (Feature of interest 15).

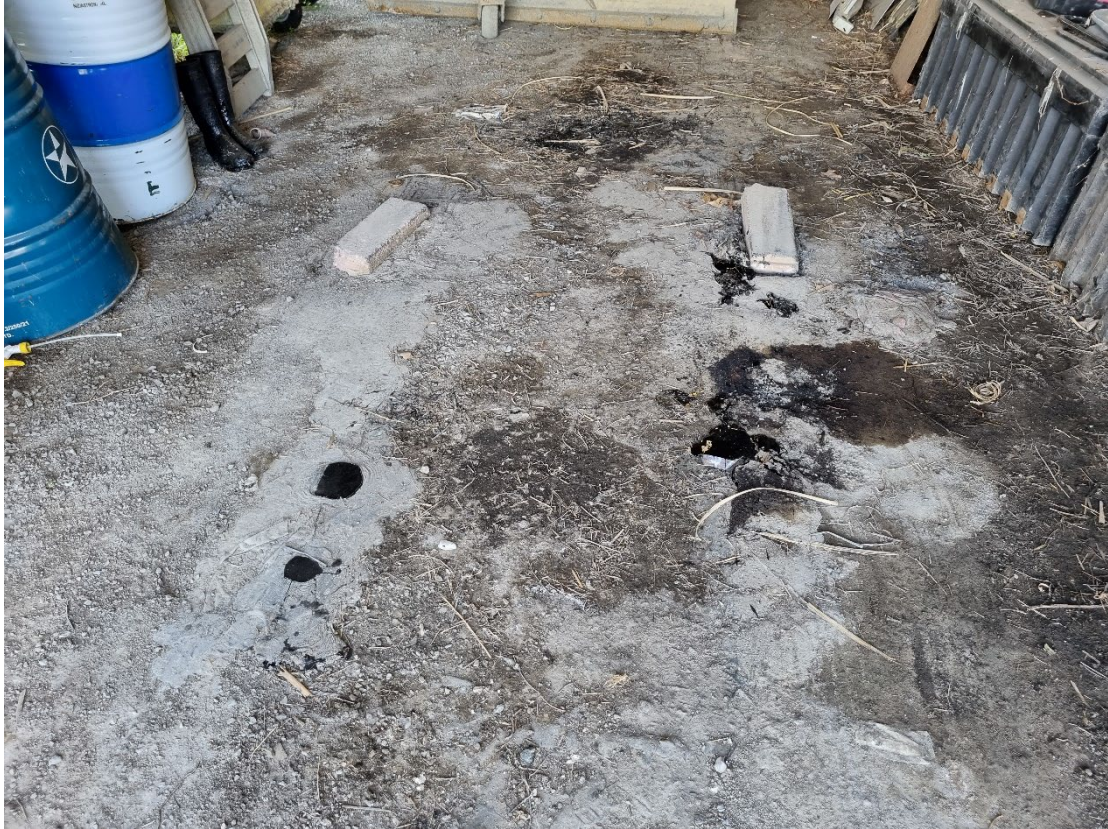
Photograph 21: Example of staining on ground in the 'Workshop'/storage shed (Feature of interest 15).

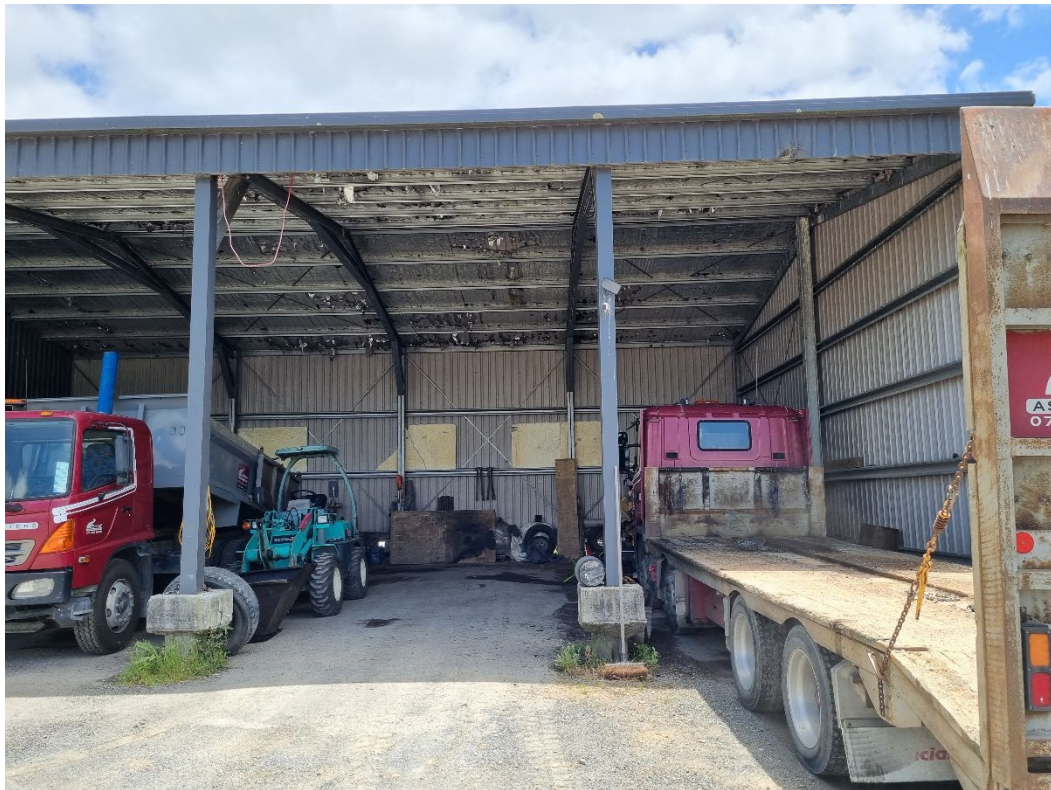
Photograph 22: 'Workshop' / Storage shed containing trucks, loader, digger and a Bitelli asphalt paver. Numerous stains on ground and general storage (i.e. empty 20L containers of engine/lube oil, tyres, carpet etc) (Feature of interest 15).

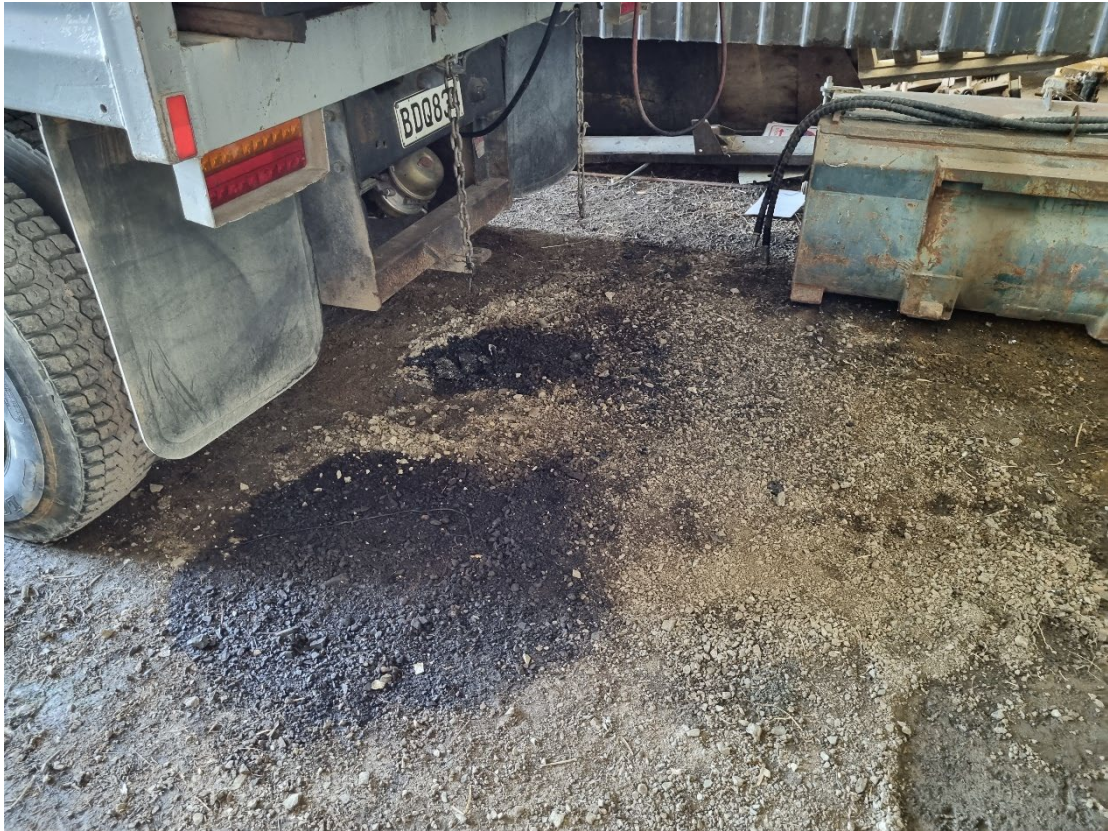
Photograph 23: Example of staining on ground in the 'workshop' / storage shed (Feature of interest 15).

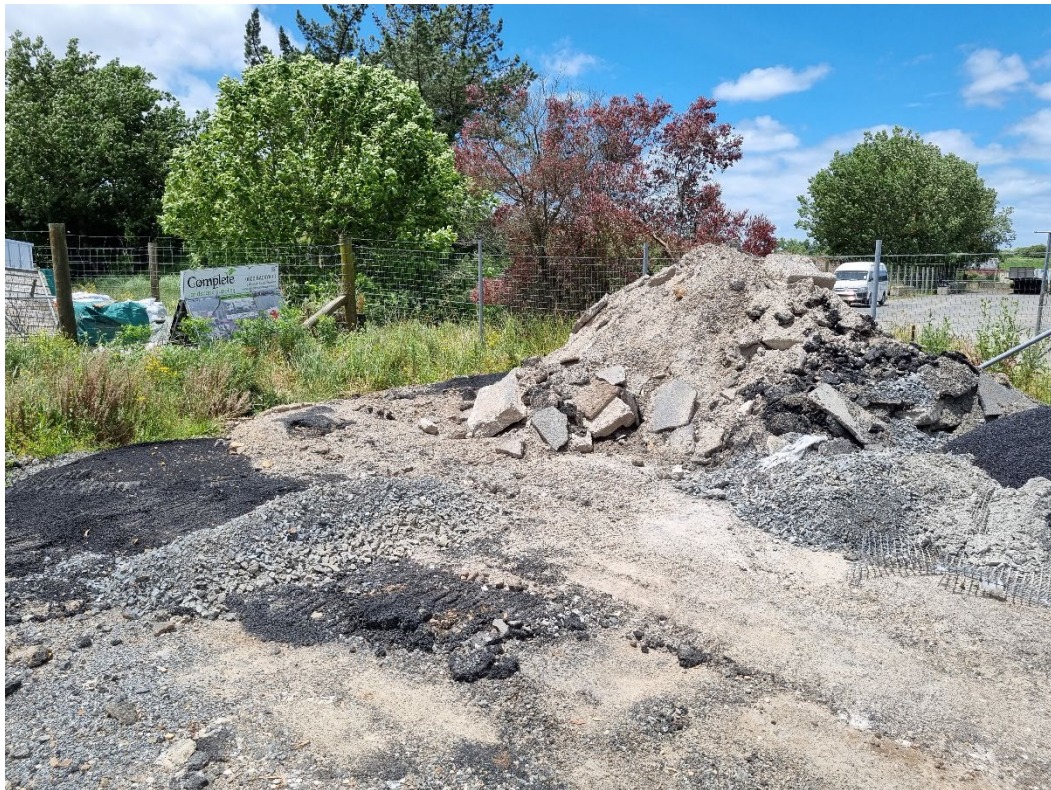
Photograph 24: Stockpile of gravel, sand, concrete and bitumen in the northeast corner of Shaw's Asphalters yard (Feature of interest 16).

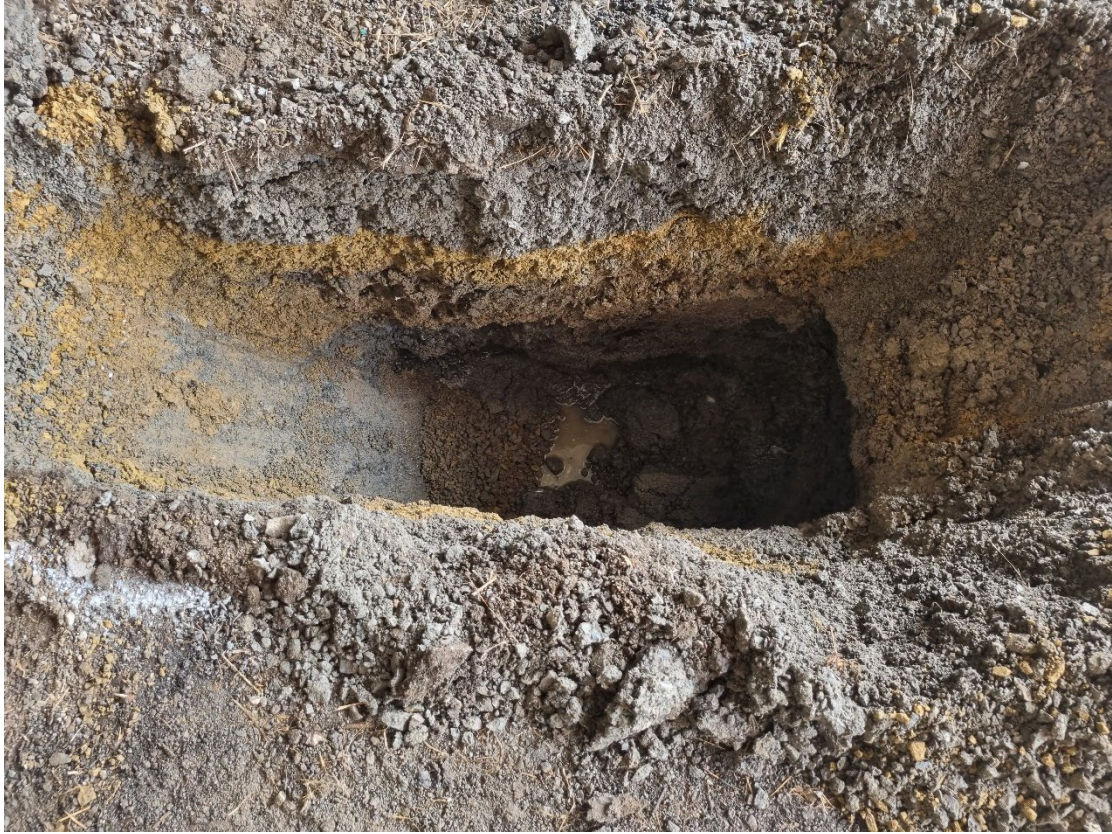
Photograph 25: Compacted layers of gravel and coarse-grained sand as observed at TP08.

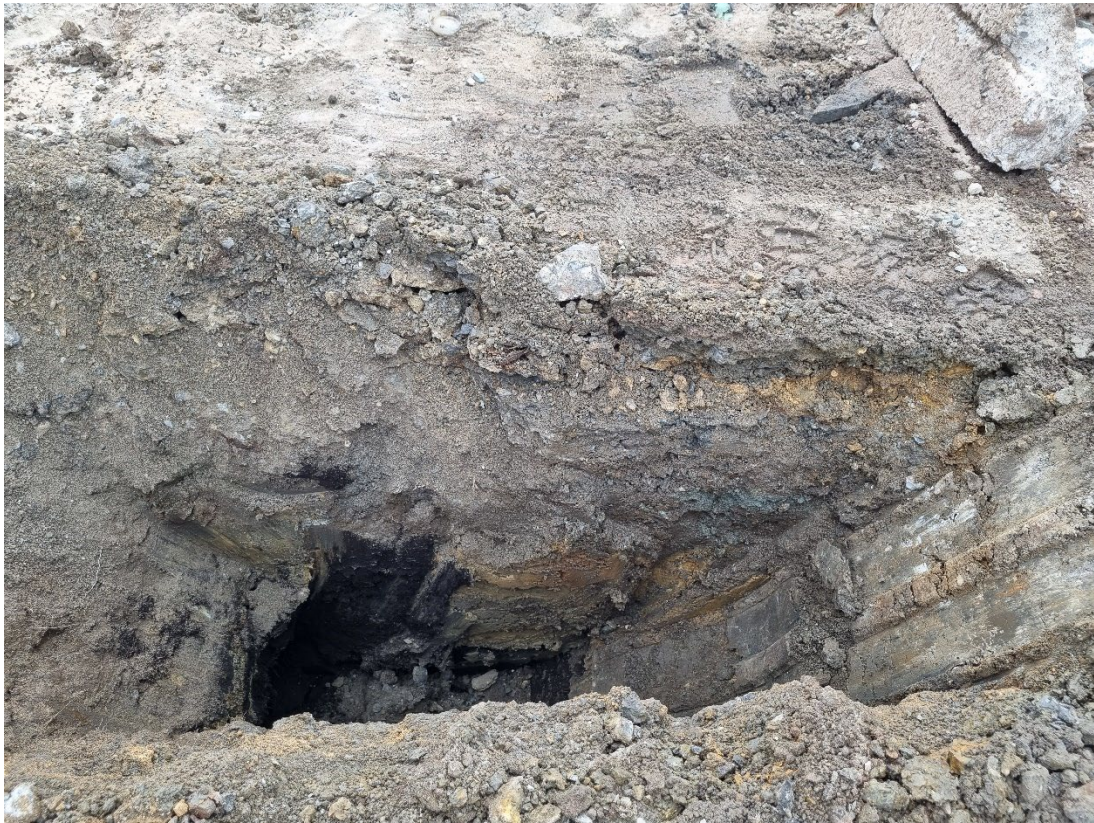
Photograph 26: Typical mixed fill encountered across the investigation area. Note the black peat at the bottom of the test pit.

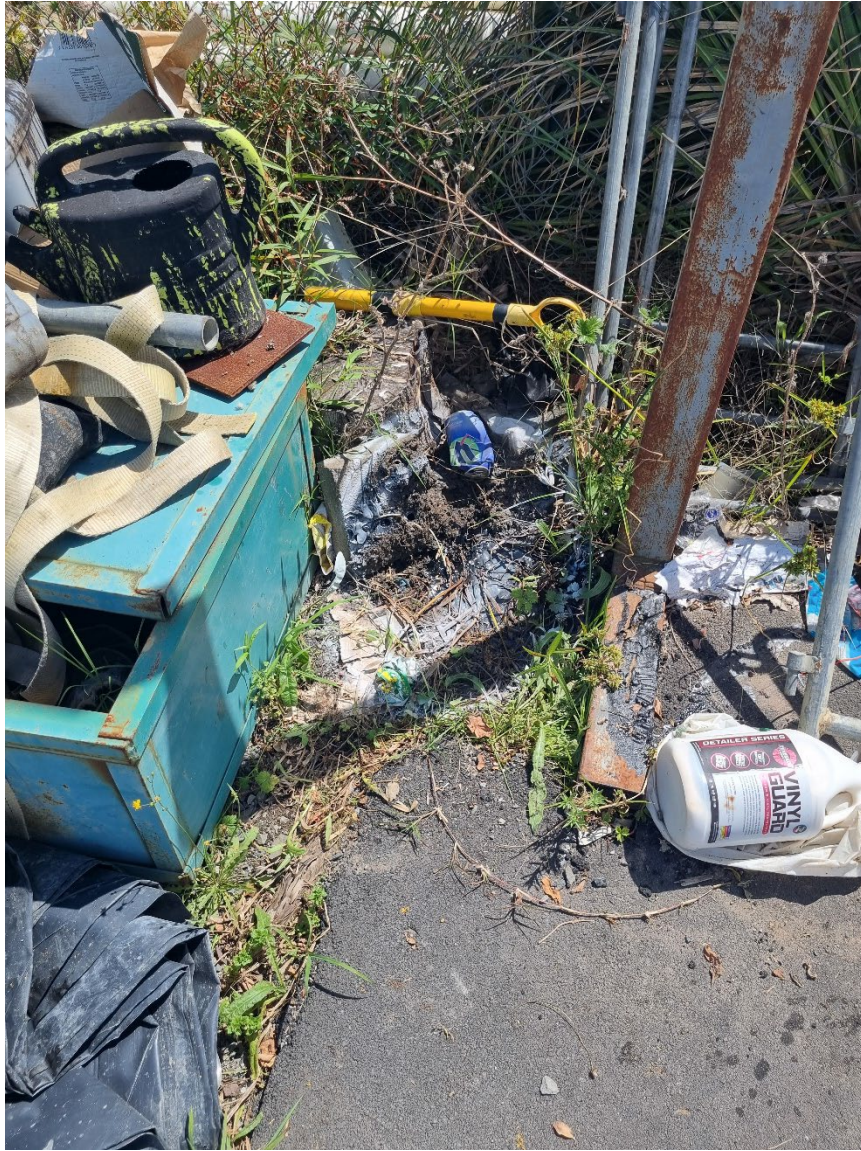
In general, no construction or demolition waste was observed within the surface / near surface fill layer, with the exception of asphalt, which was observed in all sampling locations apart from TP08 and TP09, and concrete, which was observed at locations TP01, TP03 and TP04. No evidence of possible ACM or municipal refuse was observed at any soil sampling locations. Bitumen emulsion was observed on the ground surface within Yard 6 (sample location TP03).

Photograph 27: Bitumen emulsion on ground surface at sample location TP03.
