From: [Lynne Sun](#)
To: [info](#)
Subject: External Sender: SUB Application | 318 Lamb Street, Cambridge
Date: Tuesday, 21 November 2023 3:55:04 pm
Attachments: [image003.png](#)

Resource Consent Application Form

SUBDIVISION DEVELOPMENT
LOTS 2003 & 2005 DP 535418 & LOT 2 DP 593787
318 LAMB STREET, LEAMINGTON - CAMBRIDGE
PREPARED FOR: MUSCLE DEVELOPMENTS

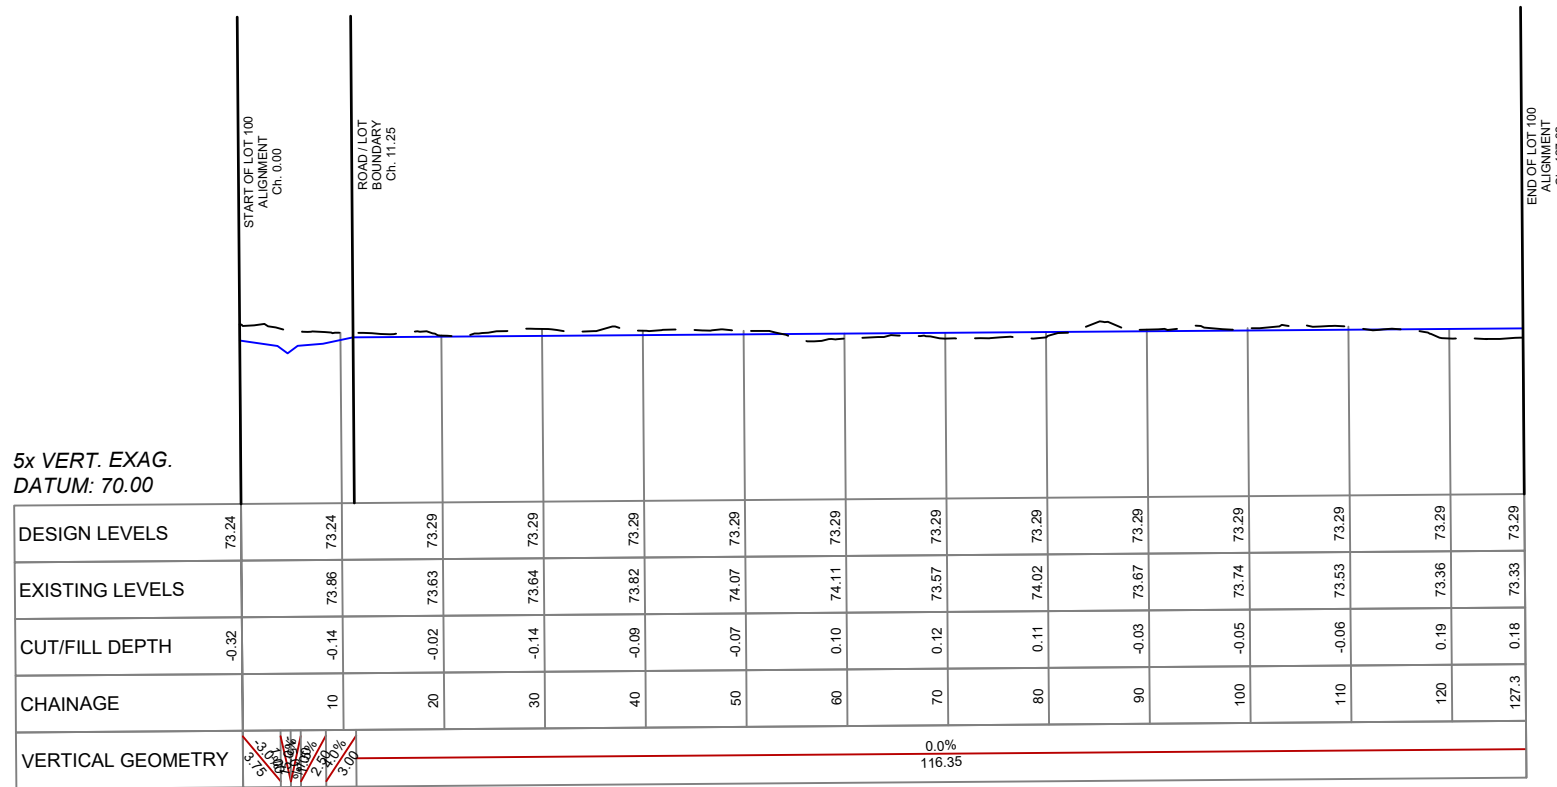
LOT 100 LONG SECTION

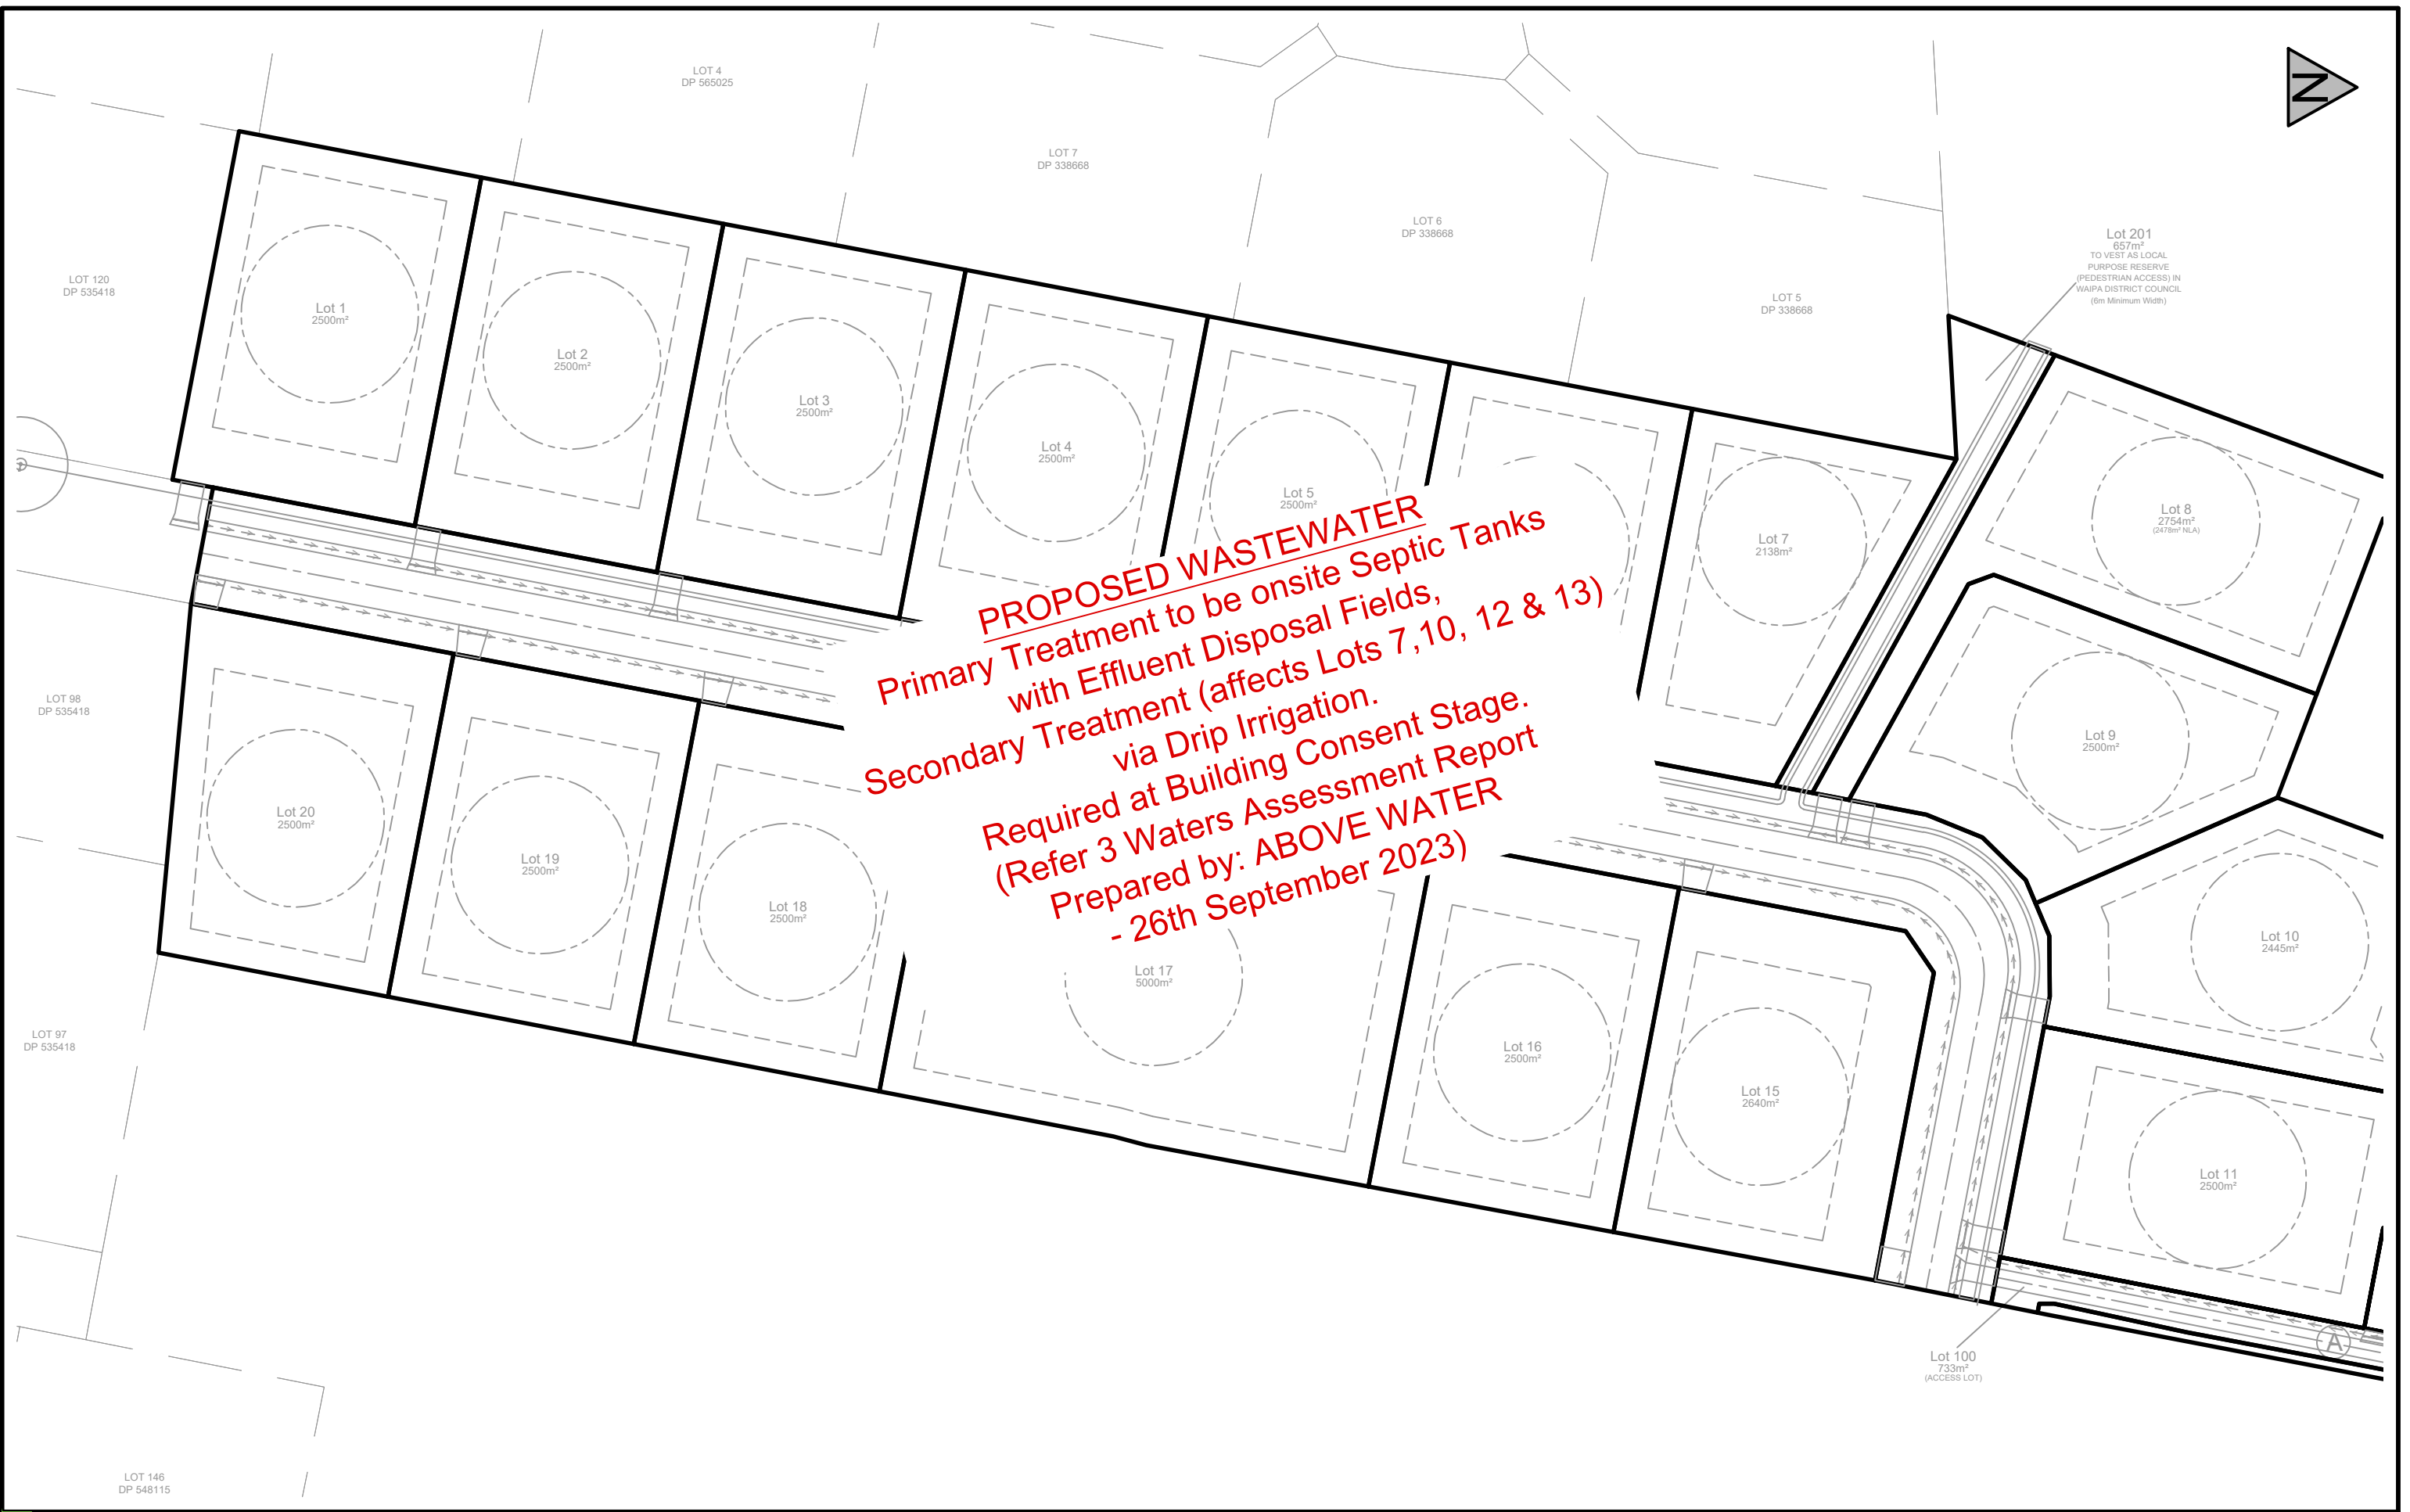
PROPOSED WASTEWATER
 Primary Treatment to be onsite Septic Tanks
 with Effluent Disposal Fields,
 Secondary Treatment (affects Lots 7, 10, 12 & 13)
 via Drip Irrigation.
 Required at Building Consent Stage.
 (Refer 3 Waters Assessment Report
 Prepared by: ABOVE WATER
 - 26th September 2023)

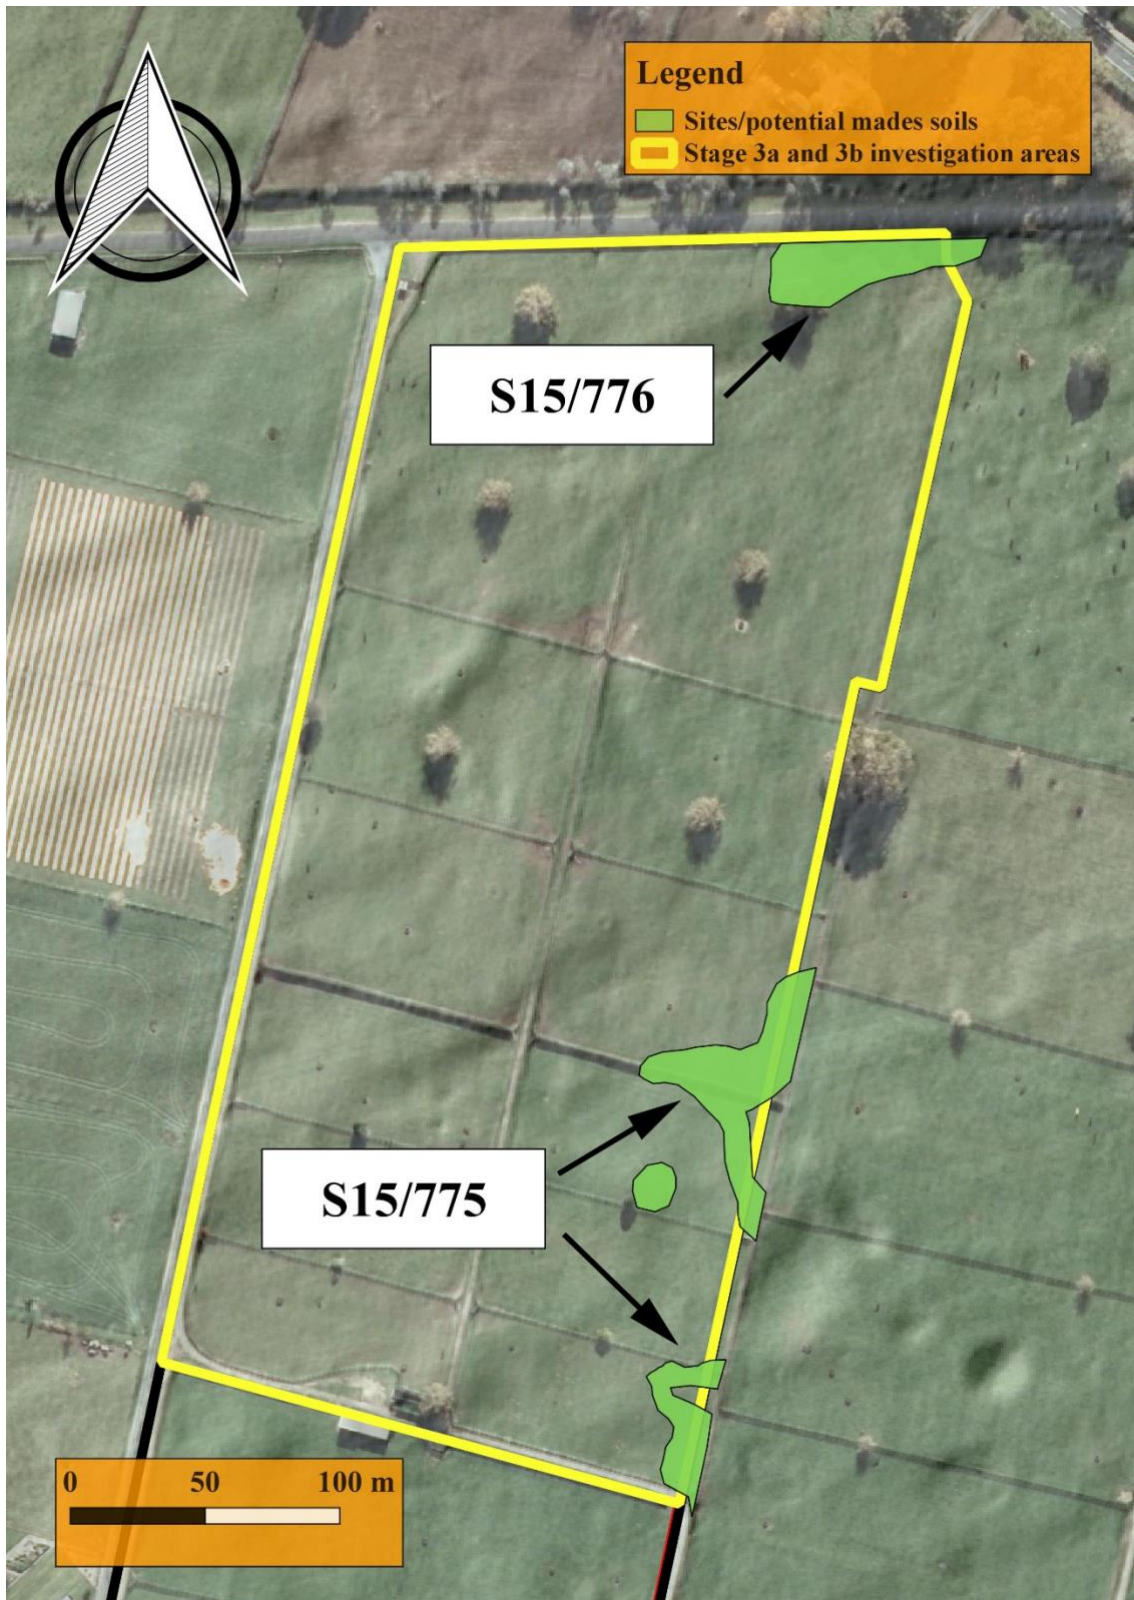
Figure 2: Distribution of potential made soils identified during coring survey of areas outlined in Stages 3a and 3b of the Pukekura subdivision, Leamington. Arrows denote tracts recorded as archaeological sites from the auger survey, while unlabeled polygons indicate areas with materials that are potentially of archaeological origin.

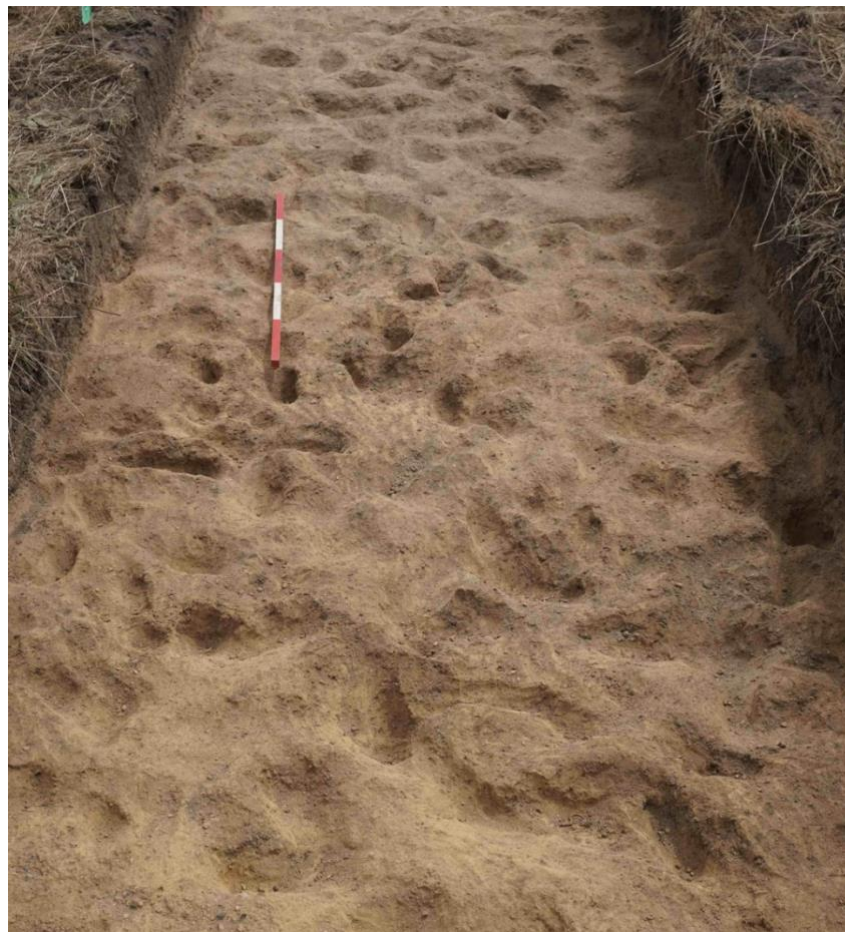
Figure 15: Example of the dimpled interface found at S15/374 at Ngaruawahia, garden site located on Waikato series soil.

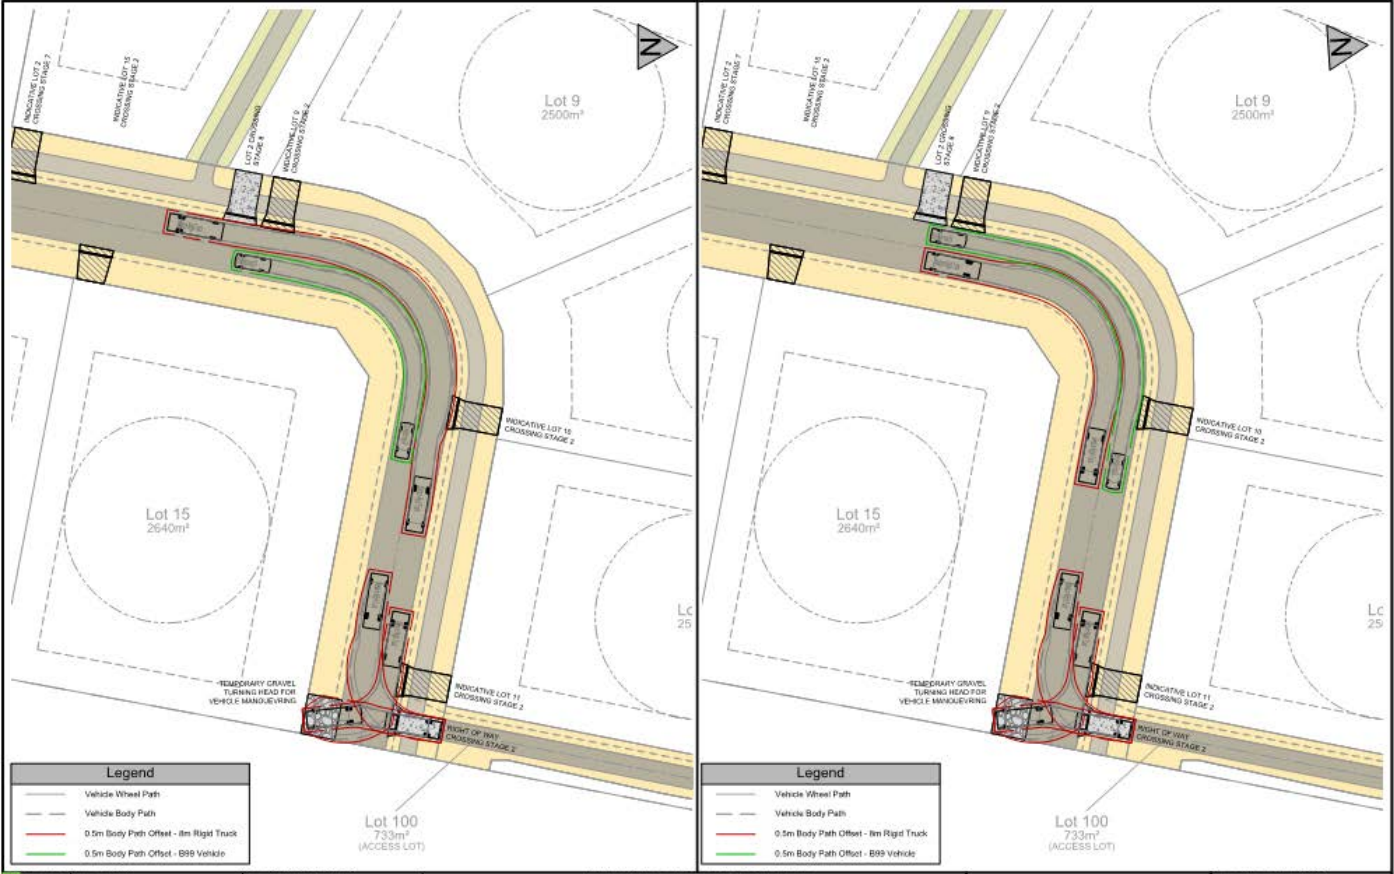
Figure 6: Vehicle tracking for a medium rigid truck (8m) and 99 percentile car

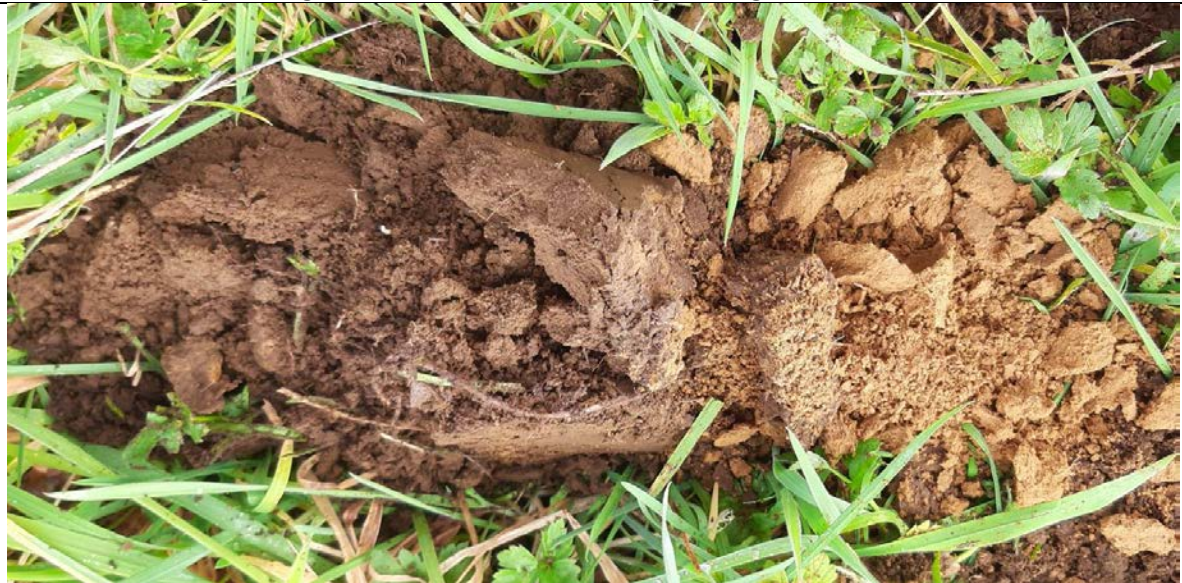
Photo 6: Typical soil conditions across site (topsoil underlain by silt and sand)

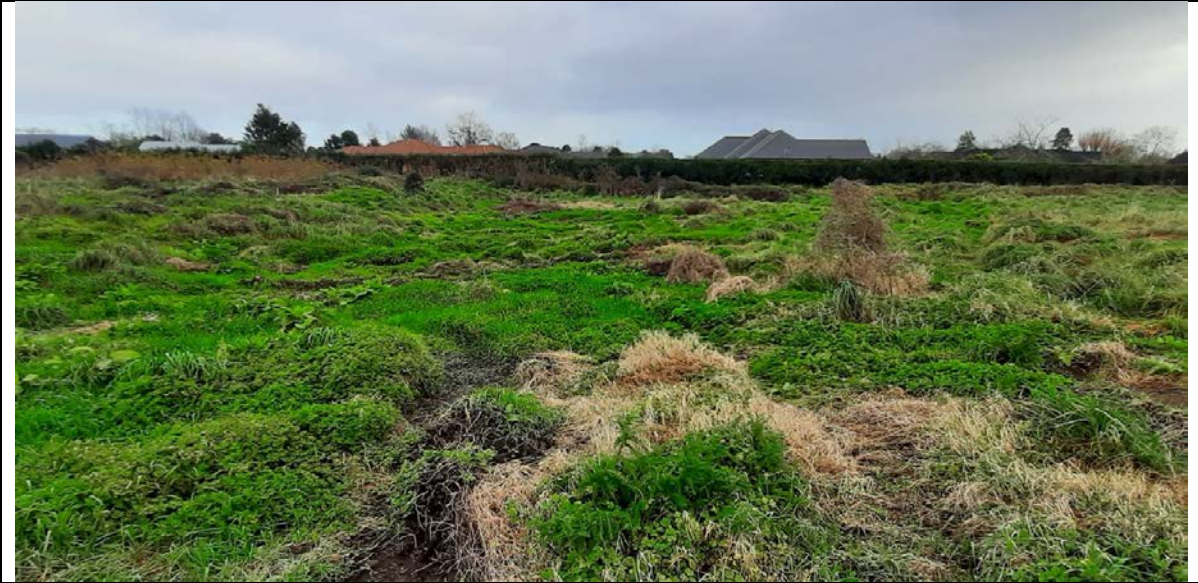
Photo 7: Rubbish pit footprint, facing west

Notwithstanding the above, the DSI did reveal that lead and arsenic were present in soil samples within the rubbish pit above the applied human health guidelines. Furthermore, it was recommended in the DSI that the soil within the rubbish pit was not suitable for offsite disposal as clean fill.

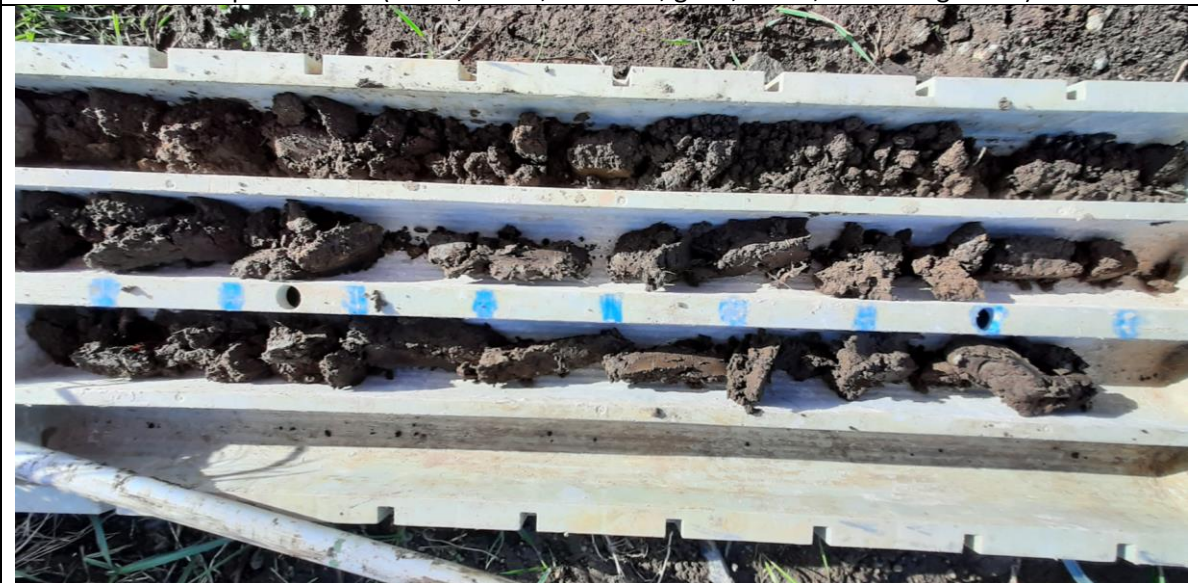
Photo 9: Soil conditions within rubbish pit (organic silt with intermixed sand, gravel, and debris)

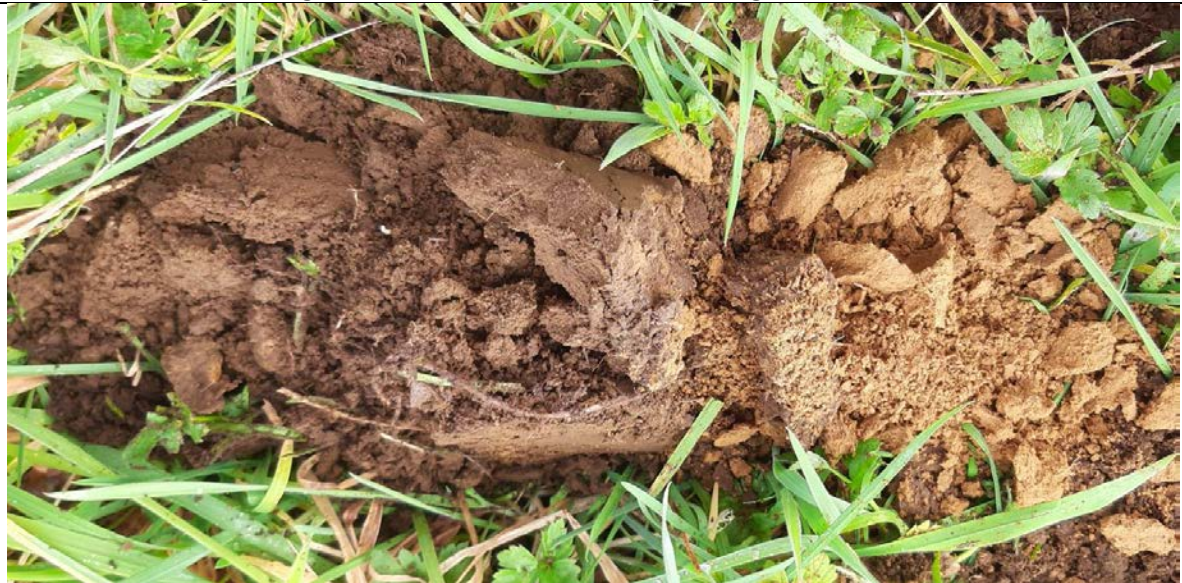
Photo 6: Typical soil conditions across site (topsoil underlain by silt and sand)

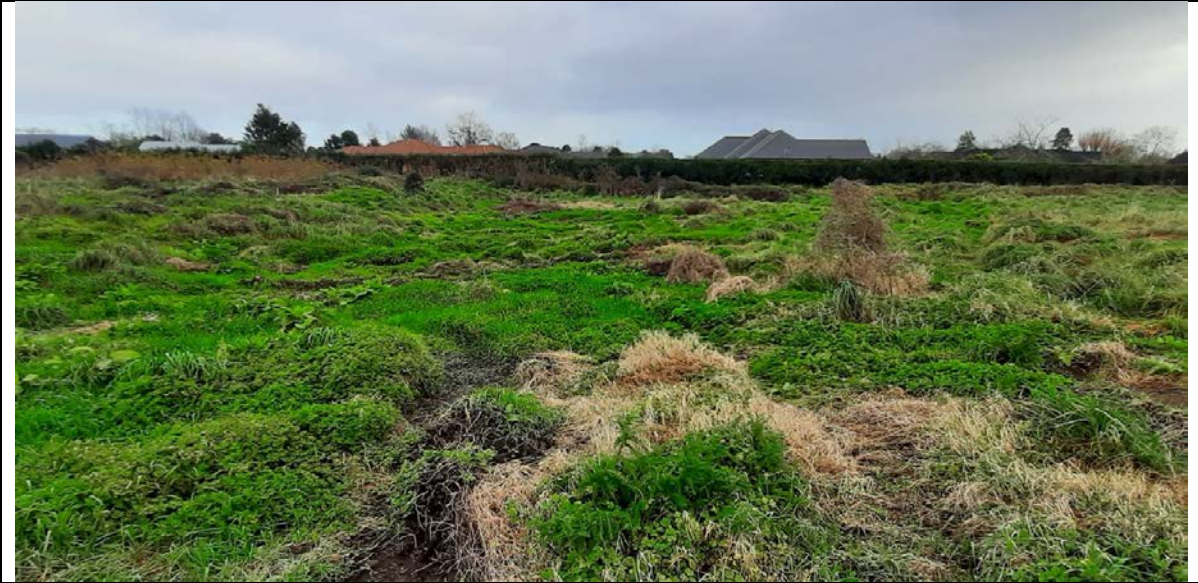
Photo 7: Rubbish pit footprint, facing west

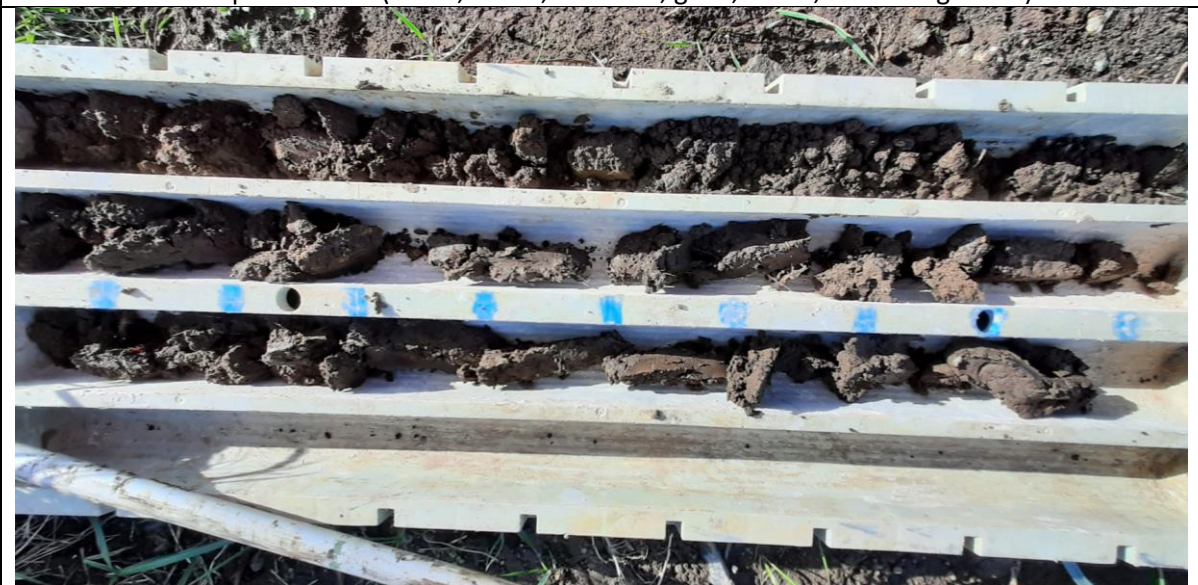
Photo 9: Soil conditions within rubbish pit (organic silt with intermixed sand, gravel, and debris)
