Victoria St Bridge(RP969) - Main Arch Bridge Structural Assessment Report

Prepared for Waipa District Council
Prepared by Beca Limited

10 November 2021

Victoria Bridge-Cambridge Steel Components Inspection Report

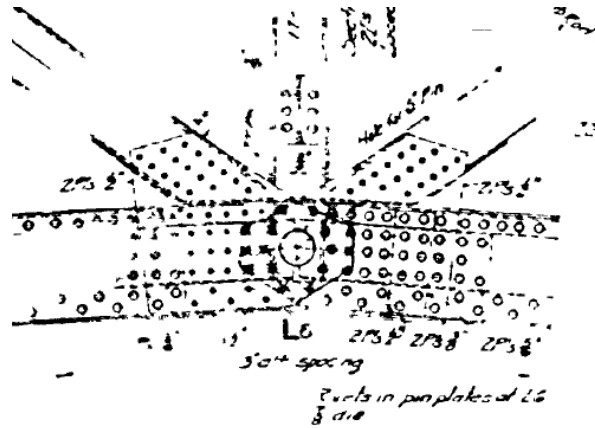
Figure 6-2 – Central Pin Original Construction Details

The bridge has a central 6" (152mm) diameter pin at mid length of the main arch span (on each side of the bridge) as indicated in Figure 6-2. The pin transfers axial loads between the main arch members, and the vertical and diagonal members that also connect to the pin.
