Liquefaction Desktop Study

Ngahinapouri Village Concept Plan

Tonkin & Taylor Ltd

August 2019

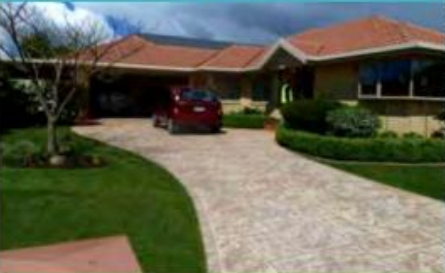
<ul style="list-style-type: none"> – None to Minor no signs of ejected liquefied material at the ground surface¹. – No more than minor differential settlement of the ground surface (eg undulations less than 25 mm in height). – No apparent lateral spreading ground movement (eg only hairline ground cracks). – Liquefaction causes no or only cosmetic damage to buildings and infrastructure (but damage may still occur due to other earthquake effects).
<p data-bbox="327 633 518 656" style="text-align: center;">Minor to Moderate</p>

Figure 2.3 presents the characteristics of liquefaction related land damage, and a summary of the likely consequences of liquefaction related damage for each category of land damage. This figure has been reproduced from (MBIE/MfE/EQC, 2017). Appendix A of the MBIE Guidance includes photos of liquefaction-induced land damage for each of these categories. These provide a useful reference for understanding the magnitude of land damage that can be expected within each category.

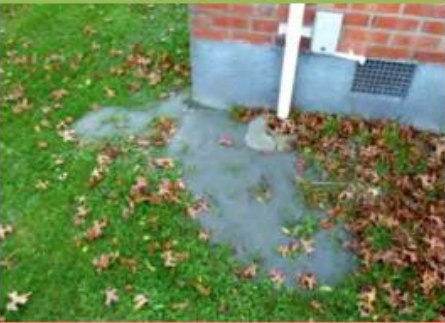
<ul style="list-style-type: none"> – Minor to Moderate quantities of ejected liquefied material at the ground surface (eg less than 25 percent of a typical residential site covered²); and/or – Moderate differential settlement of the ground surface (eg undulations 25–100 mm in height). – No significant lateral spreading ground movement (eg ground cracks less than 50 mm wide may be present, but pattern of cracking suggests the cause is primarily ground oscillation or settlement rather than lateral spreading). – Liquefaction causes moderate but typically repairable damage to buildings and infrastructure. Damage may be substantially less where liquefaction was addressed during design (eg enhanced foundations).

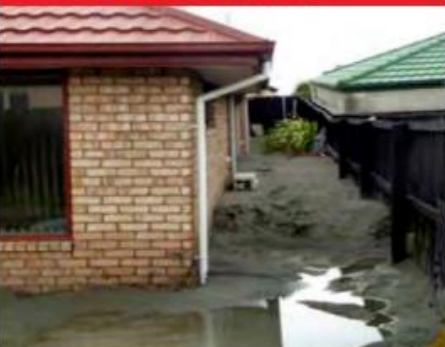
<ul style="list-style-type: none"> – Large quantities of ejected liquefied material at the ground surface (eg more than 25 percent of a typical residential site covered²); and/or – Moderate to Severe differential settlement of the ground surface (eg undulations more than 100 mm in height); and/or – Significant lateral spreading ground movement (eg ground cracks greater than 50 mm wide, with pattern of cracking suggesting direction of movement downslope or towards a free-face). – Liquefaction causes substantial damage and disruption to buildings and infrastructure, and repair may be difficult or uneconomic in some cases. Damage may be substantially less, and more likely to be repairable, where liquefaction was addressed during design (eg enhanced foundations and robust infrastructure detailing).
